Spartan Motors Chassis, Inc.

SERVICE BULLETIN

RSB13-810-003

SUBJECT: Spartan Motors Chassis, Inc. has determined a defect involving the Restraints Control Module (RCM), of the Spartan Advanced Protection System (APS) may exist in certain Metro Star and Gladiator model Emergency Response chassis cabs.

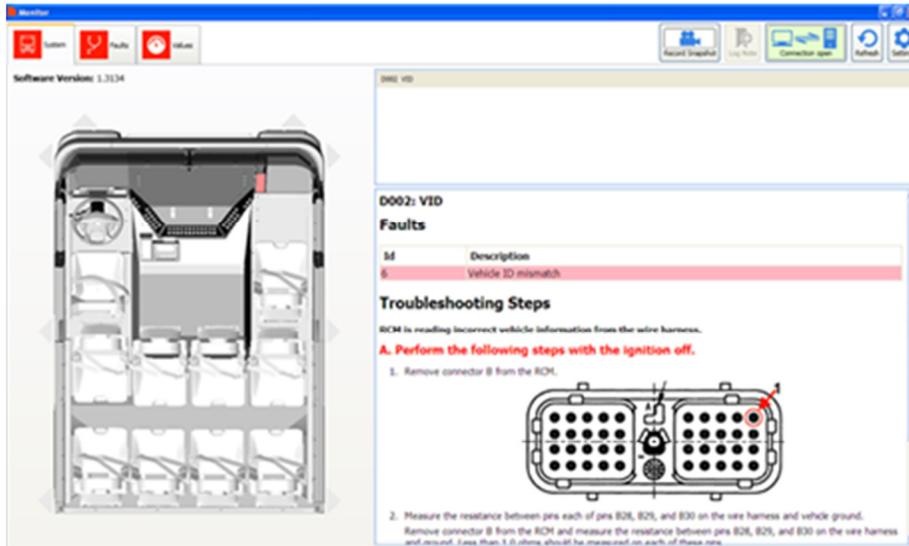
FIG. 7-1

20. An example of a unit with a fault can be seen in FIG. 7-1; which will require troubleshooting.
