Safety Defect and Noncompliance Report Guide for Vehicles

PART 573 Defect and Noncompliance Report

**Subject: Dometic Corporation Recreation Vehicle Power Awning Recall Notification**

#### 9100 POWER AWNING, WEATHERPRO AWNING AND MOTOR SERVICE KITS

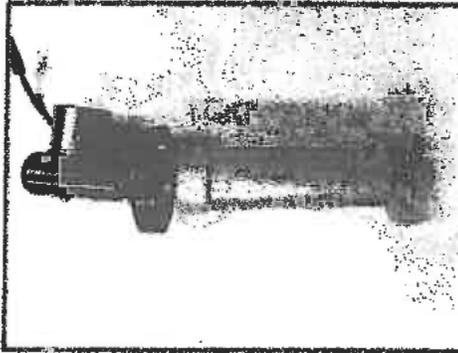
**Awning Motor –**  
Pre February 13, 2013. This motor  
is not affected by the product  
recall.

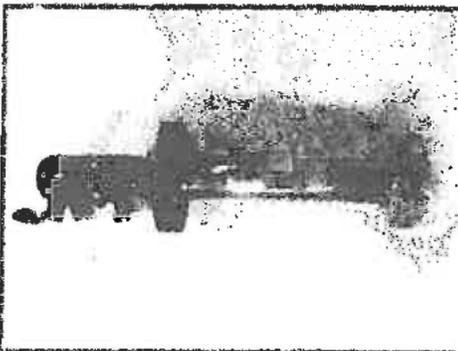
**Awning Motor –**  
This motor is affected by the  
product recall.  
Serial Range 306xxxx to 314xxxx  
Manufacturing Date Range  
02/13/2013 to 04/09/2013

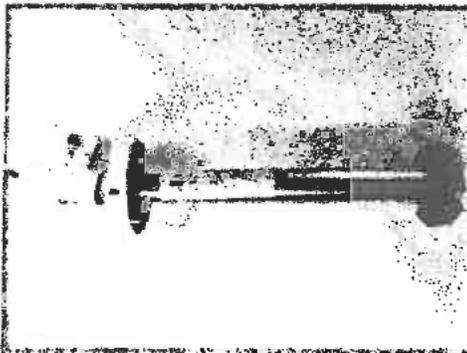
**Awning Motor –**  
Post April 9, 2013. This motor is  
not affected by the product recall.

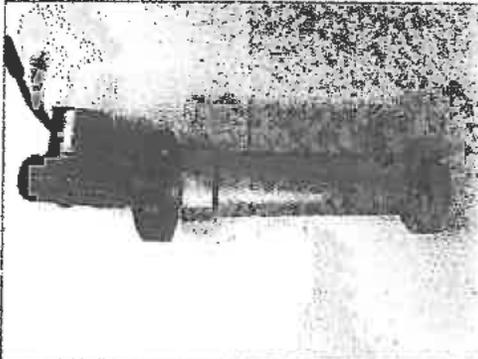
**Awning Motor**  
Pre February 13, 2013. This motor is **not** affected by the product recall.

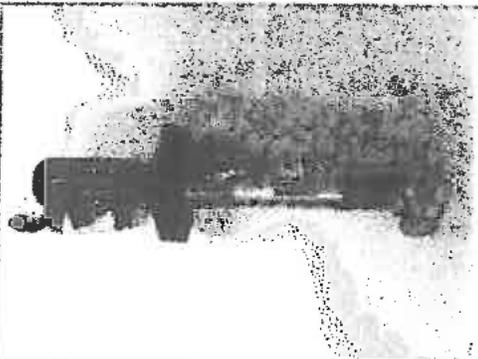
**Awning Motor**  
This motor is affected by the product recall.  
Serial Range 306xxxx to 314xxxx  
Manufacturing Date Range  
02/13/2013 to 04/09/2013

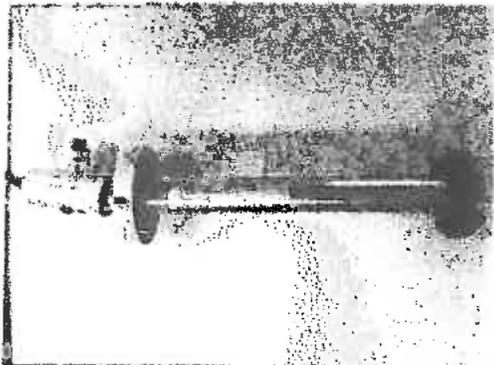
**Awning Motor**  
Post April 9, 2013. This motor is **not** affected by the product recall.
