UCI-FRAM Group

The following information is submitted in accordance with the National Highway Traffic Safety Administration's defect reporting regulations, 49 CFR § 573.6. This report relates to certain replacement fuel pumps.

This report applies to a replacement fuel pump model number E3591M. The pump fits certain General Motors vehicles, including the Chevrolet Malibu (2004 to 2008), Pontiac G6 (2005 to 2008), and Saturn Aura (2007 and 2008).

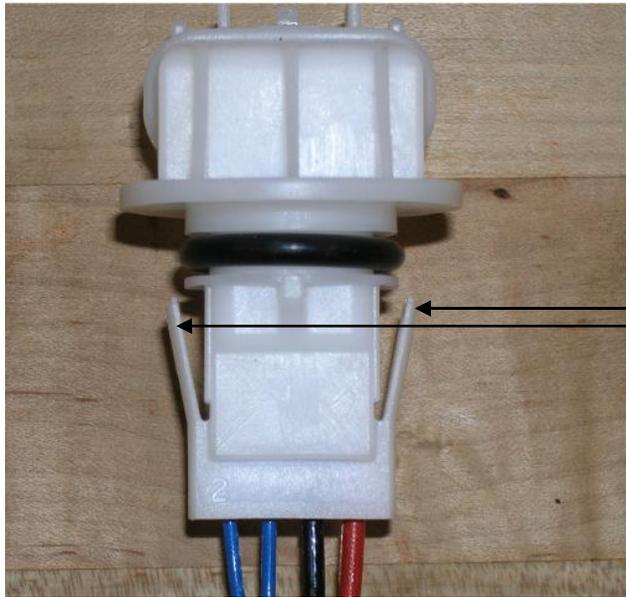
Figure 1

The E3591M has a newly-designed electrical connector that links the motor and sensors which are situated inside the fuel tank to the vehicle's electrical supply. The only product that Airtex has sold and which uses this affected electrical connector is the E3591M. The connector has plastic tabs (see, fig.1) that may not engage because they may not properly align (see, fig. 2), or break during assembly or during shipment. If the tabs are not engaged, the connector will not properly seal (see, fig. 3).

Depiction of Tabs

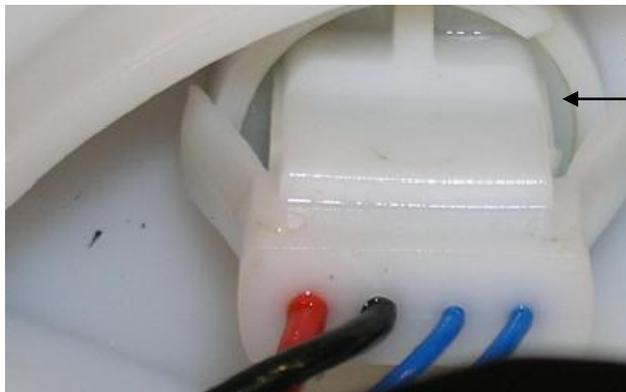
Figure 2

Tabs Not Engaged

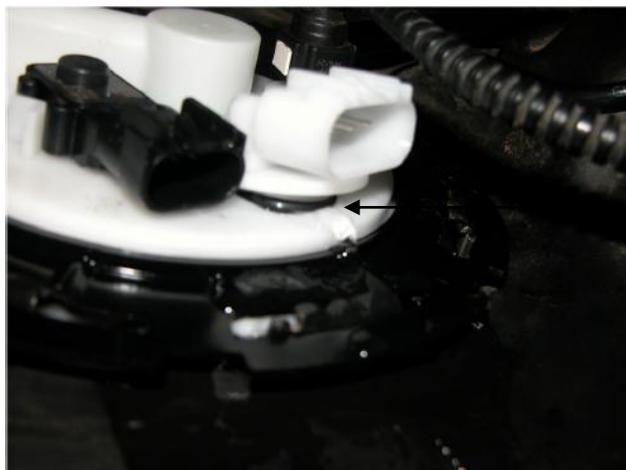
Figure 3

Failure to Seal

The resulting lack of seal may allow fuel to escape when the tank is full. Airtex has not received any reports of failures in installed pumps or any reports of leaking fuel. However, based on its investigation, Airtex believes that the 145 non-conforming pumps it manufactured may fail in this manner.

The remedy program will consist of no cost replacement of un-installed fuel pumps as well as an inspection and replacement program for any E3591M Fuel Pump installed between June 10, 2013 and August 16, 2013. To date, many customers have received notice to quarantine un-installed pumps with package date codes 243, 263, 283 and 293. Airtex is taking steps to sort these products and replace potentially defective pumps with conforming pumps at no charge.
