# RECALL CAMPAIGN BULLETIN

NTB13-073a

## VOLUNTARY SAFETY RECALL CAMPAIGN 2014 VERSA NOTE; LOWER BODY SILL BOLTS

**CAMPAIGN ID #:** PM366

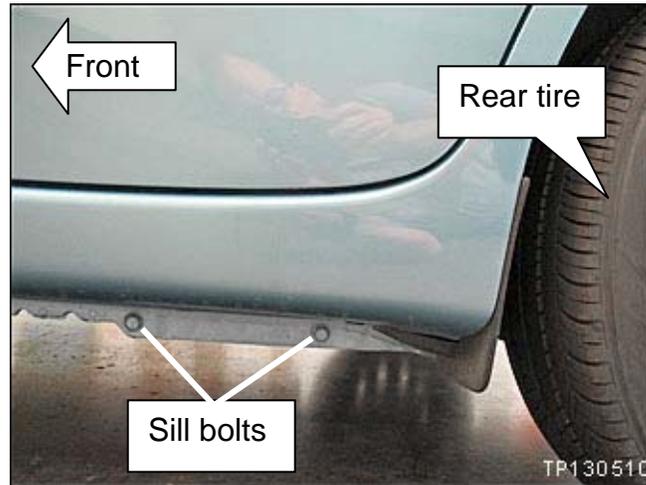
Figure 1

1. Locate the 2 lower body sill bolts on the left or right side (see Figure 1).

- Make sure both bolts are torqued to 30 N•m (3.0 kg-m, **22 ft-lb**).

- a. For missing bolts, clean the female threads with an 8 mm x 1.25 tap.
- b. Apply “thread locker” to the male threads of replacement bolts.
  - To obtain replacement bolts, see Replacement Lower Body Sill Bolts on the next page.
  - Use Loctite® 243™ medium strength thread locker or equivalent.
- c. Replace the missing bolts.
- d. Make sure both bolts are torqued to 30 N•m (3.0 kg-m, **22 ft-lb**).
- e. Apply body color touch up paint to the new bolts.
