SUBJECT: SAFETY RECALL OF SETRA S417TC MODEL COACHES
Ref.: **NHTSA # 13V-327**
Setra Bulletin # TI 32.00U08919A

TI No.: 32.00U08919A

TITLE: **Frame-end connect : of trailing arms with settlement of adjustment shim**

Retightening the bolts securing the trailing arms at the rear axle

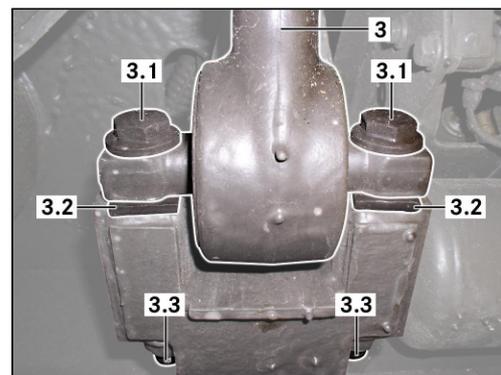
M32.00-0129-71

The frame-end connect : of the trailing arms at the rear axle may come loose.

The connect : may loosen due to settling of the adjustment shim.

- Remove corros : inhibitor from bolt heads (3.1) and nuts (3.3).
- Retighten nuts (3.3) to the specified torque.

380 Nm

- Recoat screw heads (3.1) and nuts (3.3) with corros : inhibitor.
