**Re: 49 CFR Part 573; Recall of Mercedes-Benz Front Passenger Occupant Classification System**

TO: Mercedes-Benz Dealer Principals, General Managers, Sales Managers, Service Managers, Parts Managers	FROM: Thomas Brunner, Department Manager, Vehicle Compliance and Analysis, Engineering Services
RE: Recall Campaign 2013060004 – Front Passenger Seat Occupant Classification System. Model 172 (SLK). Model Year 2013	DATE: July 19, 2013

Campaign No. 2013060004, July 2013

SUBJECT: **Model 172, Model Year 2013**  
**Replace Front Passenger Seat Occupant Classification System**

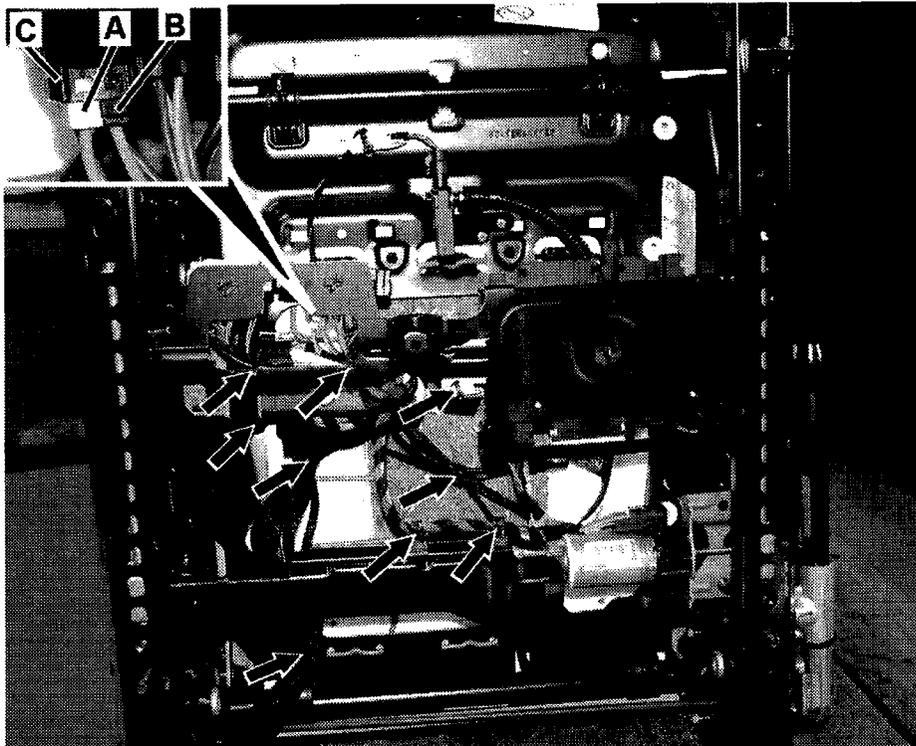
**Figure 1**

- Remove connectors (A, B, Figure 1) as a pair from connector (C), these connectors (A, B) cannot be removed separately from connector (C) (refer also to Figure 2).
- Observe routing of seat wiring harness prior to removing seat cushion. Ensure seat wiring harness is correctly re-routed when installing new seat cushion assembly.
- Cover the right door sill and door weather stripping to protect it when removing seat.
- Replace cable ties (arrows)
- Location and amount of cable ties (arrows) may vary according to equipment.

1. Replace front passenger seat cushion, refer to WIS: AR91.10-P-3310W.

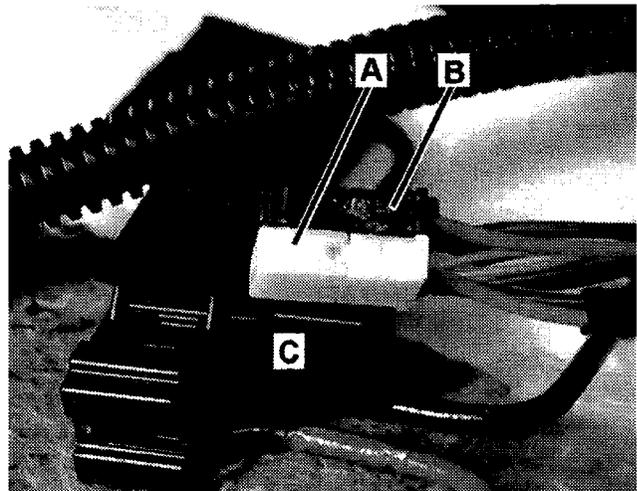
**Figure 2** (connectors A, B, shown removed from connector C)
