**Subject: NHTSA Campaign Number 13V-340/Jaguar Safety Recall J030 – XK Convertible Switch – Dealer Communications**

## **SUPPLEMENTARY INFORMATION**

**Publication Part No. JSA 18 02 30 991**

## Non-Compliance Recall J030 - Update

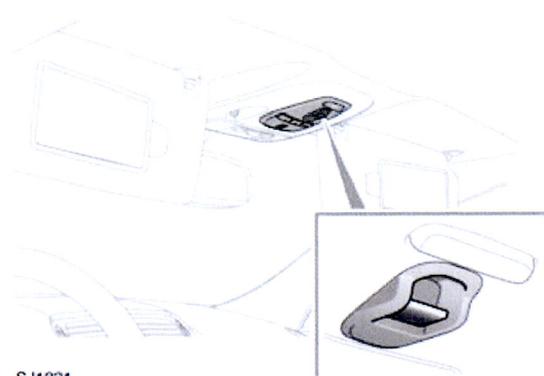
SJ1831

Rear quarter window switch (convertible only).

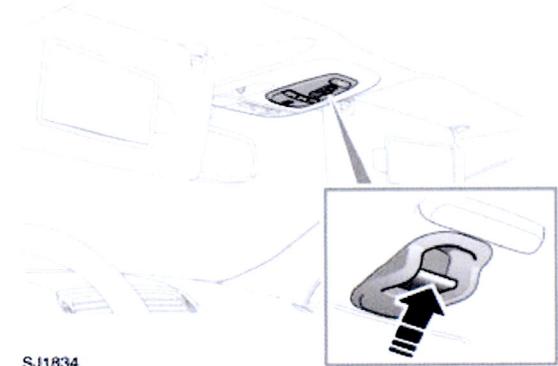
SJ1834

The power operated convertible roof and rear quarter windows, are controlled by the switch located on the overhead console. The ignition system must be on. The roof will latch and unlatch automatically.
