Reference: NHTSA Identification Number 13V-358

# **Safety Recall N51 / NHTSA 13V-358 Halfshaft-to-Gearbox Output Flange Fasteners**

**2013 (FF) Fiat 500E (Battery Electric Vehicles)**

**SAFETY RECALL N51 / NHTSA 13V-358  
HALFSHAFT-TO-GEARBOX OUTPUT FLANGE FASTENERS**

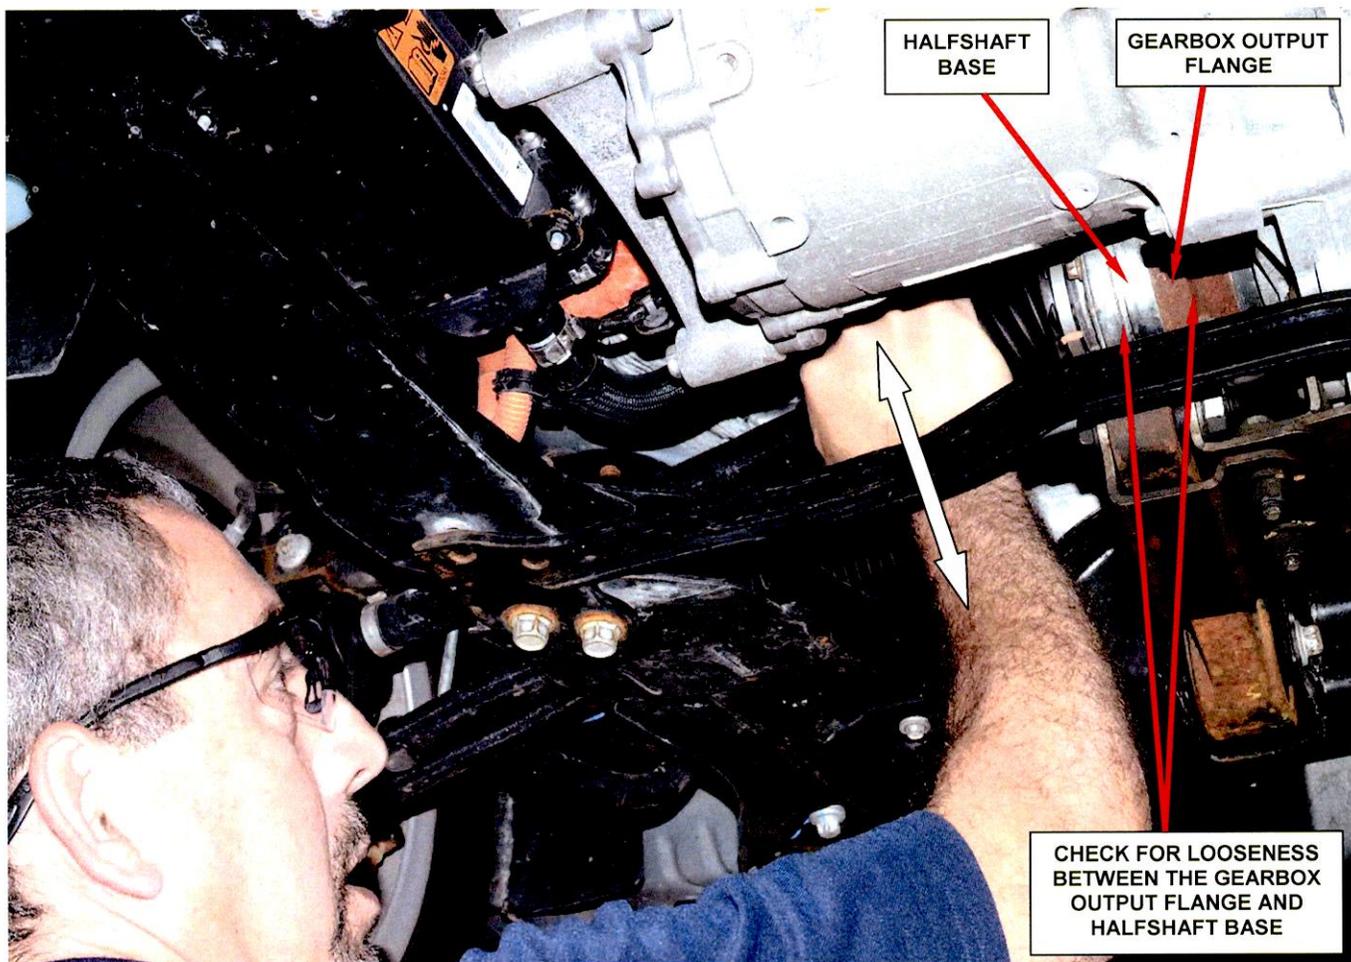
**Figure 1 – Check for Looseness  
(right side shown)**

1. Lift the vehicle on an appropriate hoist.
2. Check both halfshafts for looseness at the gearbox output flange and halfshaft base (Figure 1):
  - If the halfshafts are not loose, continue to **Section C. Replace Halfshaft Fasteners**.
  - If one or both halfshafts are loose, continue with Step 3 of this procedure.

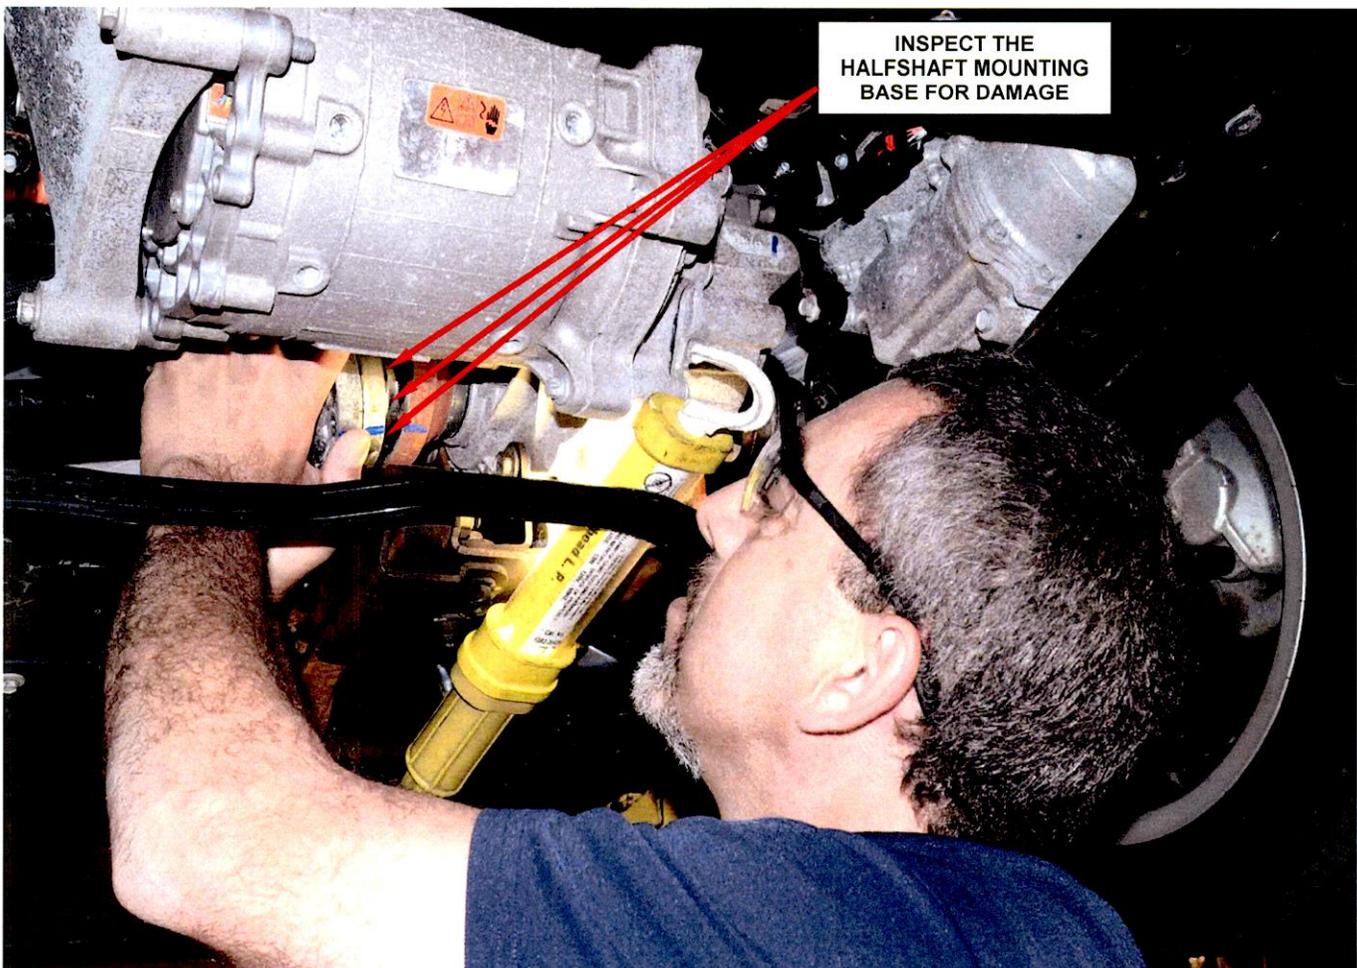
**Figure 2 – Inspect the Halfshaft Base Mounting Surface  
(right side shown)**

3. Mark the halfshaft orientation to the gearbox output flange on the loose halfshaft.
4. Remove and discard the six halfshaft-to-gearbox output flange fasteners.
5. Pull the halfshaft away from the gearbox output flange and inspect the mounting surface of the halfshaft base (Figure 2):
  - If the halfshaft mounting surface is not damaged, continue to Step 6 of this procedure.
  - If the halfshaft mounting surface is damaged, continue with **Section B. Replace Halfshaft(s)**.

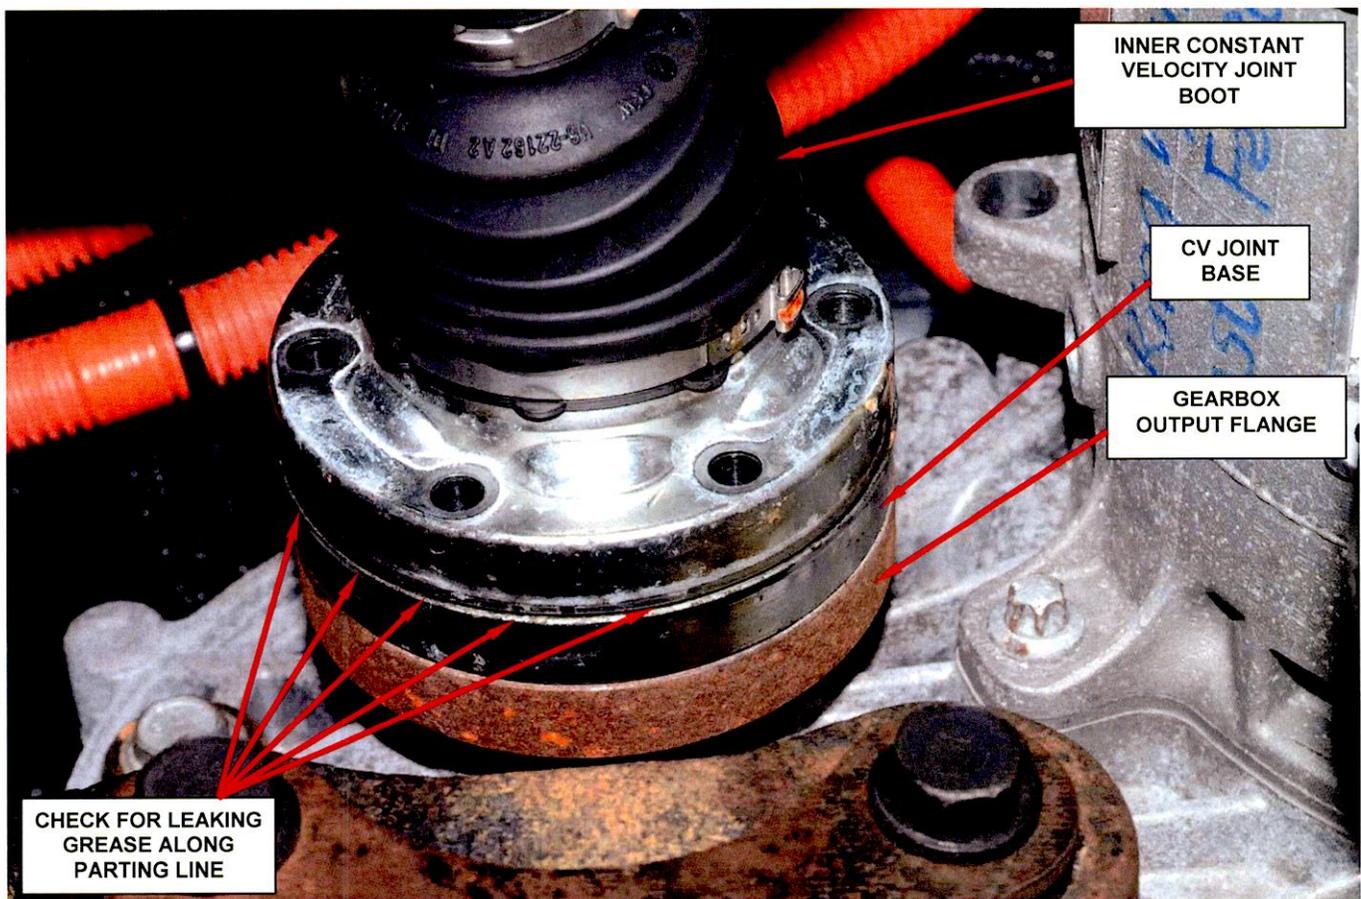
Figure 3 – Inspect for Leaking Grease at Halfshaft Base Seam

6. Inspect the halfshaft for grease leaks at the halfshaft CV joint base (Figure 3):
  - If there is no grease leaking from the halfshaft CV joint base, continue with **Section C. Replace Halfshaft Fasteners.**
  - If there is grease leaking from the halfshaft CV joint base, continue with **Section B. Replace Halfshaft(s).**
