13V-455
(6 pages)

SAFETY DEFECT AND NONCOMPLIANCE REPORT

This report serves as NOV Rolligon's notification to the U.S. Department of Transportation, National Highway Traffic Safety Administration that a defect related to motor vehicle safety exists in certain trailer assemblies manufactured by our vendor, Fusion Services. NOV Rolligon concluded the defect exists in these vehicles September 4, 2013. I was not made aware of the NHTSA reporting requirements until recently, which is the reason the report is now being filed.

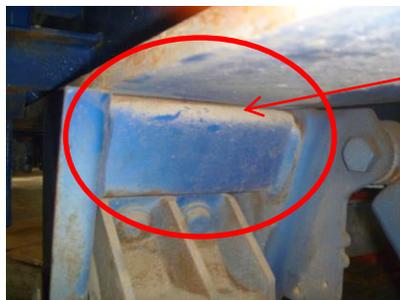
One of the four required welds is missing on the rear trailer suspension attaching the hanger to the trailer frame. The missing weld is the one located on the rear side of the hanger (see photo).

The weld in this location is missing from current Fusion manufactured assemblies.

Investigation concluded that the root cause of the missing weld derived from evidence that the information provided to our vendor, Fusion Services, was unclear since the Ridewell drawing provided

240-25K U/S is not specific to the Rolligon trailer design, and the Rolligon drawing provided 7118-01-110 references the Ridewell drawing but does not define specific weld locations of the hanger to the frame.

The missing weld could lead to additional stress on the existing welds causing cracks, which could ultimately lead to separation of the hanger to the trailer flange surface. The likelihood of this heightens if a direct hit or impact to the unit occurs out of the ordinary, resulting in additional strains to the welds. Potential consequences of this could lead to vehicle crash, serious injury, or property damage.

Cracks in any of the existing welds should be warning of a potential failure.

For this particular incident, the missing welds were added and all existing welds inspected for cracks. This occurred on the unit involved in the incident, as well as one other unit on site (7277G, 7277E). Welds were repaired as needed 9/3 thru 9/6/13. The welders and inspectors used were outsourced by NOV Rolligon's customer. This customer has been notified to invoice NOV Rolligon for reimbursement.

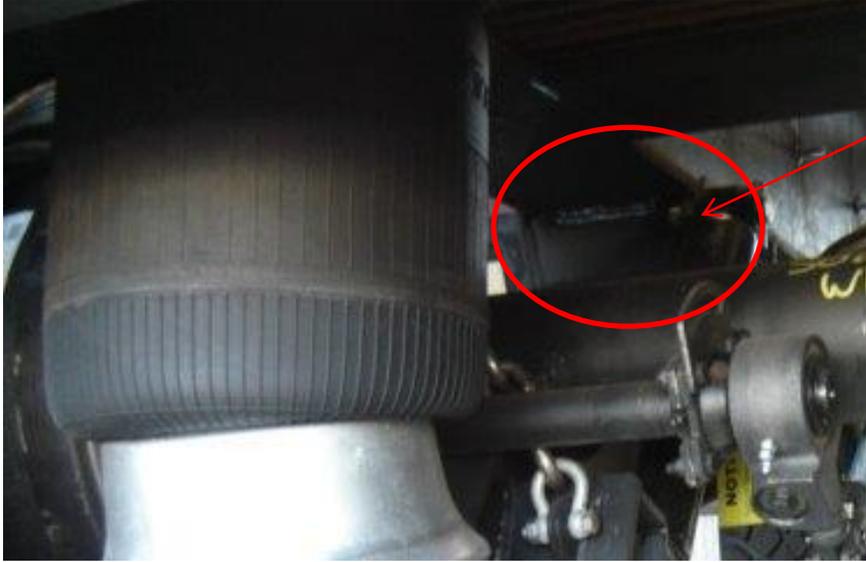
Below is a photo of what the backside of the hanger to frame assembly will look like once the weld has been added.

Weld is here.

Distinguishing characteristic between the remedy suspension assembly versus the recalled suspension assembly, is that the remedy suspension will contain a weld on the backside of the hanger to frame assembly and the recalled suspension assembly will not.
