RECALL CAMPAIGN BULLETIN

NTB13-094

VOLUNTARY SAFETY RECALL CAMPAIGN 2013 NV200 COMPACT CARGO; ENGINE HARNESS

CAMPAIGN ID #: PM374

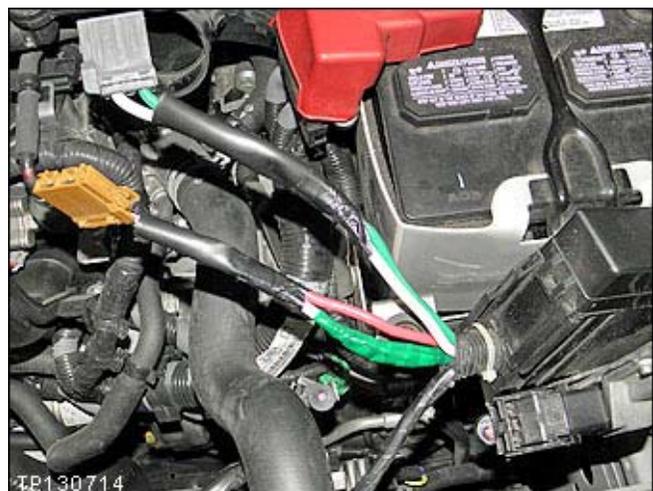
Figure 8

- With the tape removed, there will be 2 harness branches as shown.

NOTE: If there is any evidence of damage to the harness branches (melted or other), send a digital photo to: nnafqasupport@nissan-usa.com

- Make sure to include your dealer name, phone number, dealer code, and name of contact person.
- An NNA representative will contact the dealer within 24 hours with further instructions.
