Re: 573 Report for Econix DPF-A Filters

**PART 573 Defect and Noncompliance Report**

Type of Equipment:	Econix DPF-A Diesel Particulate Filters
Part/Model number:	Not Applicable
Size and function (where applicable):	dia. 350mm* len. 450mm, including the metal filter within
Inclusive dates of manufacture (month and year)	August 2009
Other information necessary to describe this equipment:	The metal filter assembly in the DPF-A filter consists of three layers of stainless steel sheets (thickness 1.5 to 2 mm), which are designed to prevent/minimize heat transfer from the metal filter within to the outer surface of the assembly. The manufacturer is FiberTech (www.metalfiber.com), and a relevant catalogue is also attached.
Total number of these items of equipment:	327

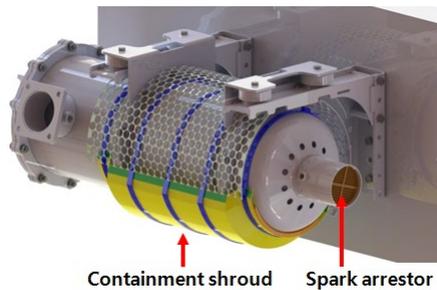
SK has determined that improper maintenance and operation of the Econix DPF Filter may lead to partial filter melting and/or failure of the product. Specifically, extended usage of the expendable parts of the filter (nozzle and igniter) far beyond the service requirements may result in repetition of inadequate regenerations, which increases the amount of particulate matter (PM) left in the metal filter. Once un-regenerated PM reaches a critical amount, the next regeneration of the filter can result in a thermal event, which may damage the metal filter and create a risk of partial filter melting, possibly presenting a fire risk.

to “mandatory” annual inspection and cleaning. This might have caused customers to be unaware of certain aspects of proper operation and maintenance of the DPF-A filter, including annual replacement of the expendable parts. Although a reasonable degree of customer’s attention to the service requirements was assumed and would result in safe operation, addition of a containment shroud of ceramic wool, a spark arrester, or other safety device, as a means of secondary safety measure, in case of improper operation or maintenance of the filter (see the picture below) would substantially mitigate the risks.

Replacement: In lieu of resubmitting the DPF-A filters for recertification, SK has agreed to remove the DPF-A filters from service and reimburse owners for replacement filters. Owners will be advised to contact selected DPF dealers for help in selecting a suitable replacement DPF filter that is certified by CARB and scheduling the replacement. Once the replacement is completed, owners should present proof of the original purchase price to the dealer. Once this is received from the dealer together with proof of the removal and replacement of the owner's Econix DPF Filter, a payment for the removal and replacement of the Econix DPF Filter, not to exceed the owner's original purchase price (including tax and installation cost) will be sent to the dealer on the owner's behalf. The owner will be responsible for any amount owed to the dealer above this amount
