November 2013  
FL647A  
NHTSA # 13V-468  
Transport Canada # 13-313

## Subject: Minotour Floor Sheets

**Models Affected: Specific Thomas Built Buses Minotour DRW school buses manufactured June 29, 2013, through July 16, 2013.**

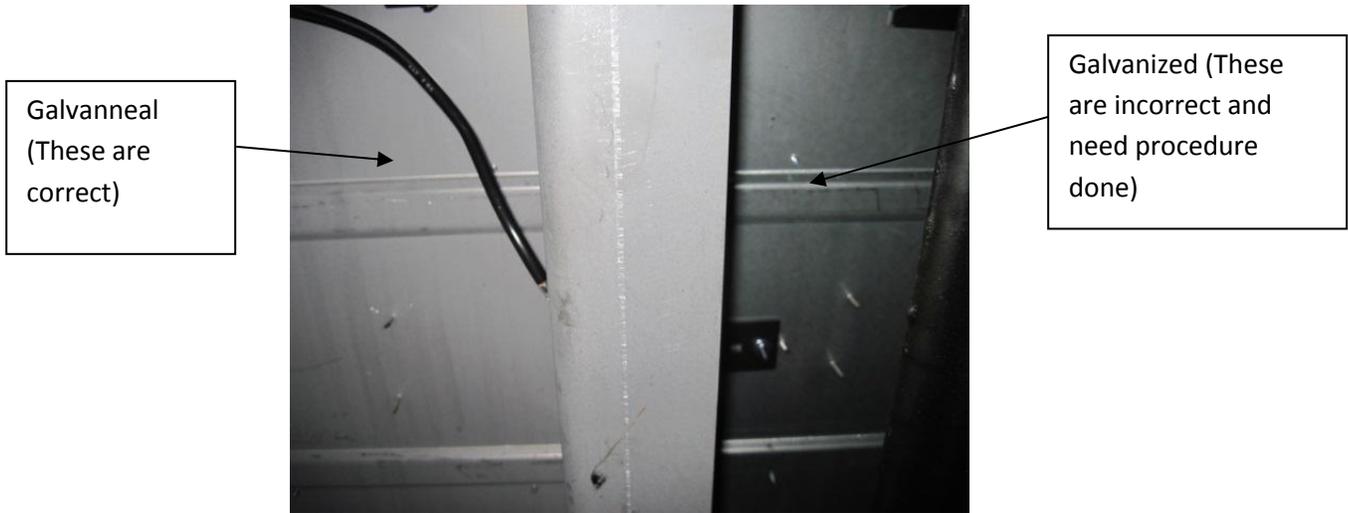
Figure 2

4. The sheet that is shiny is the one that will need to have this procedure done to it. If it has a dull finish then you can proceed to the next one. Check all sheets (see Figure 2). If any doubt, complete procedure with all sheets.
