IMPORTANT SAFETY RECALL NOTICE

NHTSA Campaign Number: 13E-055

The parts have been marketed by Federal-Mogul under the MOOG brand name for aftermarket service use. The front wheel bearings involved in this recall are MOOG Part Nos. 515082 and 515083.

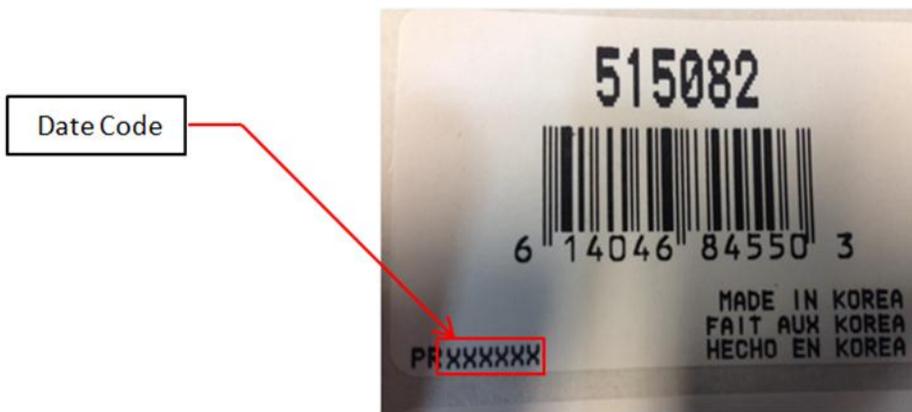
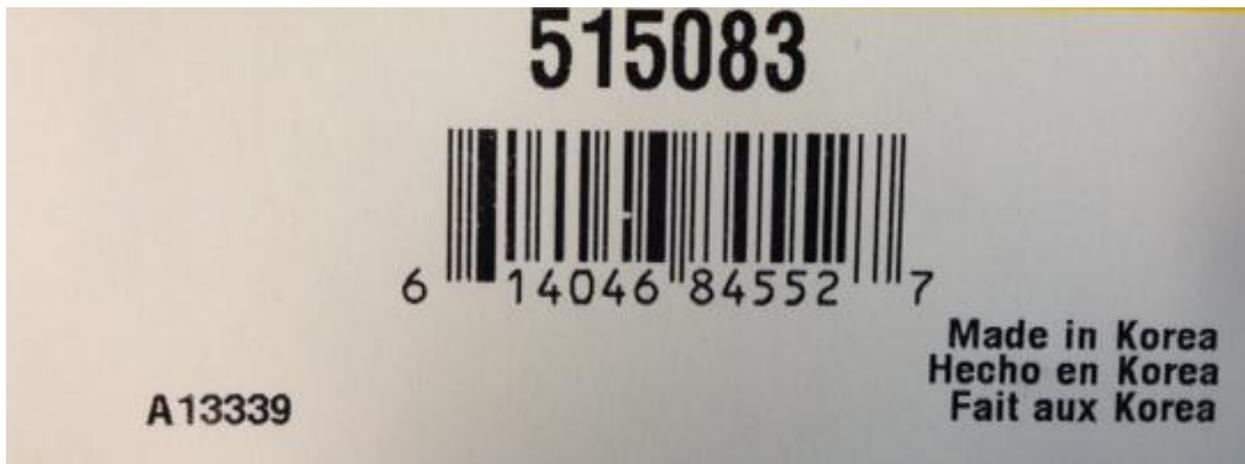
MOOG Part Nos. 515082 and 515083.

The recall includes parts within the following date code ranges: A13239-A13253, and A13274.

The part number label is affixed to the product packaging. The location of the part number and date code are illustrated in the following image:
