**Re: Defect Information Report – Supplemental Report No. #1
13V-539, FL-651, TBB Saf-T-Liner C2 Seat Track Rivets
Dealer Notice**

December 2013
FL651A-G
NHTSA # 13V-539
Transport Canada # 13-379

Subject: TBB Saf-T- Liner C2 Seat Track Rivets

Models Affected: Specific Thomas Built Buses Saf-T-Liner C2 school buses manufactured July 9, 2013, through September 12, 2013.

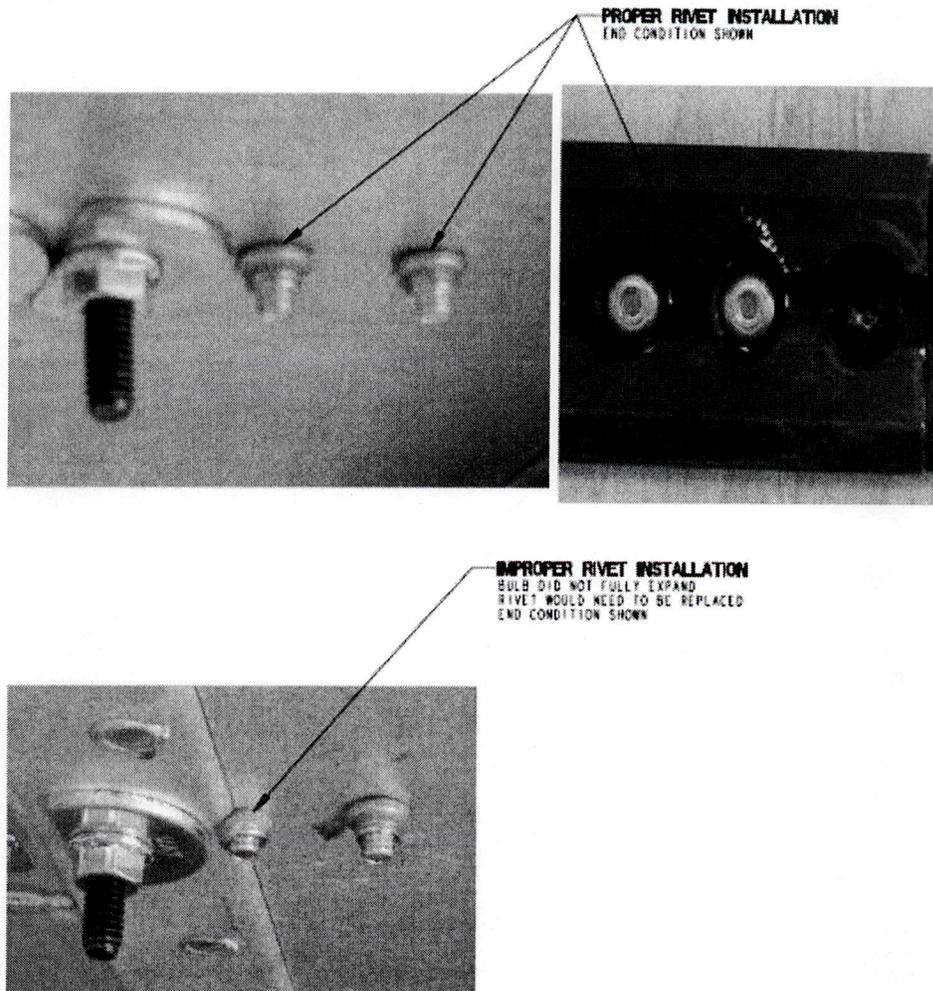
Figure 2

RIVET INSTALLATION QUALITY

- 1) ADDITIONAL #15 RIVETS (182294) ARE TO BE PLACED IN 12" INCREMENTS.
- 2) USE "P" BIT (\varnothing .3230") TO DRILL HOLE THRU TRACK AND FLOOR AT APPROPRIATE RIVET LOCATION.
- 3) ADD 82° COUNTERSINK AT .165" DEPTH.
- 4) INSTALL RIVET WHERE AN ACCEPTIBLE BULB IS POSSIBLE WITH TWO THREADS VISABLE AND WITHOUT INTERFERENCE. INSTALL BOLT (174029) WITH BRACKET (125077), NUT (69004121) AND WASHER (69004114) AT ANY LOCATION WITH A Z-RAIL OR OTHER INTERFERENCE THAT DOES NOT ALLOW A RIVET WITH AN ACCEPTIBLE BULB AND AT LEAST TWO VISABLE THREADS (REFER TO VIEW A, SHEET 1).

- 4) Using countersink tool (TBB185642), create a countersink in each of the holes that were previously drilled. This should be an 82 degree countersink at a .191" depth.
- 5) Insert #15 Rivet (TBB 182294) into each hole drilled and using appropriate rivet gun install rivet.
- 6) Make sure that the rivet is seated properly as shown in **Figure 2**. If it does not seat properly, drill out and reinstall.
- 7) If Z-section interferes with installing rivet, use bracket (TBB125077) over the Z-section as shown in Figure 3, along with bolt (TBB 174029), washer (TBB 69004114) and Flange Nut, (TBB69004121).
