Re: 49 CFR Part 573; Recall of Mercedes-Benz Front Seat Belt Anchor Fittings

NHTSA Recall Number
13V-576

Campaign No. 2013110008, December 2013

SUBJECT: **Model Year 2014, Model 222 (S-Class)
Check Left and Right Front Seat Belt Anchor Fitting**

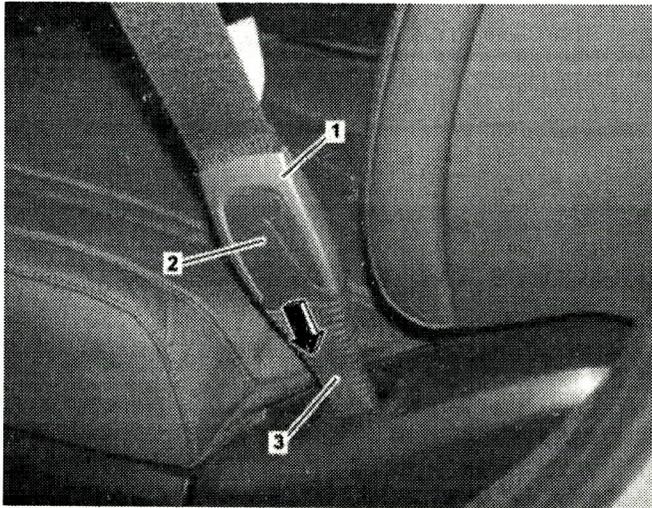
Figure 1

1. Slide the boot (3, Figure 1) with cover (2) on the seat belt anchor fitting outer shell (1) downwards into the outer shell (1) by approximately 5 mm on both sides and hold the cover (Figure 2).

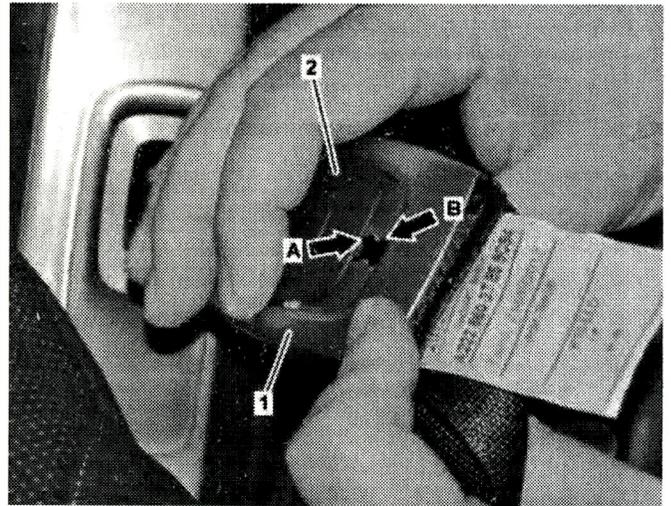
Figure 2

2. Slightly lift the cover guide (arrow A, Figure 2) out from the outer shell support/mount (arrow B) on both sides (Figure 2) then push cover (2) down far enough to expose the locking mechanism (4, Figure 3).

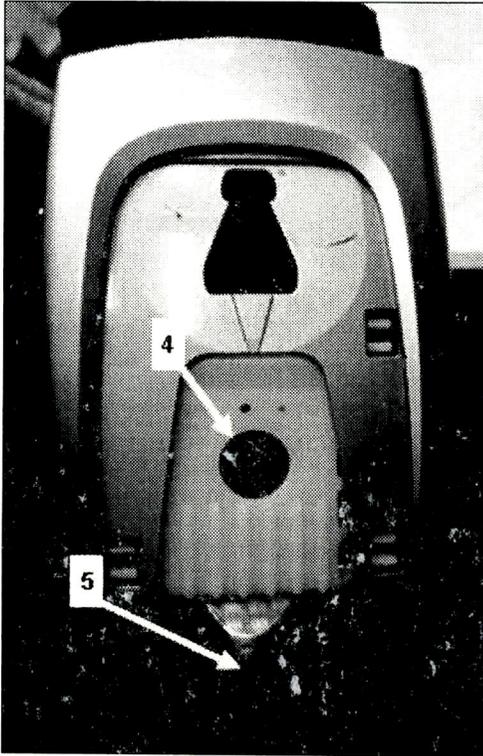
Visually inspect the locking mechanism (4, Figure 3). The locking mechanism (4) must be as shown in Figure 3 – vertical to the anchor cable (5).
4.

Only seat belt anchor fittings (1, Figure 1), for which the pull test **AND** the visual inspection (locking mechanism is vertical, Figure 3) are successful, are OK:

5. Lock seat belt anchor fitting (1, Figure 1) into anchor cable (5, Figure 3), refer to WIS: AR91.40-P-1030-02LF steps: 3-10.. This WIS document is attached to after the last page of this campaign.

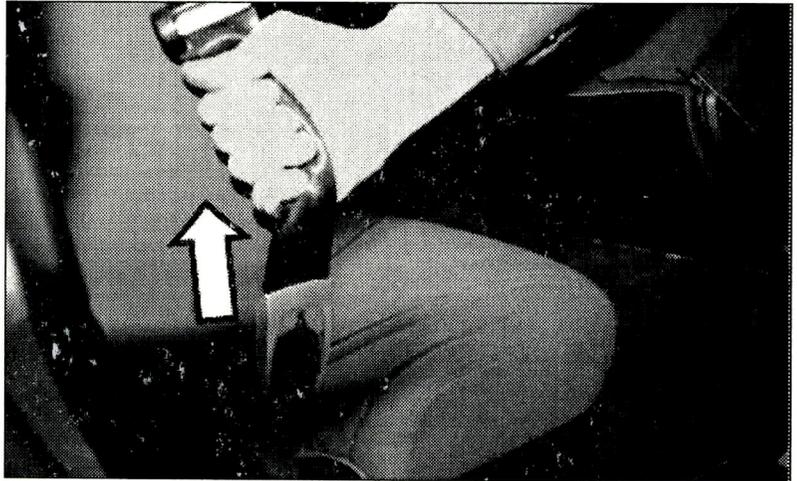
Figure 4

Check that the locking mechanism (4, Figure 3) is correctly seated/locked by pulling sharply upwards on the belt strap (Figure 4): The connection for the seat belt anchor fitting (1, Figure 1) must **not** loosen when doing so.

Seat belt anchor fitting may release suddenly when pulled out of seat belt anchor.
