**Subject:** 2100 Plus Muncie CS10 & CS11 PTOs

**Number:** SB 265A **DATE:** 12/04/2013

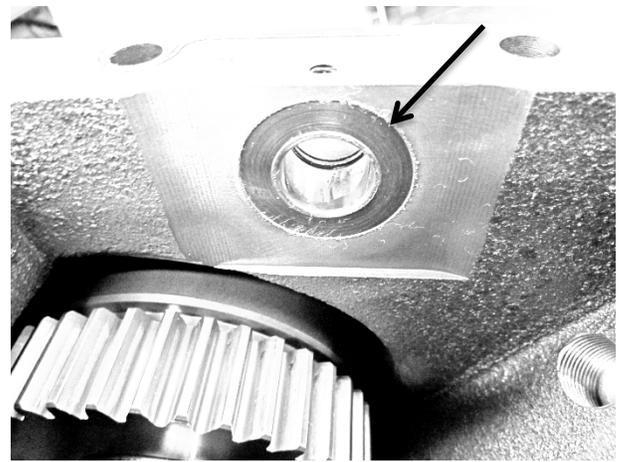
Inspection of the Housing. The area around the idler shaft shows little to no wear. This is an example of no wear.

If the Area around idler shafts shows wear, then the unit needs replacing.
