Recall Campaign 13V - 407: Replace Rear Bulb Carriers (Side Panel)

E60 including the M5

Produced from March 2007 to December 2009

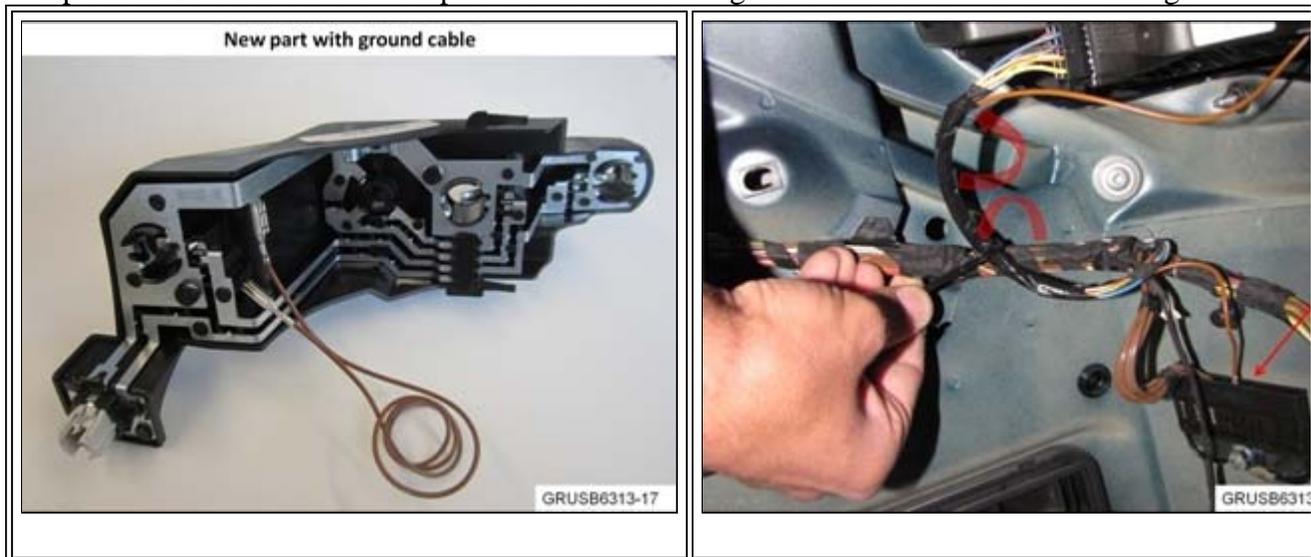
The electrical contacts of the rear bulb carrier on the rear side panel may be susceptible to corrosion due to aging and/or environmental influences. As a result, this corrosion of the contacts could render the rear lamp(s) inoperative. In certain cases, this could potentially damage the lamp's bulb carrier.

A poor ground connection at the rear lamp assembly (connectors X338 left side – pin #8 and X339 right side – pin #5) causes a malfunction of the rear tail lamps.

The pictures below show the new part with the additional ground cable and final wire routing.

3. Using the E60 service repair kit, **replace both carriers** along with **new light bulbs that are supplied in the kit.**
4. Inspect both connector socket housings and replace **only** the affected side where corrosion or thermal damage is present. Refer to ISTA Repair Instruction 63 21 055, "Replace a socket housing for left or right-hand boot lid light."
