Re: 49 CFR Part 573; Recall of Mercedes-Benz Front Passenger Occupant Classification System

TO: Mercedes-Benz Dealer Principals, General Managers, Sales Managers, Service Managers, Parts Managers	FROM: Thomas Brunner, Department Manager, Vehicle Compliance and Analysis, Engineering Services
RE: Recall Campaign 2013 110009- Front Passenger Seat Occupant Classification System. Model 231 (SL). Model Year 2013	DATE: December 20, 2013

Campaign No. 2013110009, December 2013

SUBJECT: **Model 231 (SL Class), Model Year 2013**
Replace Front Passenger Seat Occupant Classification System

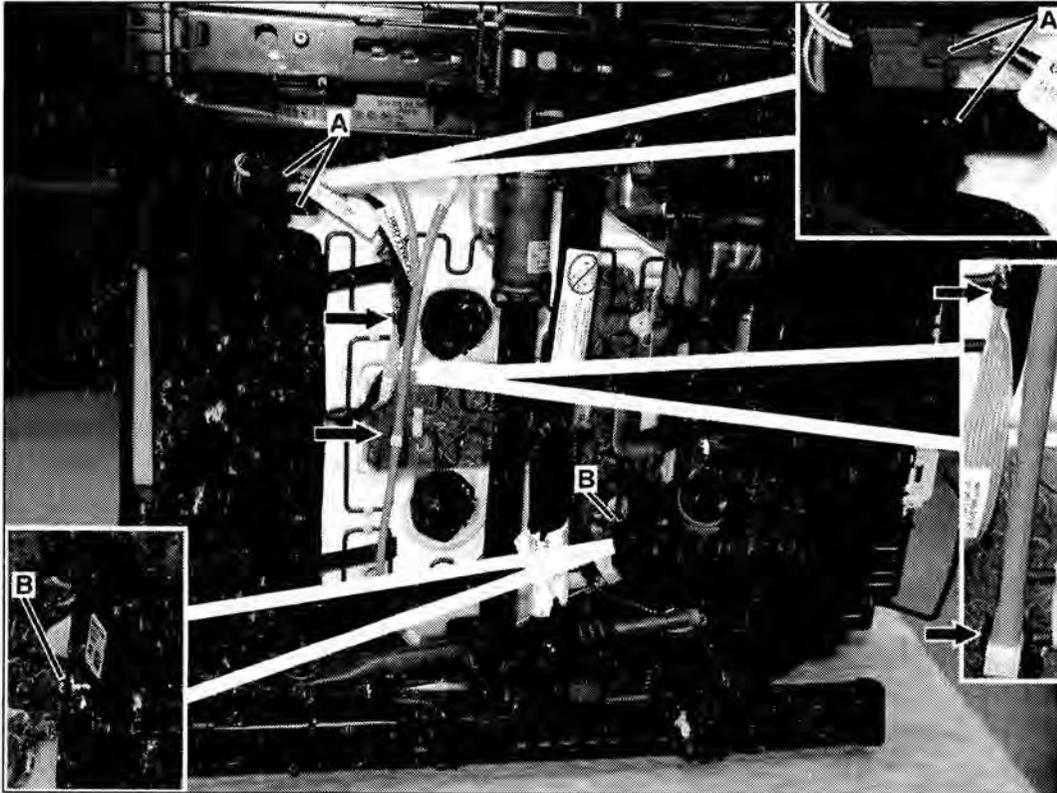
Figure 1

- Cover the right door sill and door weather stripping to protect it when removing seat.
- Replace 2 cable ties (arrows, Figure 1).
- Location and amount of cable ties (arrows) may vary according to equipment.
- Disconnect harness connectors (A).
- Remove bolt (B) for weight sensing system sensor.

Replace front passenger seat cushion, refer to WIS: AR91.60-P-0720RKA.
