RECALL CAMPAIGN BULLETIN

NTB13-032b

VOLUNTARY SAFETY RECALL CAMPAIGN 2013 SENTRA OCS SENSORS

CAMPAIGN ID #: PC213
NHTSA #: 13V-069
APPLIED VEHICLES: 2013 Sentra (B17)

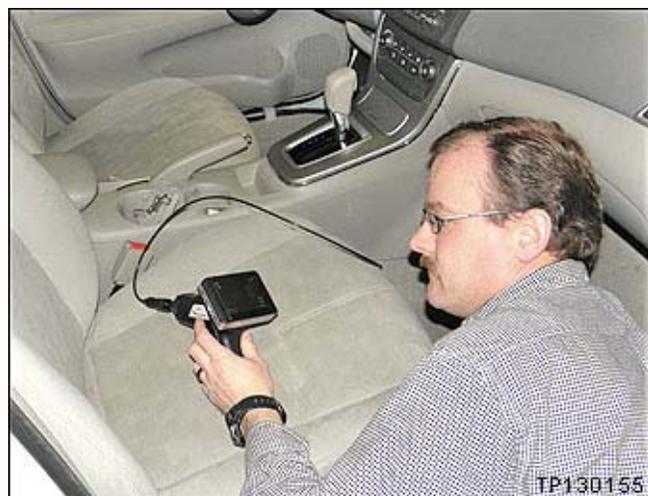
Figure B

3. Use borescope (J-50079 or equivalent) to read the lot code on top of each sensor.

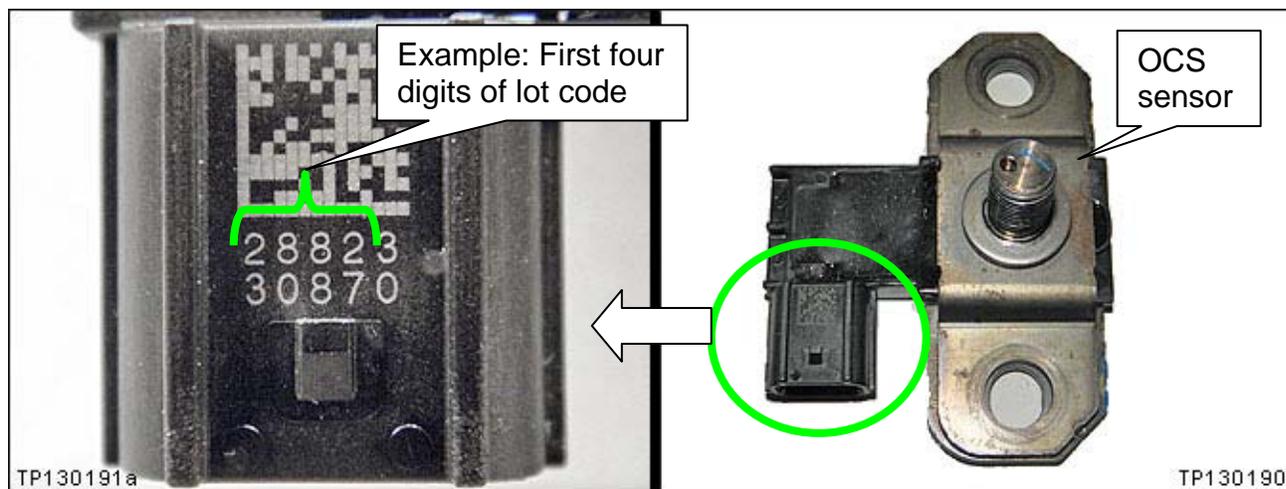
Figure C

OCS sensor lot code example – your vehicle’s lot code numbers may be different.

4. Write the first four digits of the lot code **for each sensor** on the repair order.
 - In the **example** above, the first four digits are “2882”.
5. Reconnect the electrical connectors for both OCS sensors.
6. Use the flow chart on the next page to determine if the OCS sensors are NG or OK.
 - **Both sensors must be checked.**

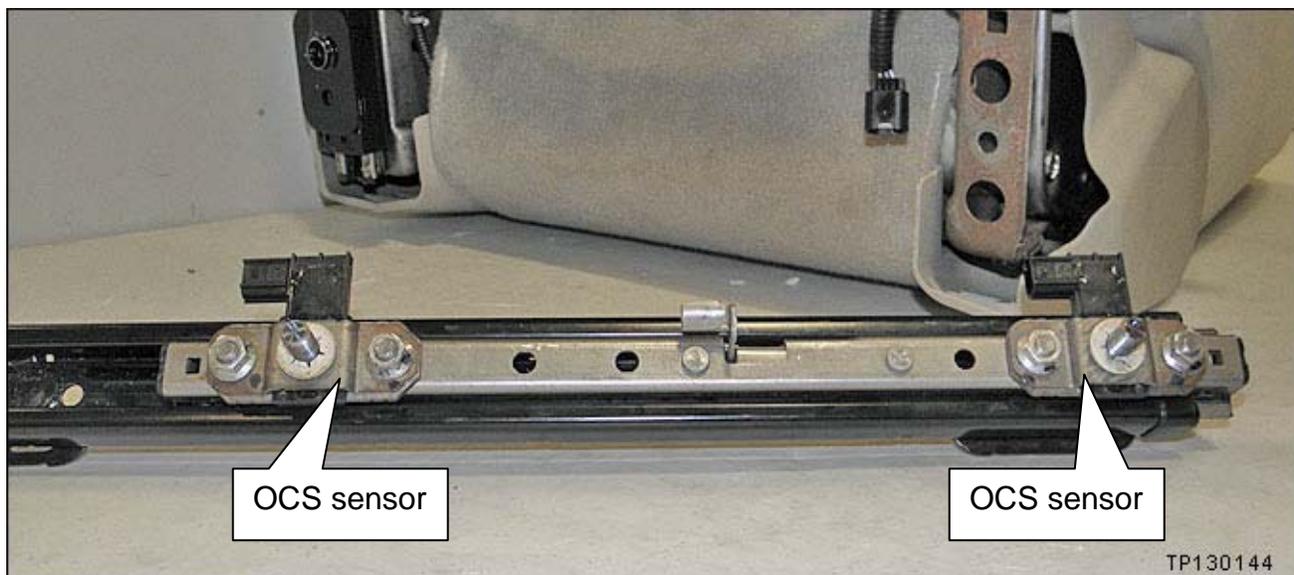
Figure 20

- **Only replace OCS sensor(s) if the lot code is NG (see pages 5 and 6).**
- Some vehicles will require only one new sensor; some will require two new sensors.

23. Remove the old OCS sensor(s).

24. Install new OCS sensor(s).

- Make sure the spacer plate under the sensor(s) remains on the seat track.
- Do not reuse the old nuts.
- **Use new 12 mm nuts.**
- Tighten the 12 mm nuts holding the new sensor(s) **finger tight only.**
Do not torque at this time.
