L9 Seat Belt
GU, CXU and MRU

SAFETY RECALL INFORMATION:

(January 2014)

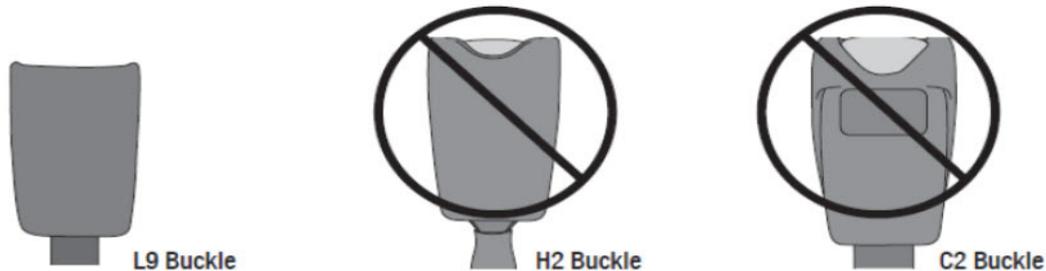
- A. Verify the buckle is an IMMI buckle by looking for the IMMI logo on the back housing.
- B. Verify that the IMMI buckle is an L9 buckle.

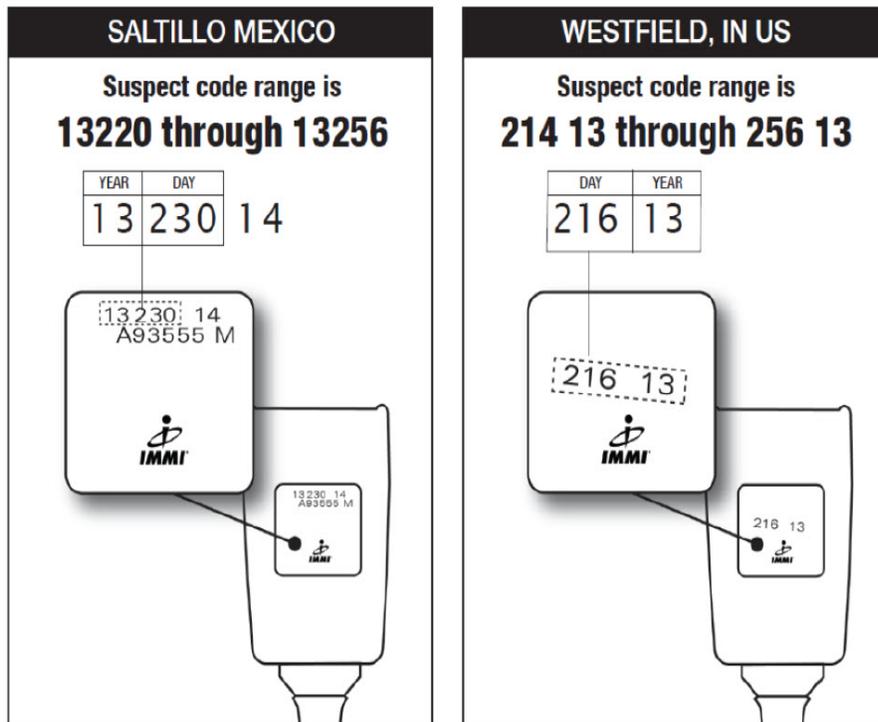
- C. Find the buckle assembly date code on the back housing of the buckle.
- D. There are two different date code formats as illustrated.

- E. If the buckle is within the date ranges noted in the previous step, replace the buckle. Utilize the repair below.
- F. If the buckle is not within the date ranges noted in the previous step, do not replace the buckle.
