SERVICE PROCEDURE

13517

SUBJECT: SAFETY RECALL

Chassis skirt to fuel tank interference on certain ProStar® models with feature codes 0016XSA, 0016XSB, 0016XSC, or 0016XSD built 12 December 2012 through 08 August 2013.

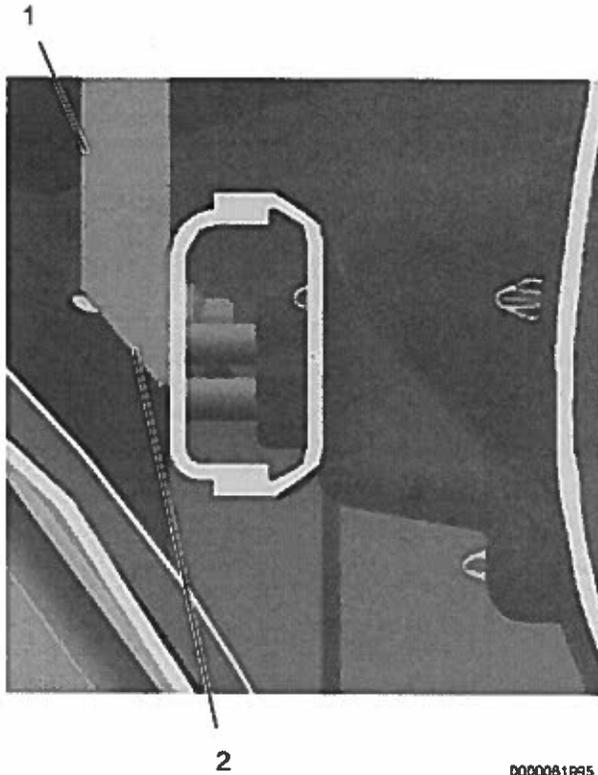
Figure 10. S-Bracket Chamfer.

During vehicle operation, the rear chassis skirt upper horizontal support S-bracket may contact the fuel tanks during frame twist, and it is possible for the bracket to wear a hole in the top of the fuel tank, which may result in a fuel leak. A hole at the top of the fuel tank may allow fuel to spill on the roadway, which may cause a slippery road condition. This would increase the risk of a motor vehicle crash, which may result in property damage, personal injury, or death.

1. S-bracket (3) (2 not shown)
2. 45° chamfer

17. Using a grinder, add 45° chamfer (Figure 10, Item 2) to all S-brackets (Figure 10, Item 1) on upper horizontal support rail.
18. Paint cut surface of S-brackets.
19. If observed, document fuel tank concerns with photographs and descriptions, and proceed to replacement of fuel tank if required. Refer to [AFC12928](#) for fuel tank removal and installation procedures.

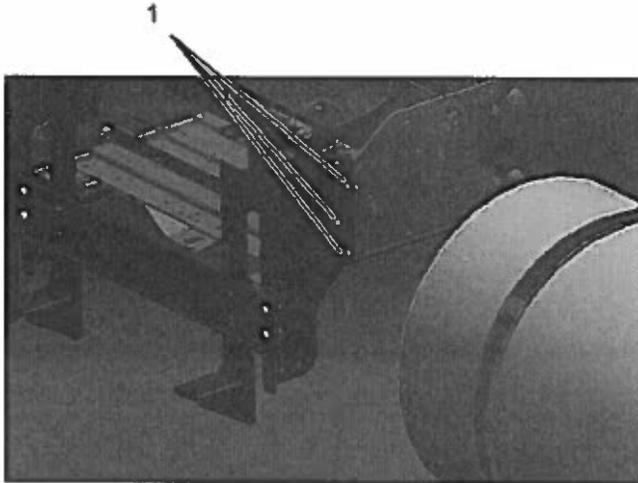
Figure 12. Intermediate Bracket Adjustment.

1. M10 bolt (3)

21. Loosen three M10 bolts (Figure 12, Item 1) from intermediate bracket.
22. Adjust intermediate bracket up and outboard as much as possible.
23. Using torque wrench, tighten three M10 bolts (Figure 12, Item 1) to 37 lb-ft (50 N·m).

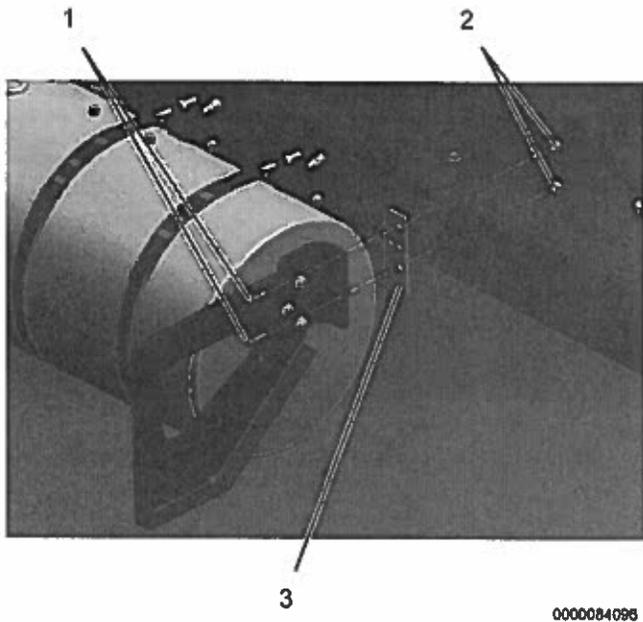
Figure 13. Frame Stanchion Spacer.

1. M14 bolt (3) (1 not shown)
2. Nut (3) (1 not shown)
3. 4040097C1 Frame Spacer

24. Remove three bolts and nuts (Figure 13, Items 1 and 2) from frame stanchion.

25. Position stanchion away from frame, and install frame spacer (Figure 13, Item 3) with three bolts and nuts (Figure 13, Items 1 and 2). Using torque wrench, tighten three bolts and nuts to 100 lb-ft (127 N·m).

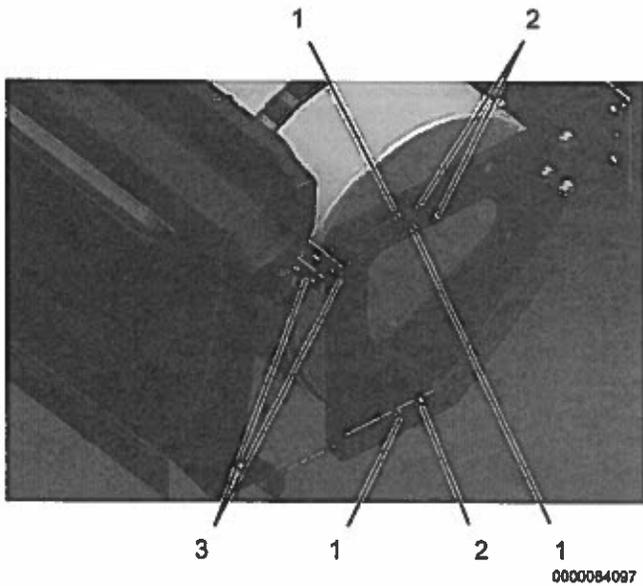
Figure 14. Operator-Side Rear Skirt Assembly.

1. Washer (3)
2. M10 nut (3)
3. 4038093C1 Rear Skirt Spacer (2)

26. Install rear skirt assembly with two spacers (Figure 14, Item 3), and install three nuts with washers (Figure 14, Items 1 and 2) onto rear of rear skirt assembly. Using torque wrench, tighten three nuts to 37 lb-ft (50 N·m).

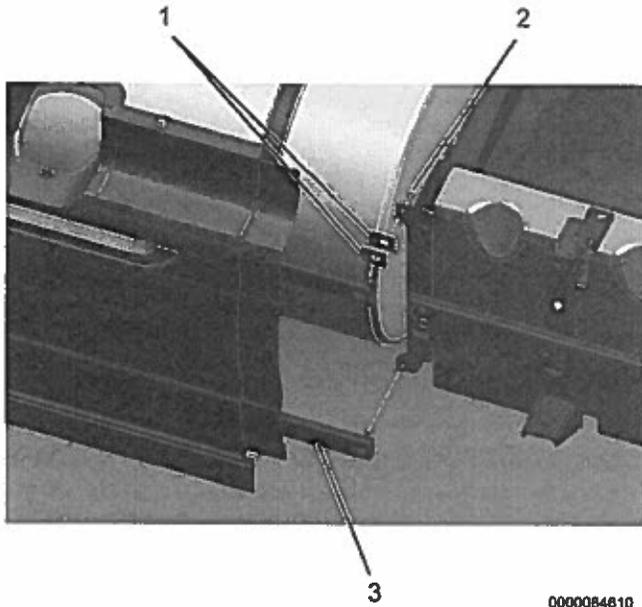
Figure 15. Passenger-Side Rear Skirt Assembly.

1. 4038097C1 Rear Skirt Spacer (2)
2. M10 nut (2, 1 not shown)
3. Rear skirt assembly

27. Install rear skirt assembly (Figure 15, Item 3) to front vertical support with two spacers (Figure 15, Item 1), and install two original nuts (Figure 15, Item 2) onto rear of rear skirt assembly. Using torque wrench, tighten two nuts to 37 lb-ft (50 N·m).

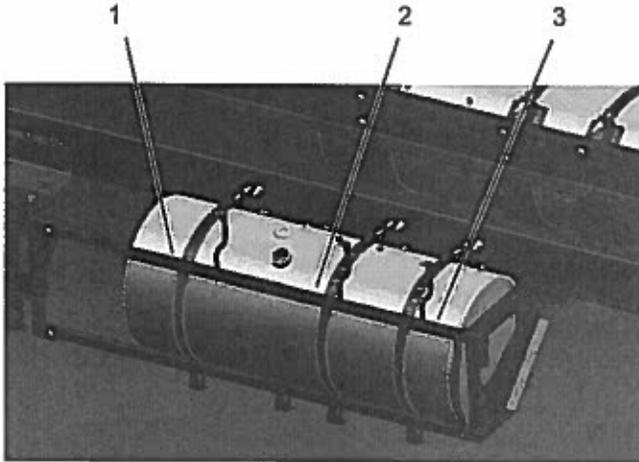
Figure 18. Rear Skirt Measurement Points.

1. Front rail to fuel tank (forward of S-bracket and tank strap)
2. Rear rail to fuel tank (forward of S-bracket)
3. Rear rail to fuel tank (aft of S-bracket and tank strap)

31. Using 11 mm feeler gauge or equivalent, measure distance between fuel tank and upper horizontal support rail. Measurements should be taken and noted at the following points:

- Front rail to fuel tank (forward of S-bracket and tank strap, Figure 18, Item 1)
- Rear rail to fuel tank (forward of S-bracket, Figure 18, Item 2)
- Rear rail to fuel tank (aft of S-bracket and tank strap, Figure 18, Item 3)
