NHTSA Safety Recall  
No. 13V-458

## IMPORTANT SAFETY RECALL

# Customer Service Notice

## Pressure Switch and Exhaust Thermal Blanket Inspection

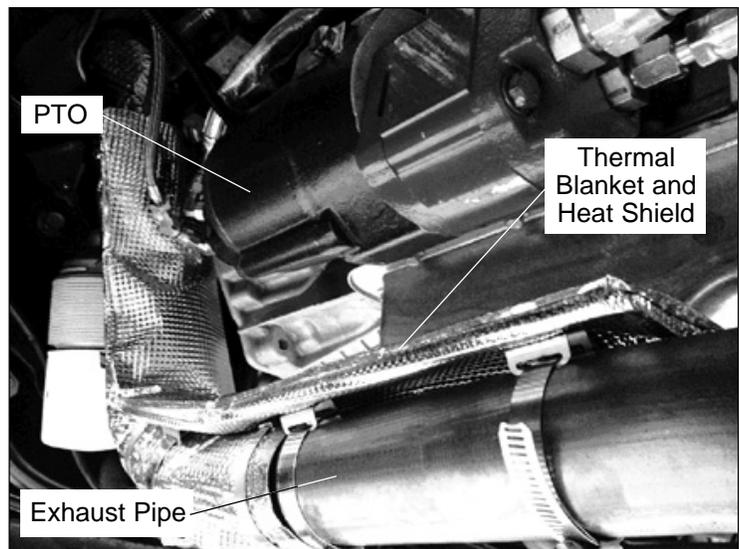
**Figure 1 — Thermal Blanket**

Altec has been made aware of a possible issue concerning a pressure switch and exhaust thermal blanket (refer to Figure 1) provided by the supplier of the power take off (PTO). Over time, the pressure switch can develop a low volume transmission fluid leak and the exhaust thermal blanket can deteriorate causing it to absorb hydraulic oil or transmission fluid. A buildup of oil or transmission fluid on the thermal blanket may increase the possibility of a fire. **Death or serious injury can result from a chassis fire.**

If the exhaust thermal blanket fails the inspection and/or there is evidence of a pressure switch leak, remove the exhaust thermal blanket at the time of the inspection and install the Pressure Switch and Exhaust Heat Shield Kit, part number 970510446, within 30 days of removal of the exhaust thermal blanket. Pressure switches and exhaust thermal blankets that pass the inspection must still have the Pressure Switch and Exhaust Heat Shield Kit installed at the next service interval.

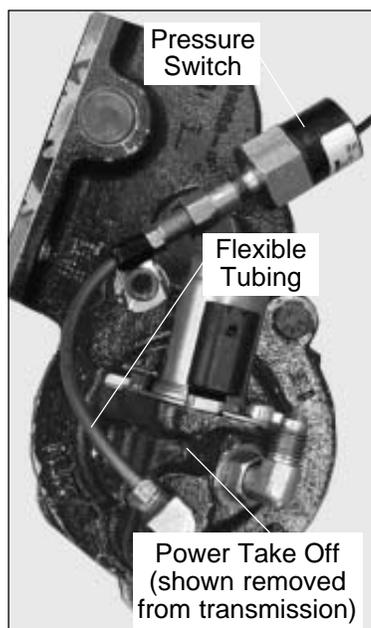
**Figure 1 — Front Pressure Switch Location**

1. Position the unit on a level surface, apply the parking brake and chock the wheels. Shut off the engine and allow the chassis exhaust system to cool to the touch.
2. Using a mechanic's creeper, get under the chassis near the PTO on the driver's side of the transmission.
3. Find the thermal blanket that is attached with band clamps to the exhaust system near the PTO.
4. Use your hand to determine if the thermal blanket is wet with fluid. Look at the pressure switch to see if it is leaking transmission fluid. The pressure switch is located either on the front side of the PTO connected to a flexible tube (refer to Figure 1), or on the side near the rear of the PTO connected to a formed tube (refer to Figure 2).
