SAFETY RECALL BULLETIN

SUBJECT:			No: SR-13-009REVII
2008-2013 LANCER EVOLUTION CLUTCH MASTER CYLINDER – SAFETY RECALL CAMPAIGN – REVISED			DATE: April, 2014
			MODEL: 2008 – 2013 Lancer Evolution
CIRCULATE TO:	<input checked="" type="checkbox"/> GENERAL MANAGER	<input checked="" type="checkbox"/> PARTS MANAGER	<input checked="" type="checkbox"/> TECHNICIAN
<input checked="" type="checkbox"/> SERVICE ADVISOR	<input checked="" type="checkbox"/> SERVICE MANAGER	<input checked="" type="checkbox"/> WARRANTY PROCESSOR	<input checked="" type="checkbox"/> SALES MANAGER

This bulletin supercedes SR-13-009REV, issued December, 2013 to add an inspection only campaign operation. See the Inspection Procedure Section for additional details. Changes are italicized and indicated by ◀.

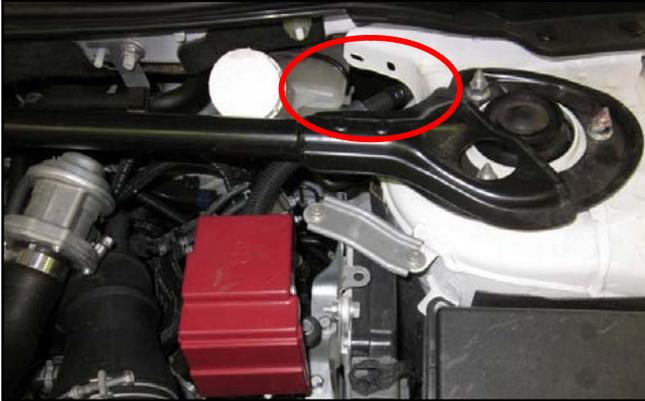
1. Open the hood. With a flashlight, inspect the bulkhead where the clutch master cylinder is mounted. The area is circled in the illustration below.

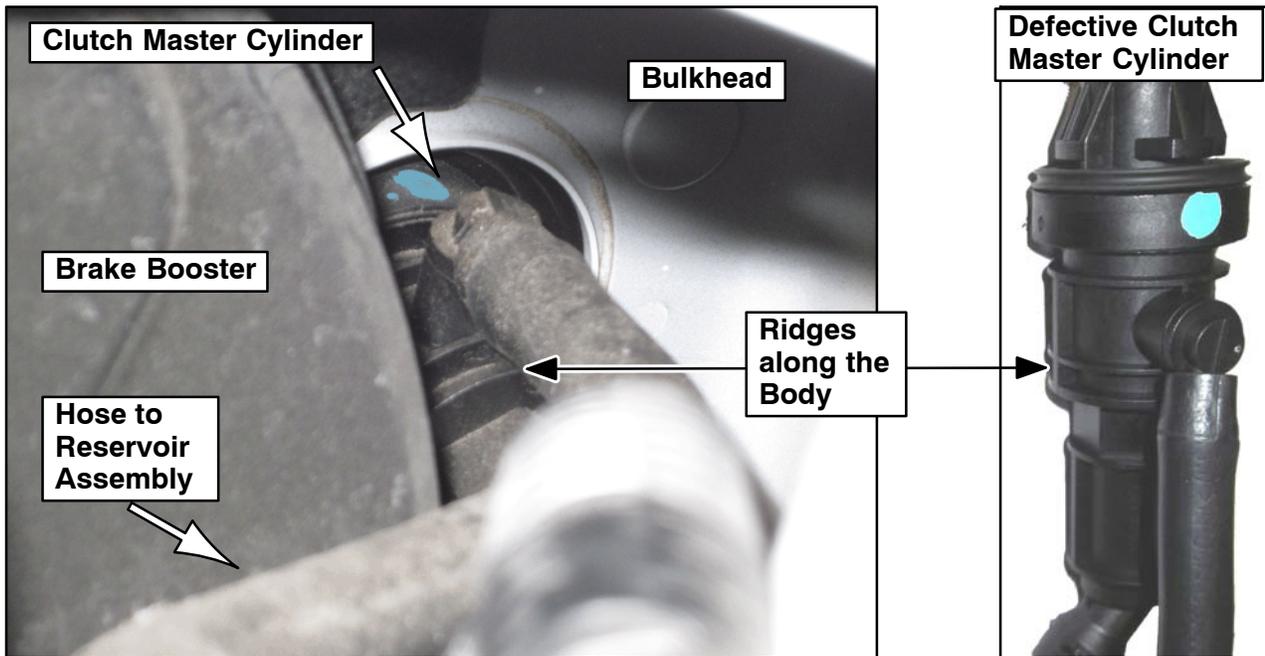
2. A defective clutch master cylinder body has a ridge pattern.

3. If the installed clutch master cylinder **does not look similar** to the defective unit shown above, please confirm with the vehicle owner if they want this recall performed or do not want to have the countermeasure unit installed.
4. Document on the repair order that the customer has declined to have the countermeasure clutch master cylinder installed as part of Safety Recall SR-13-009.
5. Ensure the customer signs the repair order acknowledging the declination.
6. Complete the campaign claim and enter campaign operation number **C1309W02**.

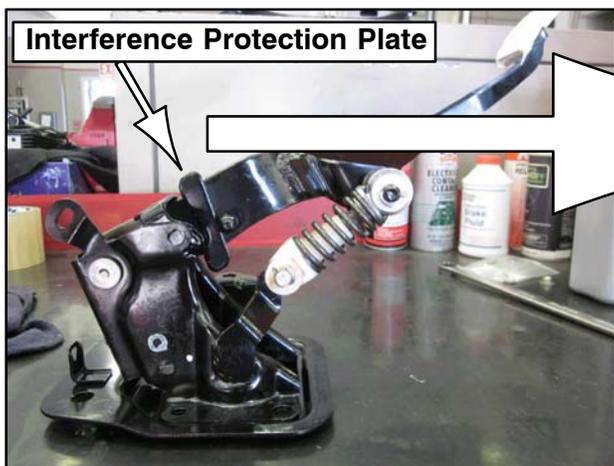
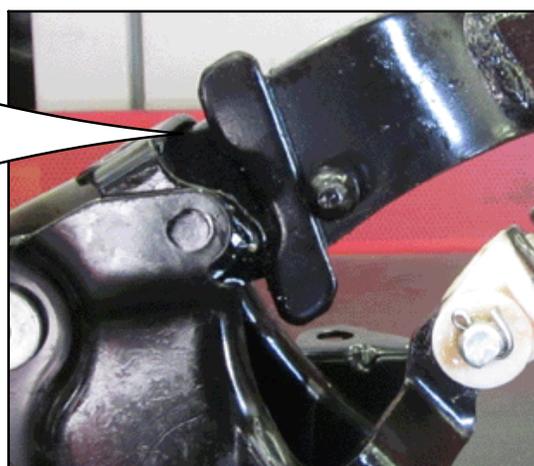
2. Inspect the clutch pedal to determine if an interference protection plate has already been attached to it.

- a. If the interference protection plate is attached to it, proceed directly to the **INSTALLATION PROCEDURE** in the following section.
- b. If the interference protection plate is absent, proceed directly to Step 3 below.

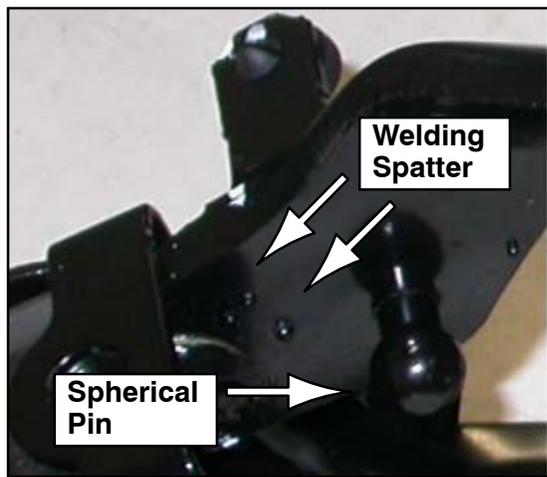
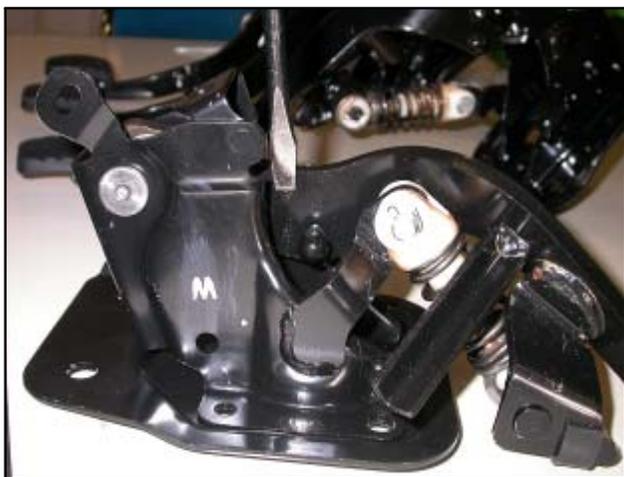
3. Place the clutch pedal flat on a level surface. Visually inspect and touch the area near the spherical pin for welding spatter. If present, remove the welding spatter with a slotted screwdriver or similar tool.
