RECALL CAMPAIGN BULLETIN

NTB14-027

VOLUNTARY SAFETY RECALL CAMPAIGN OCCUPANT CLASSIFICATION SYSTEM MODULE REPROGRAMMING

CAMPAIGN ID #: R1405

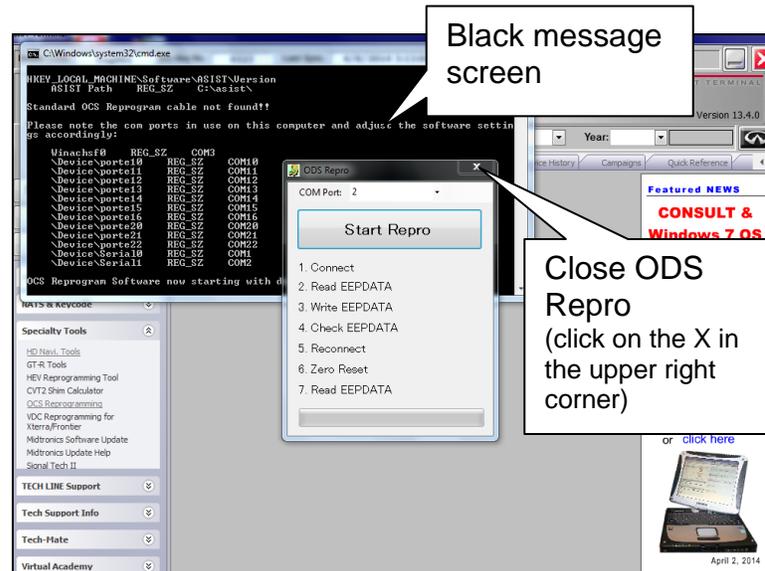
Figure 2

NOTE: If you get a black message screen as shown in Figure 2, this indicates that the reprogramming cable is not connected, or the cable driver did not install correctly.

- Close ODS Repro.
- Close ASIST.
- Start over from step 1.
