SUBJECT: SAFETY RECALL OF 2009 - 2011 MCI D SERIES COACHES

Ref.: **MCI Service Bulletin 388B**
NHTSA # 14V-329
(Prior NHTSA # 12V-250)
Transport Canada # 2014-236
(Prior Transport Canada # 2012-173)

Service Bulletin No. 388B

MODEL D Series Coaches	TYPE Field Change Program	SECTION/GROUP 7 – Electrical	DATE July 14, 2014
SUBJECT INTERIOR LED LIGHTS			
CONDITIONS

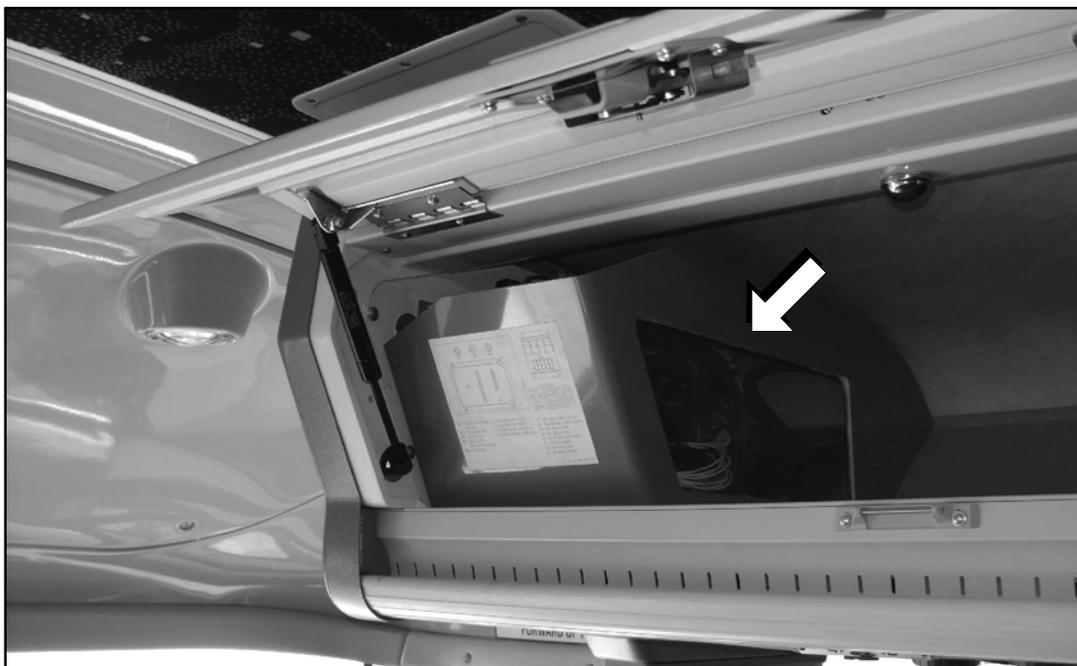
Figure 1.

1. Turn the main battery disconnect switch to the OFF position.
2. Chock both sides of the tires.
3. Enter the coach cabin. Open the curbside, parcel rack compartment #1 door.
4. Locate the junction box mounted to the parcel rack compartment wall (refer to Figure 1).

5. Remove and retain the junction box cover and hardware, to be re-used at a later step in this procedure.

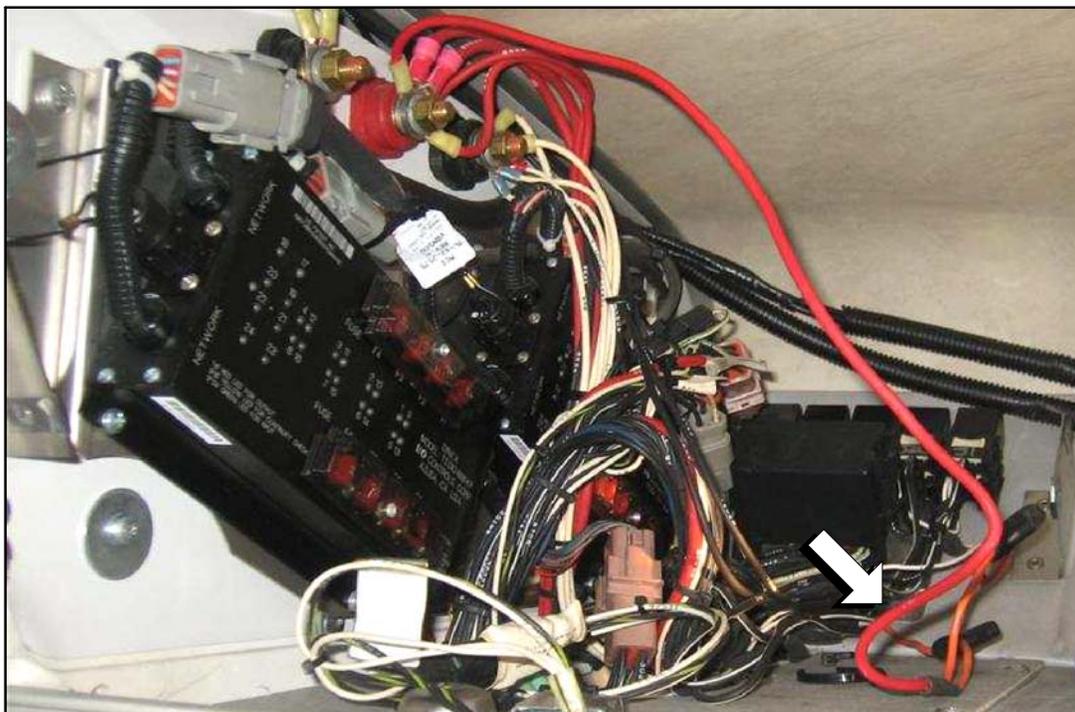
Figure 2.

- 6. Locate the red and orange wires installed in the procedure steps of FCP388 (refer to Figure 2).

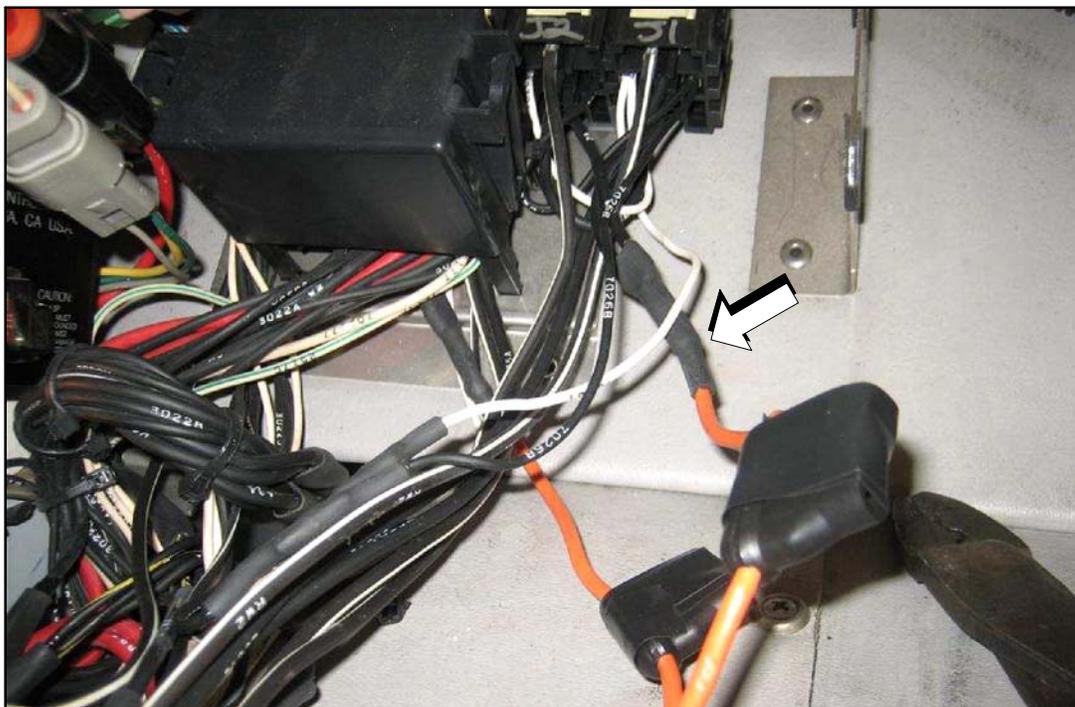
Figure 3.

- 7. Locate the fuse holders (refer to Figure 3). Using wire cutters, cut the wires at the wire splice.

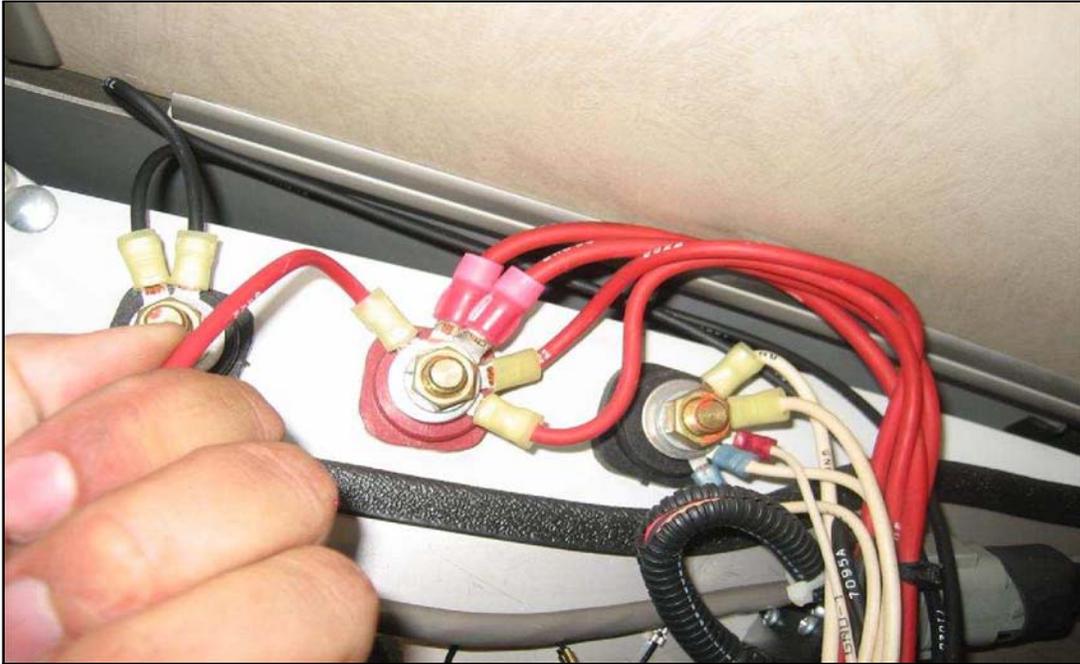
Figure 4.

8. Trace the routing of the red wire cut at the wire splice to the 24 VDC red stud block. Remove and retain the nut. Remove and discard the red wire. Return the nut to the stud block.

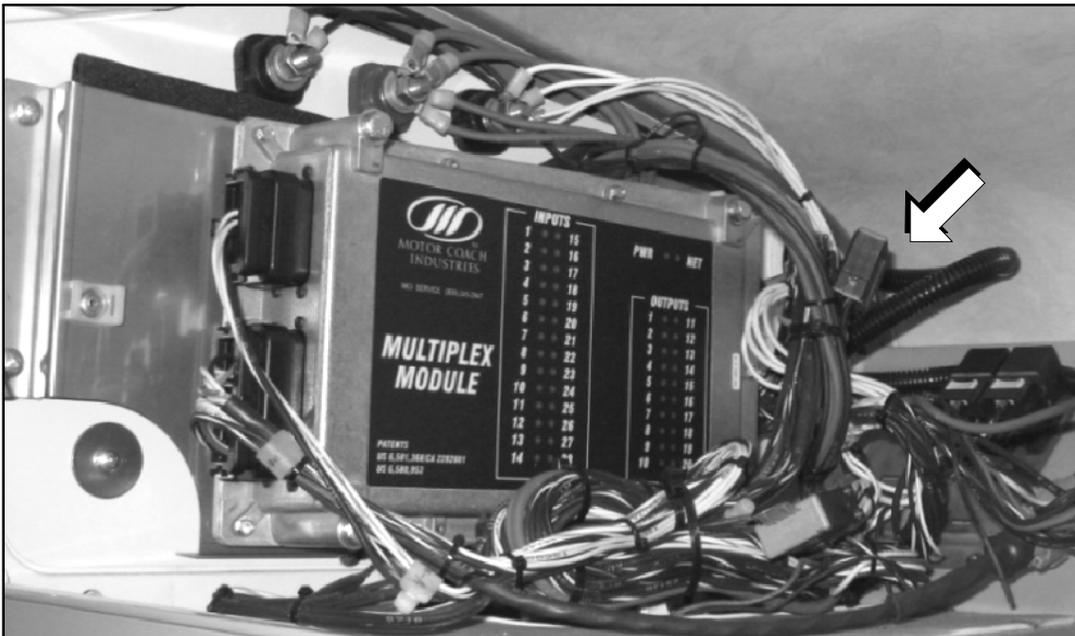
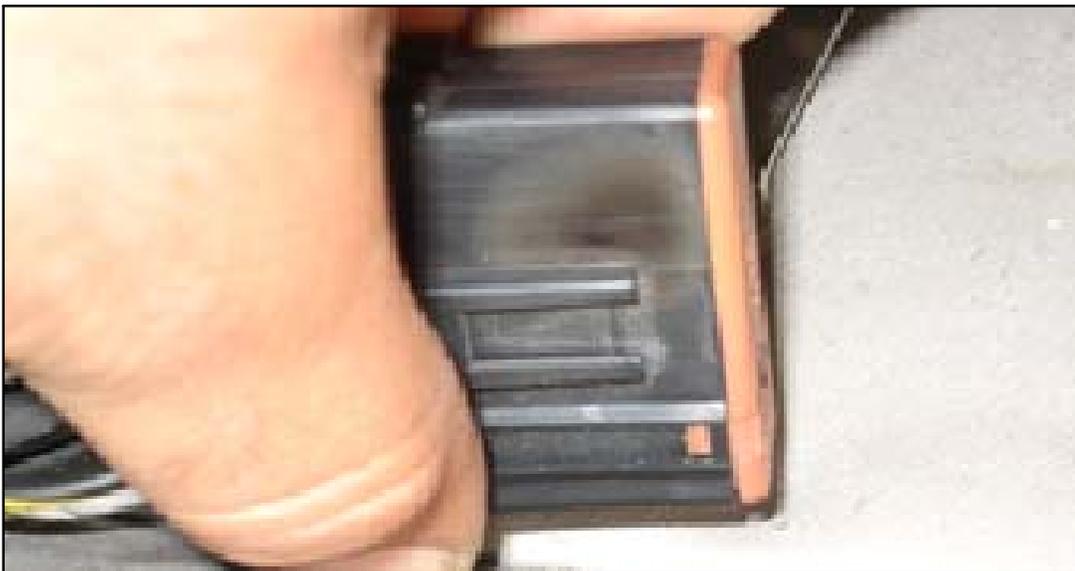
Motor Coach Industries, Inc. ("MCI") has become aware that when the LED lights are in operation in certain 2009–2011 D series coaches equipped with a Vansco or IO multiplex system, the power draw from the LED lights may exceed the design limits of the fuse block terminal and the splice clip connector. In this situation, excessive heat may build up at the fuse block and connector that may cause the components to melt.

Figure 6. Connector S102 (splice clip connector design / brown color).

9. Locate connector S102 (refer to Figures 5 and 6).

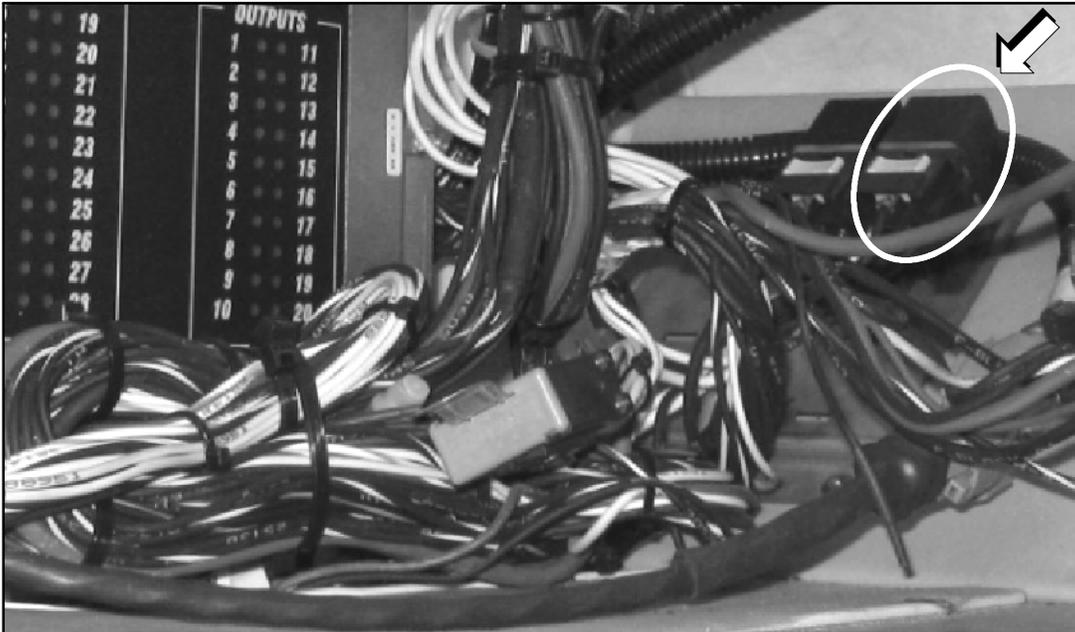
Figure 8. Relay J location in curbside, parcel rack compartment #1.

17. Locate Relay J (refer to Figure 8). Remove circuit 7026B from Relay J cavity 86 and splice with circuit 7026B from the Interior Light Relay Kit, p/n 07-08-4682B, using heatshrink, p/n 07-08-4684.
18. Remove circuit 70261 from Relay J cavity 85 and splice with circuit 70261 from the Interior Light Relay Kit, p/n 07-08-4682B, using heatshrink, p/n 07-08-4684.
19. Discard Relay J and its base. Using wire cutters, cut and remove any other wire connected to the relay.

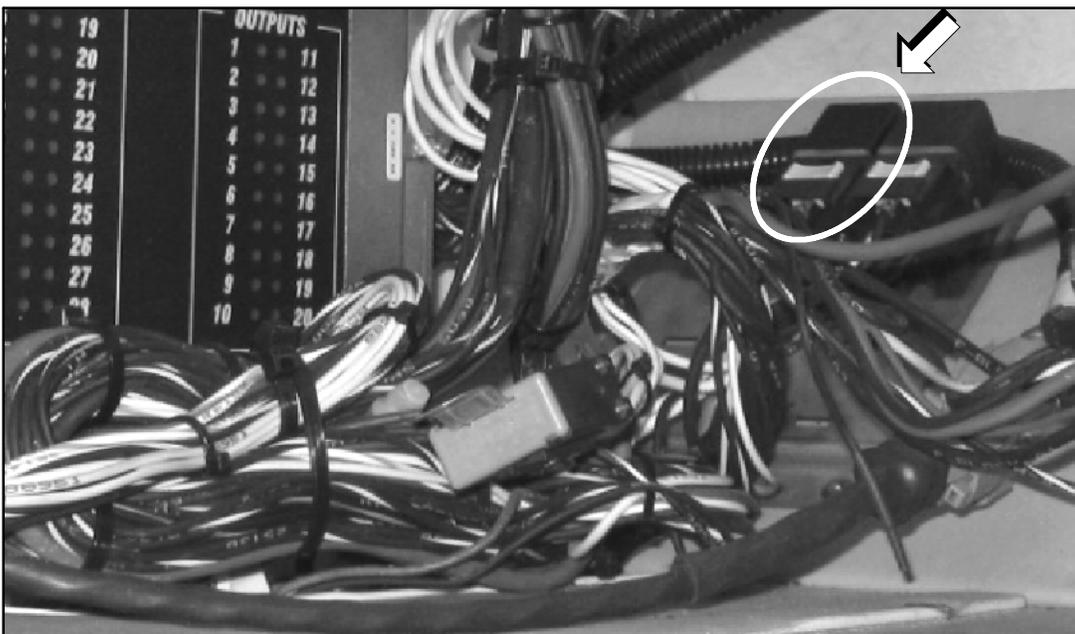
Figure 9. Relay K location in curbside, parcel rack compartment #1.

20. Locate Relay K (refer to Figure 9). Remove circuit 7029 from Relay K cavity 86 and splice with circuit 7029 from the Interior Light Relay Kit, p/n 07-08-4682B, using heatshrink, p/n 07-08-4684.
21. Remove circuit 70291 from Relay K cavity 85 and splice with circuit 70291 from relay kit (07-08-4682B) using 07-08-4684.
22. Discard Relay K and its base. Using wire cutters, cut and remove any other wire connected to the relay.

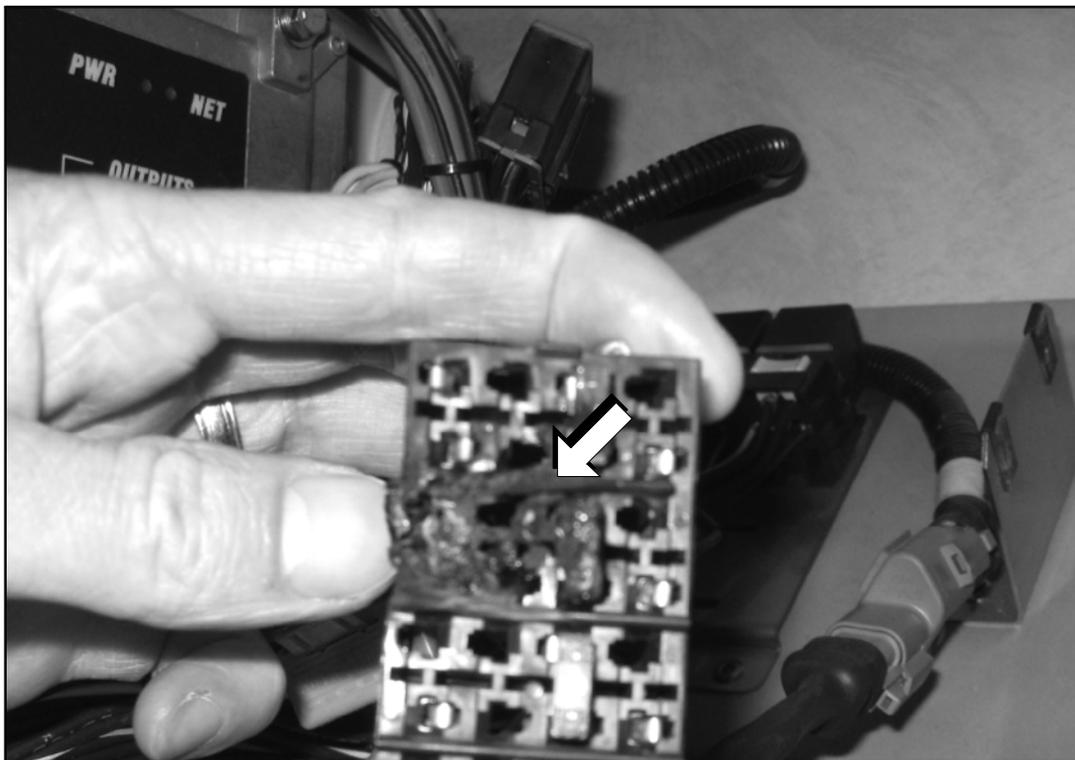
23. Visually inspect the fuse block for heat damage or melting at locations A1 and A2 (refer to Figure 10).

Figure 10. Fuse block in curbside, parcel rack compartment #1.

Upon visual inspection, if the fuse block exhibits signs of heat damage or melting, contact the MCI Fleet Support Technical Center at 1-800-241-2947 for further information and replacement parts.

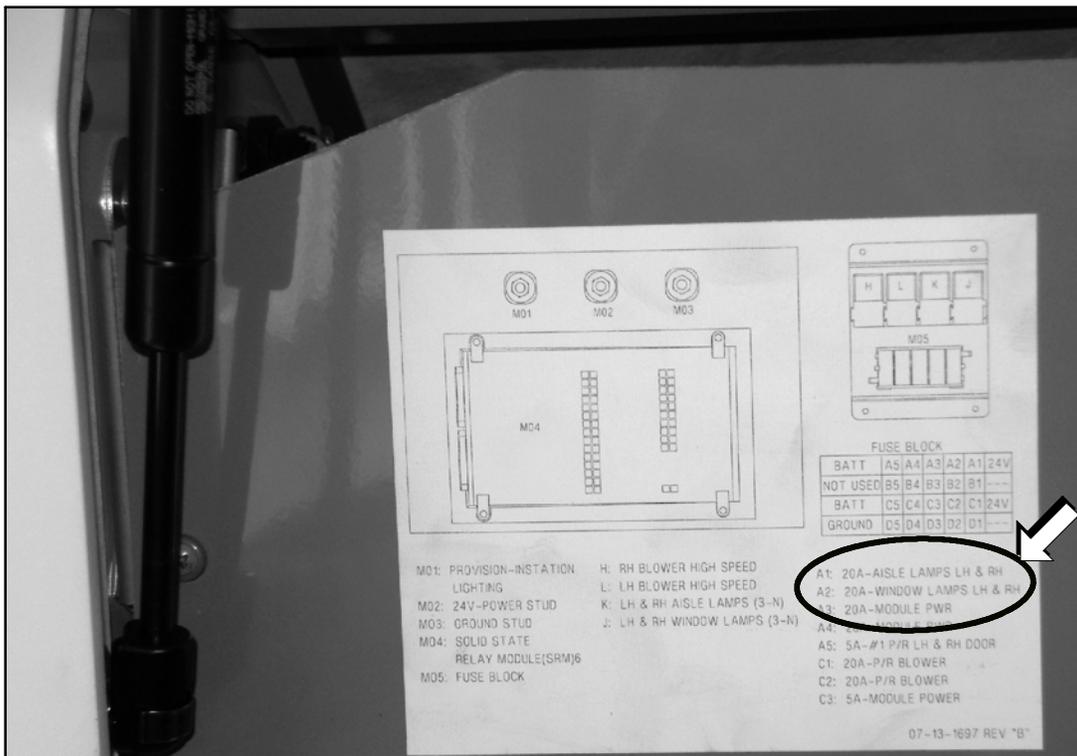
Figure 12. Decal legend location on junction box cover in curbside, parcel rack compartment #1.

29. Using the decals, p/n 07-08-4682B, cover locations A1 and A2 on the Decal legend affixed to the junction box cover.
