Subject: Agility Fuel Systems Recall – CNG Rail Mount System Mounting System Defects

Attached is a vehicle defect initial information report, which is being submitted by Agility Fuel Systems pursuant to 49 C.F.R. Part 573.

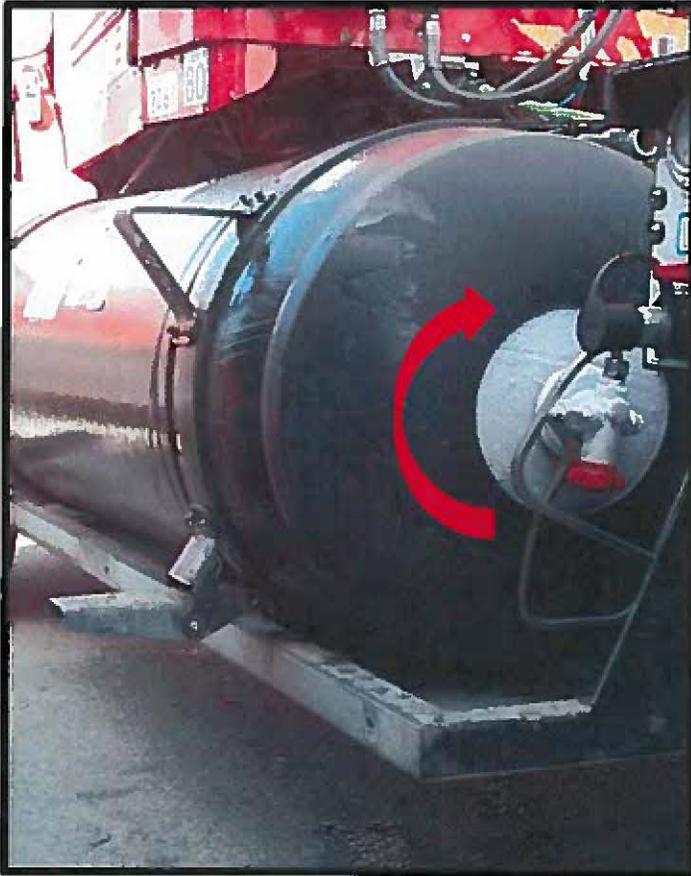
If the tank rotates within the mounting system, it can rotate until the fuel lines can be either compromised to the point of failure or can be pinched to the point that fuel will not freely flow

from the tank. Compromised fuel lines may leak or fail, which would result in a gas leak of varying magnitude and interruption of fuel flow to the engine.

Picture 2 - Significant tank rotation causing fuel lines to be compromised and the flow to/from the tank restricted

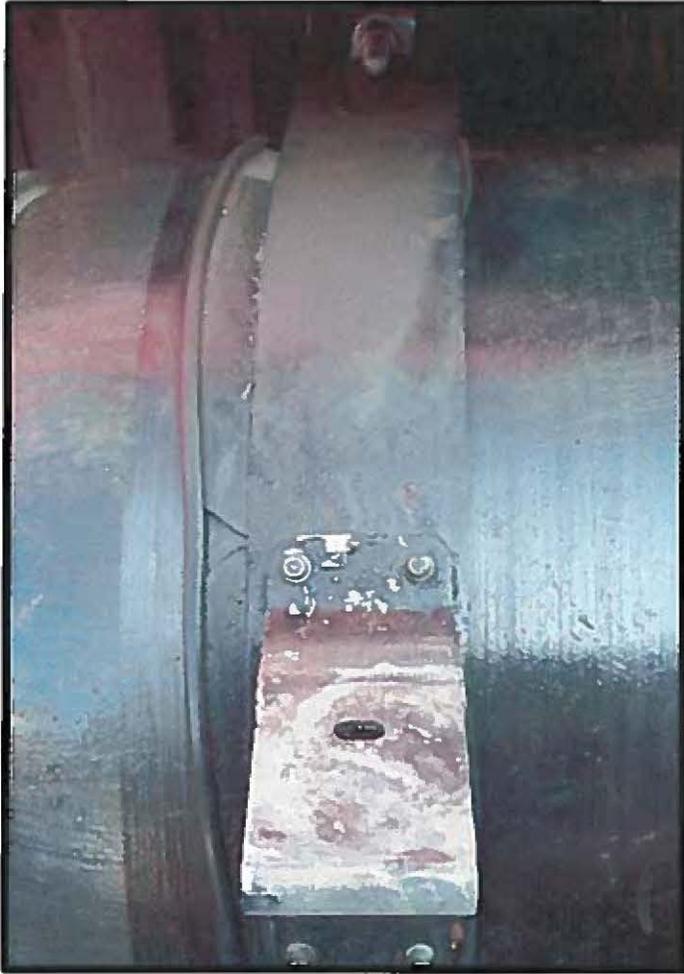
If the brackets become loose, the rubber isolator may become displaced and the tank may contact the metal bracket. This contact may lead to abrasion damage of the tank.

Picture 3 - Loose mounting straps allowing rubber isolator to be displaced, possibly allowing the tank to contact the metal brackets, possibly leading to abrasion damage to the tank
