Thor Motor Coach Recall Repair Instructions

Recall #	14V-		
Description/Title:	Outlaw 29H Generator Exhaust Pipe Replacement		
Affected Product Line(s):	Certain Outlaw 29Hs Offline between 1/13/2014 and 4/25/2014.		
Service Campaign # :	RC000089	Released Date:	
Failure Code:	TMCRC80435V	Document Date:	
Time Allowed:	0.5	Document Revision:	A

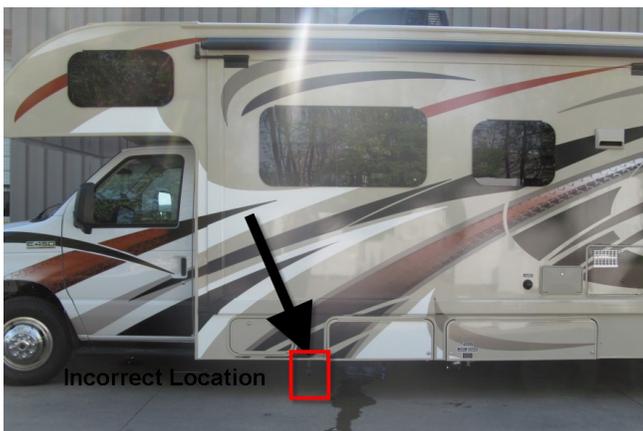
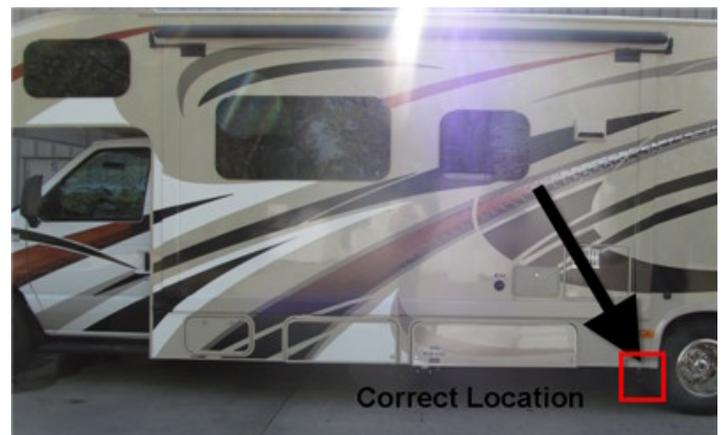
Determine whether the unit has the old or new generator tail pipe by going to the driver's side of the unit and finding where the generator exhaust pipe is located. If it is between the first and second compartment door, a new generator exhaust pipe will need to be installed. If it is between the 3rd compartment door and the wheel well, the recall does not need to be performed.
