Service Bulletin No. 388B

MODEL D Series Coaches	TYPE Field Change Program	SECTION/GROUP 7 – Electrical	DATE
SUBJECT INTERIOR LED LIGHTS			
CONDITIONS

THIS BULLETIN SUPERSEDES SERVICE BULLETIN 388 IN ITS ENTIRETY.

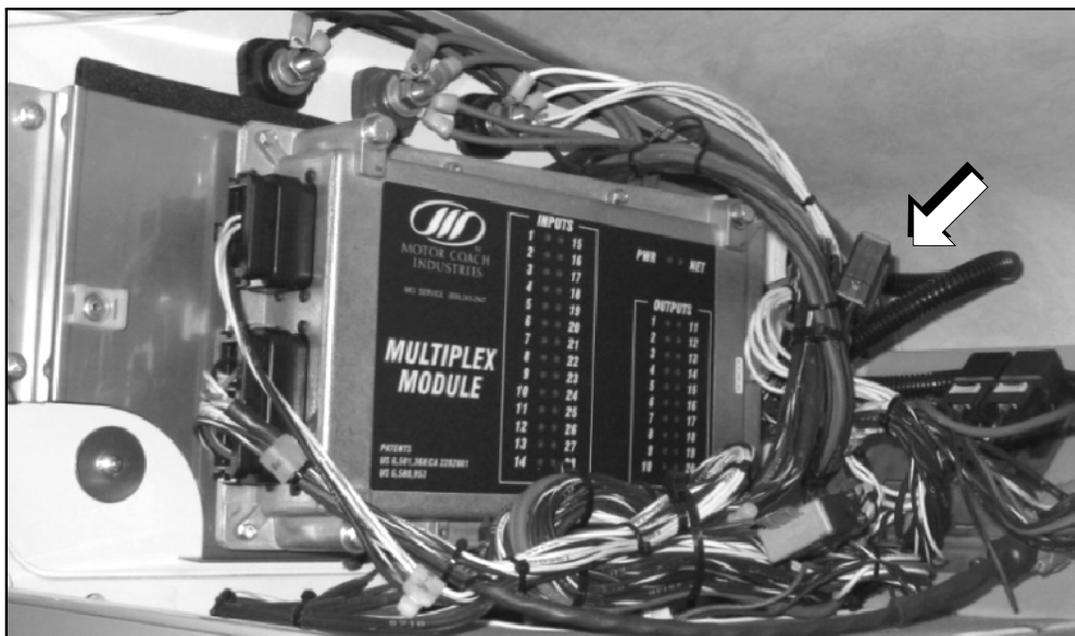
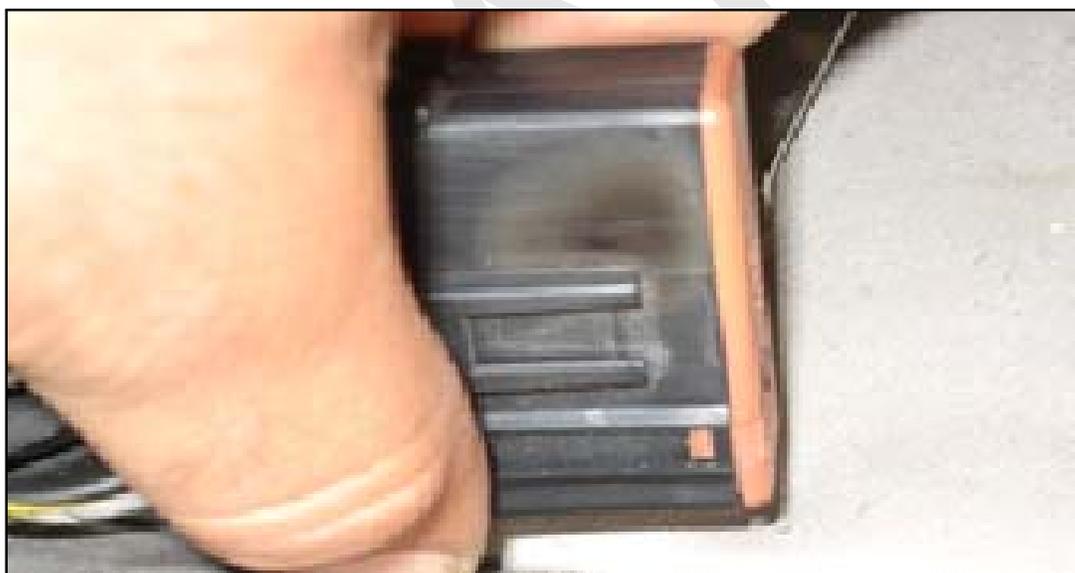
Motor Coach Industries, Inc. ("MCI") has become aware that when the LED lights are in operation in certain 2009–2011 D series coaches equipped with a Vansco or IO multiplex system, the power draw from the LED lights may exceed the design limits of the fuse block terminal and the splice clip connector. In this situation, excessive heat may build up at the fuse block and connector that may cause the components to melt.

Figure 6. Connector S102 (splice clip connector design / brown color).

9. Locate connector S102 (refer to Figures 5 and 6).

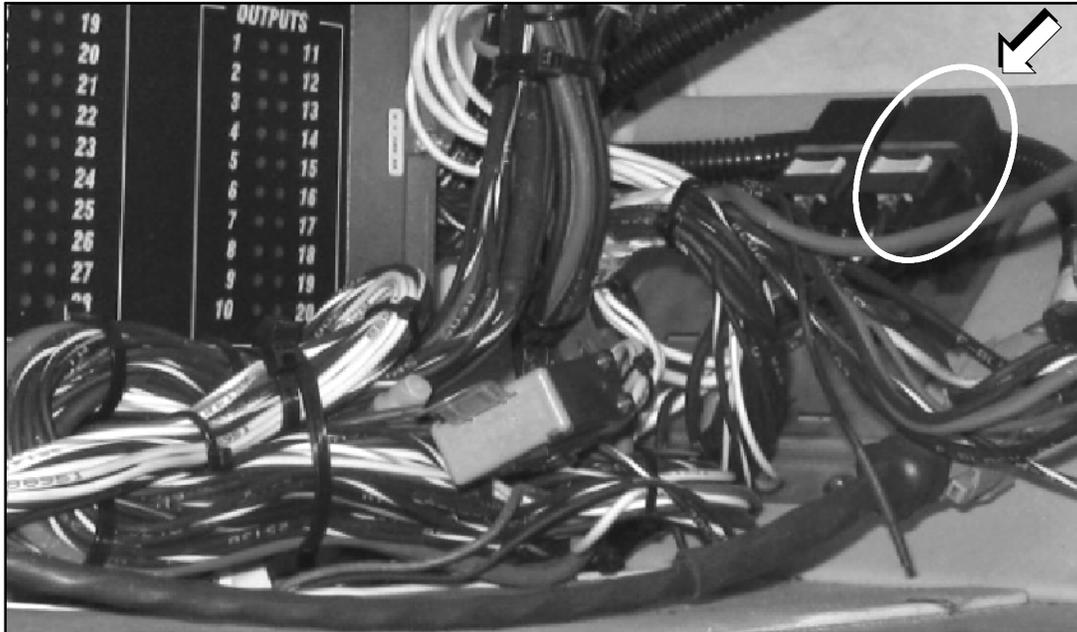
Figure 8. Relay J location in curbside, parcel rack compartment #1.

17. Locate Relay J (refer to Figure 8). Remove circuit 7026B from Relay J cavity 86 and splice with circuit 7026B from the Interior Light Relay Kit, p/n 07-08-4682B, using heatshrink, p/n 07-08-4684.
18. Remove circuit 70261 from Relay J cavity 85 and splice with circuit 70261 from the Interior Light Relay Kit, p/n 07-08-4682B, using heatshrink, p/n 07-08-4684.
19. Discard Relay J and its base. Using wire cutters, cut and remove any other wire connected to the relay.

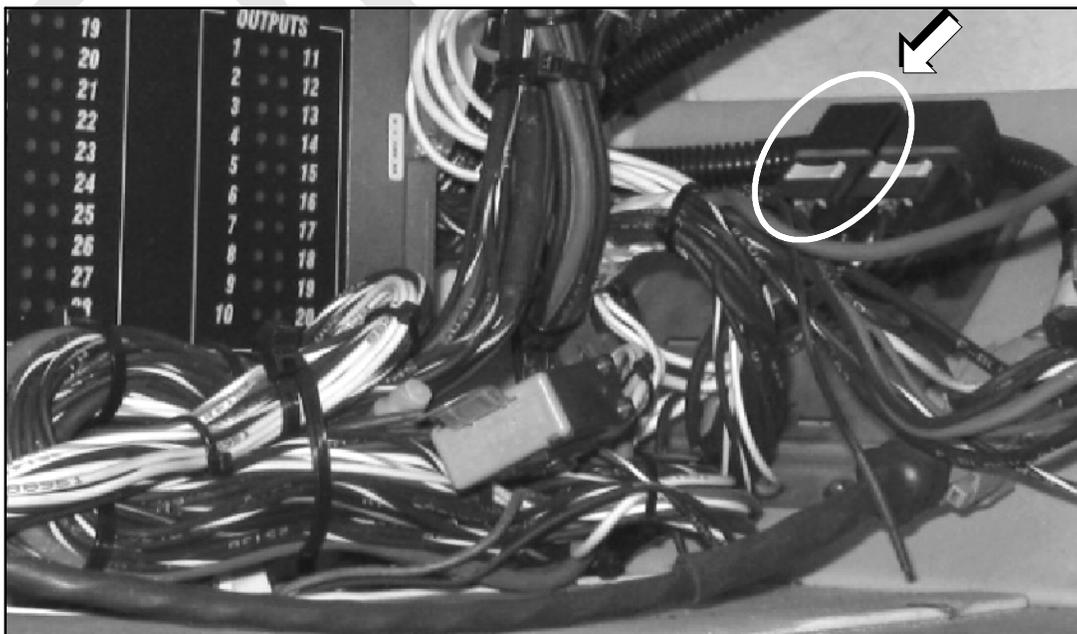
Figure 9. Relay K location in curbside, parcel rack compartment #1.

20. Locate Relay K (refer to Figure 9). Remove circuit 7029 from Relay K cavity 86 and splice with circuit 7029 from the Interior Light Relay Kit, p/n 07-08-4682B, using heatshrink, p/n 07-08-4684.
21. Remove circuit 70291 from Relay K cavity 85 and splice with circuit 70291 from relay kit (07-08-4682B) using 07-08-4684.
22. Discard Relay K and its base. Using wire cutters, cut and remove any other wire connected to the relay.

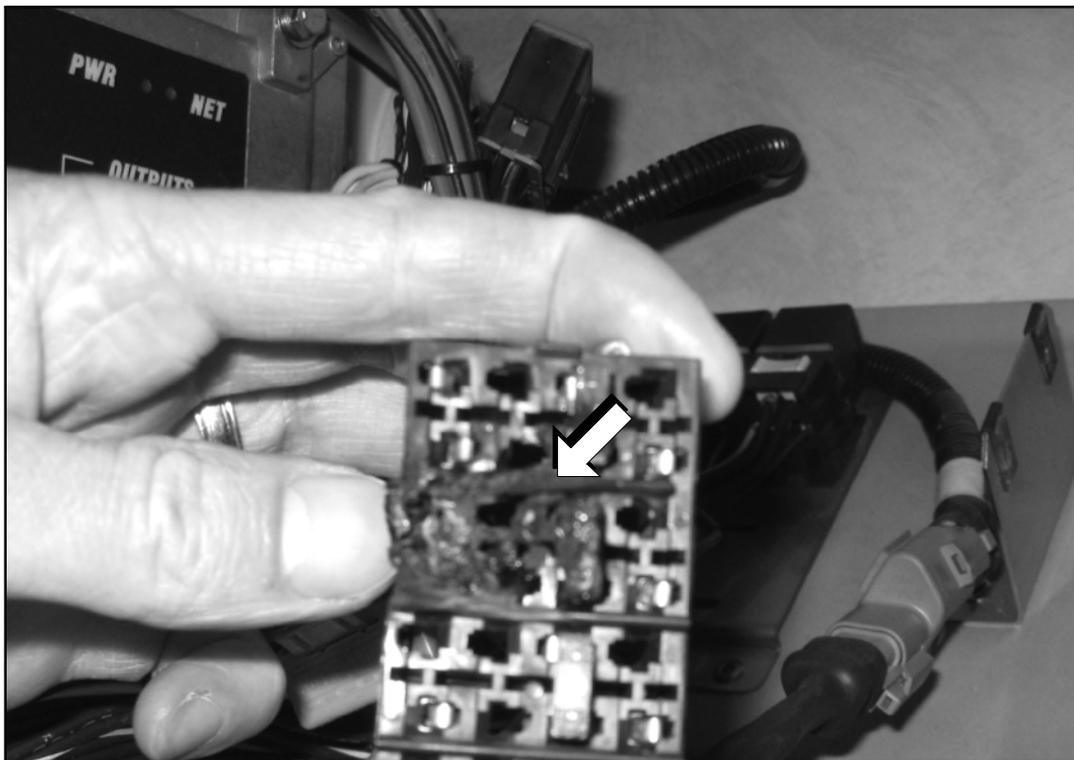
Figure 10. Fuse block in curbside, parcel rack compartment #1.

Upon visual inspection, if the fuse block exhibits signs of heat damage or melting, contact the MCI Fleet Support Technical Center at 1-800-241-2947 for further information and replacement parts.

23. Visually inspect the fuse block for heat damage or melting at locations A1 and A2 (refer to Figure 10).

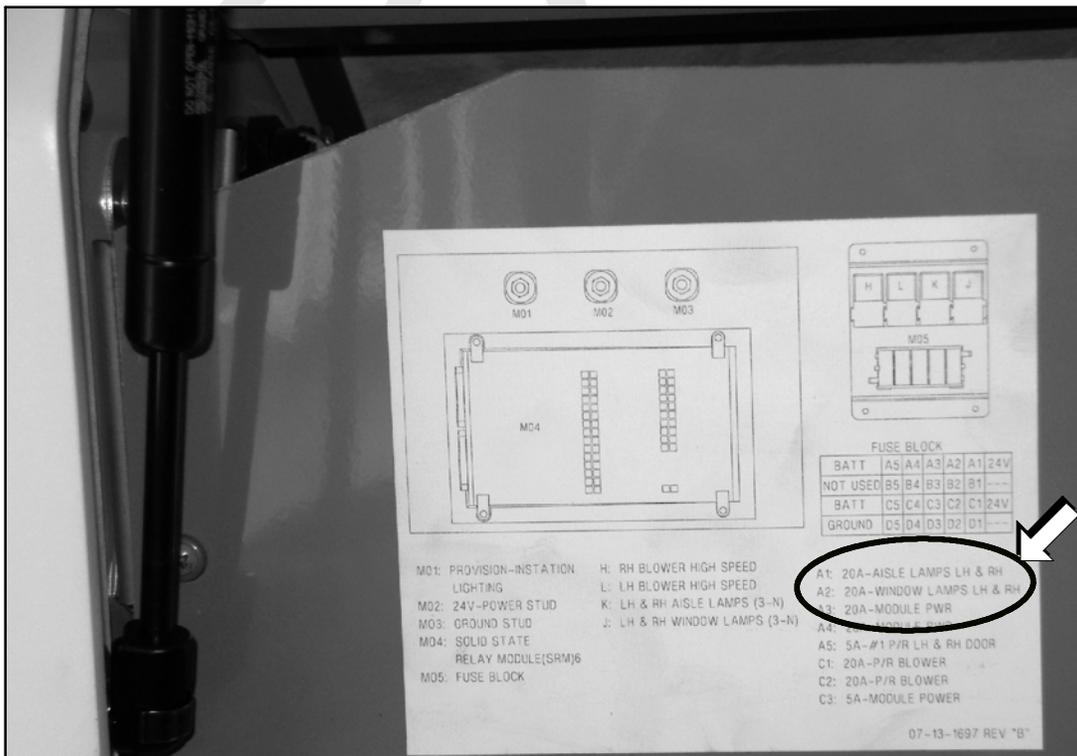
Figure 12. Decal legend location on junction box cover in curbside, parcel rack compartment #1.

29. Using the decals, p/n 07-08-4682B, cover locations A1 and A2 on the Decal legend affixed to the junction box cover.
