Subject: Updated Agility Fuel Systems Recall Documentation – CNG Rail Mount System Mounting System Defects

**1. The manufacturer's name:**

Agility Fuel Systems

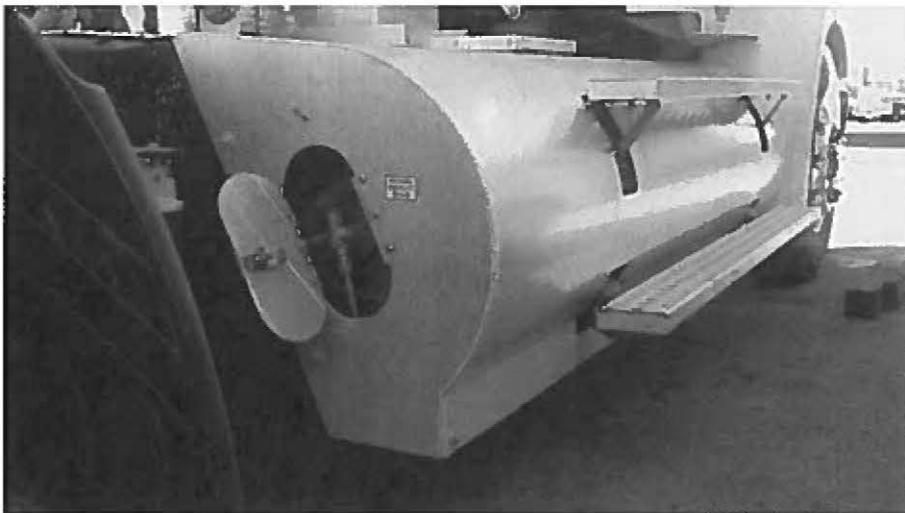
*Picture 1 - Agility CNG Rail Mount System*

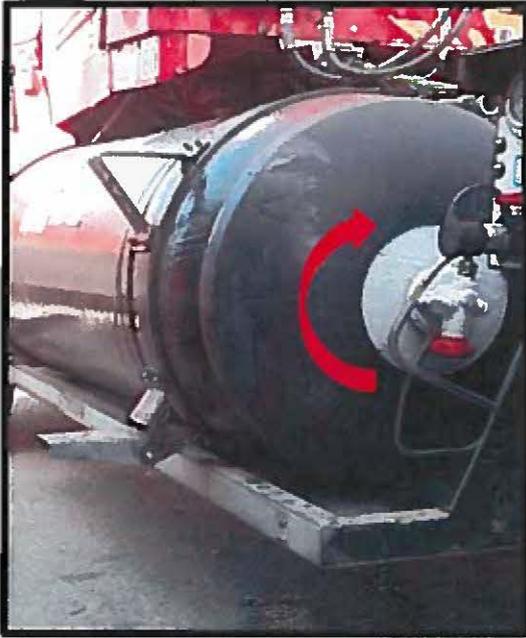
If the tank rotates substantially within the mounting system, the fuel lines could be compromised to the point of failure or pinched to the point that fuel will not freely flow from the tank. Compromised fuel lines may leak or fail, which would result in a gas leak of varying magnitude and interruption of fuel flow to the engine.

*Picture 2 - Significant tank rotation causing fuel lines to be compromised and the flow to/from the tank restricted*

Of the above listed 1036 tanks with potential mounting system defects, 596 have been repaired in the field by Agility. Agility has developed an update kit, which improves the mounting system by use of a revised design stainless steel tank strap and mounting hardware along with a new isolator design that together provides improved durability and tolerance for tank expansion and contraction. Agility will install the update kit on each of the remaining systems in the field.

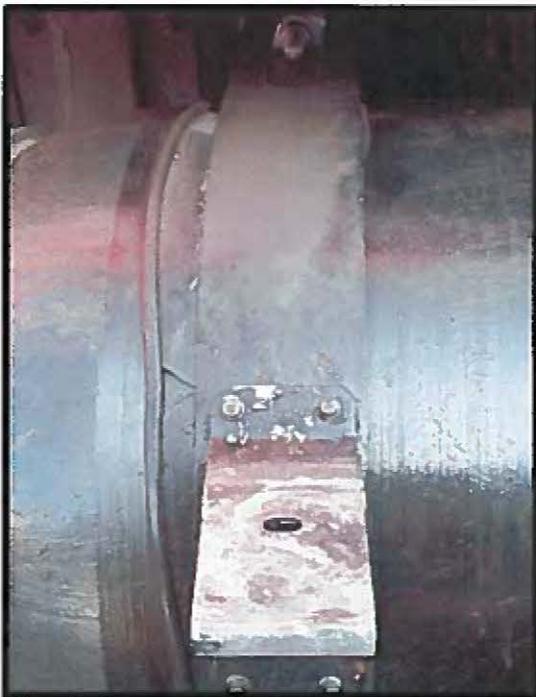
In addition, severe displacement could cause abrasion damage to the tank if the rubber isolators, which are normally positioned between the tank and the bracket system, are displaced and the tank contacts the metal mounting brackets directly.

*Picture 3 - Loose mounting straps allowing rubber isolator to be displaced, possibly allowing the tank to contact the metal brackets, possibly leading to abrasion damage to the tank*
