**NUMBER:** 21-013-14 REV. A

**GROUP:** Transmission and Transfer Case

N28 Transmission Oil Cooler Tube Interim Repair

2012-2013 (JK) Wrangler

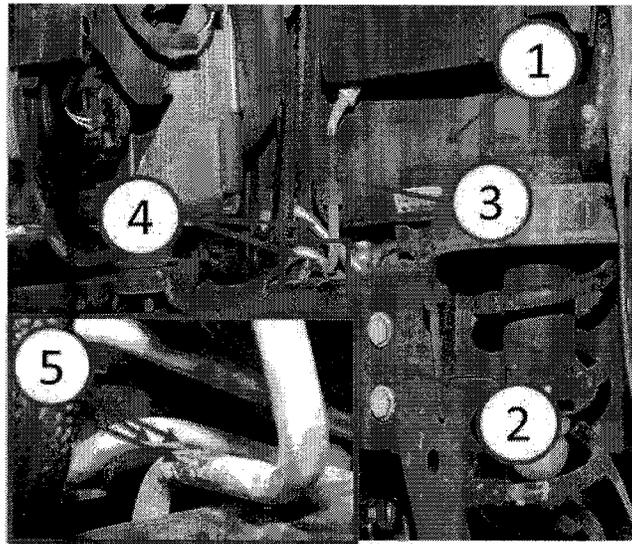
**Fig. 3 Inspect TOC Tube**

- 
4. Using a small inspection mirror, check for wear marks on the transmission oil cooler tube and power steering return tube where they intersect . Were there any wear marks on the transmission oil cooler or power steering return tube (Fig.3)?
    - a. Yes>>> Contact a STAR agent for further assistance at 1-800-850-STAR, select "Part or Labor Operation Restriction". Enter part number (**digits only**) for part number CBRAN283AA (**digits 283**).
    - b. No>>> Proceed to Step 5.

- 1 - Power Steering Pump
- 2 - Left Frame Rail
- 3 - Power Steering Return Tube
- 4 - Transmission Oil Cooler Tubes
- 5 - Suspect Wear Area

- 
5. Install transmission oil cooler tube protective sleeve. Carefully slide the protective sleeve over the transmission oil cooler tube (Fig.5). Install a plastic tie strap at each end of the protective sleeve and remove the tie strap excess (Fig.4) (Fig.5).
