PART 573 Defect and Noncompliance Report

Manufacturer Corporate Name: LiquidSpring LLC

Equipment Brand or Trademark: CLASS (Compressible Liquid Adaptive Suspension System)

The item of equipment subject to the recall is a fluid volume mount bracket of the suspension system. The following suspension models and manufacture dates are the affected population.

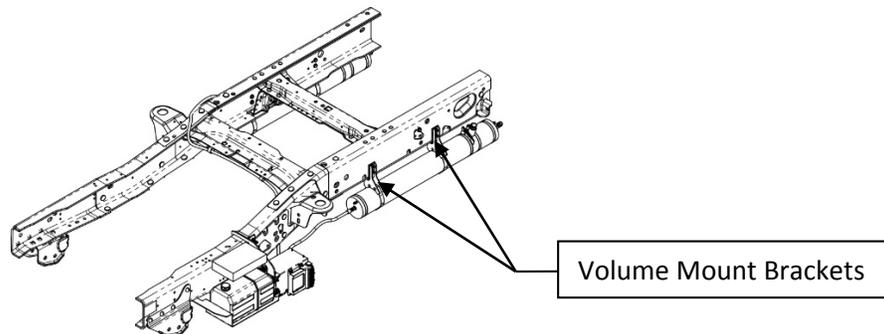
The volume mount bracket affixes a fluid volume to the chassis frame. There are 2 fluid volume mount brackets per fluid volume and 2 fluid volumes per suspension system. Therefore, each suspension system has 4 fluid volume mount brackets affected by the recall. See illustration below for typical fluid volume mount brackets on one side of the chassis.

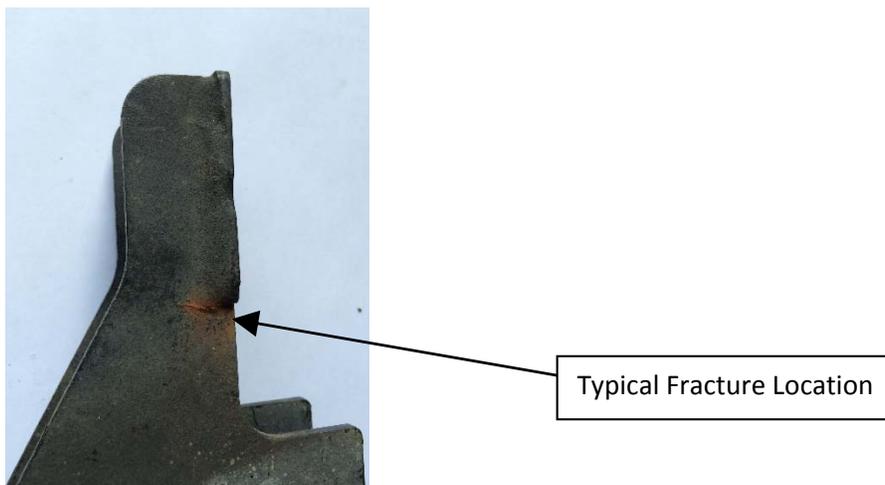
Description of the Defect: The fluid volume mount bracket can develop a complete fracture such that the bracket separates from the chassis frame and is unable to provide support for the fluid volume at the bracket location.

Cause of the Defect: The cause of the defect is material fatigue in a portion of the fluid volume mount bracket due to application load conditions. More severe duty service conditions increase the likelihood of fracture initiation and propagation.

Potential Warnings of the Defect: The fracture(s) in the fluid volume mount bracket can be detected in early initiation and propagation stages prior to complete fracture of the bracket. See below.

The production remedy for the fluid volume mount bracket defect is implementation of a re-designed bracket that will not experience a fracture due to severe duty load conditions. The re-designed fluid volume mount bracket was implemented in production on all affected models manufactured on or after May 14, 2014. The re-designed bracket is readily distinguished from the original bracket.
