# Recall Bulletin

## PRODUCT SAFETY RECALL

**SUBJECT:** Electric Power Steering Assist

**MODELS:** 2008 Chevrolet Malibu  
2008 Pontiac G6  
2008 Saturn Aura

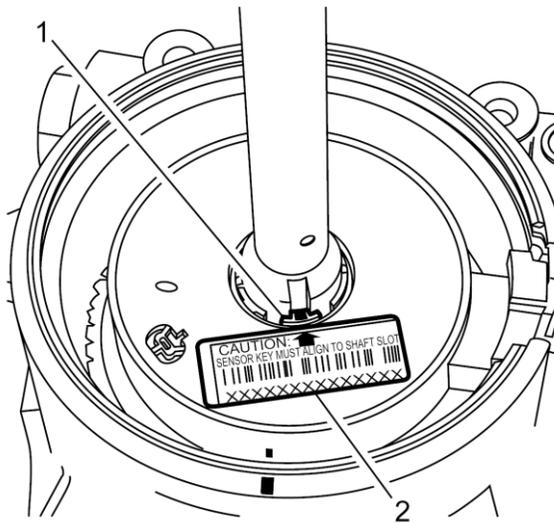
3824308

3. Document the last 9 digits of the NEW steering shaft torque sensor on the vehicle repair order. The serial number is located on the bottom of the caution label (2).
4. Remove the power steering assist motor. Refer to *Power Steering Assist Motor Replacement* in SI.
5. Install a new power steering assist motor. Refer to *Power Steering Assist Motor Replacement* in SI.
