Brake Parts INC LLC  
4400 Prime Parkway  
McHenry, IL 60050

14E-036  
(9 pages)

**PART 573 Defect and Noncompliance Report**

Date: July 2, 2014

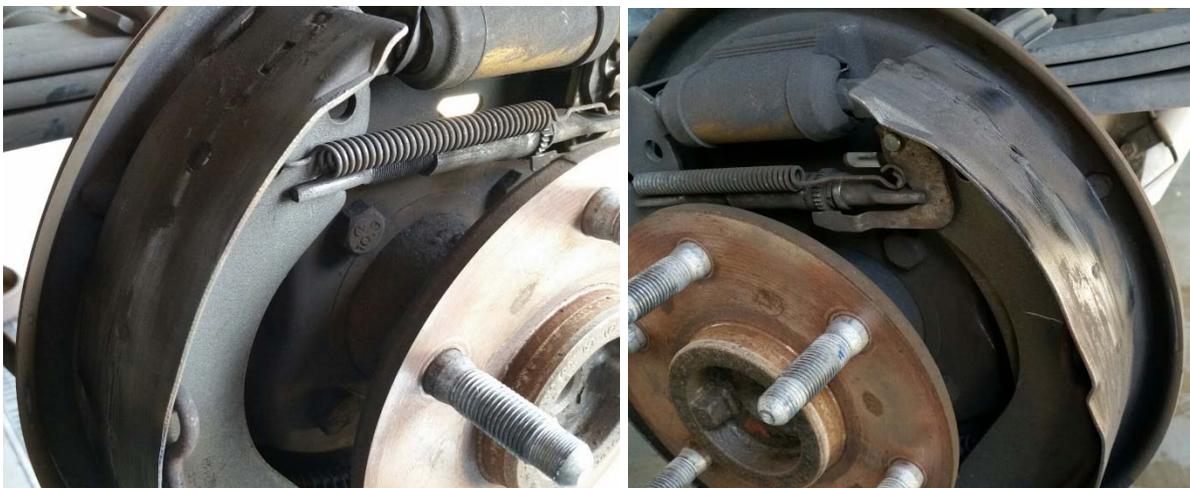
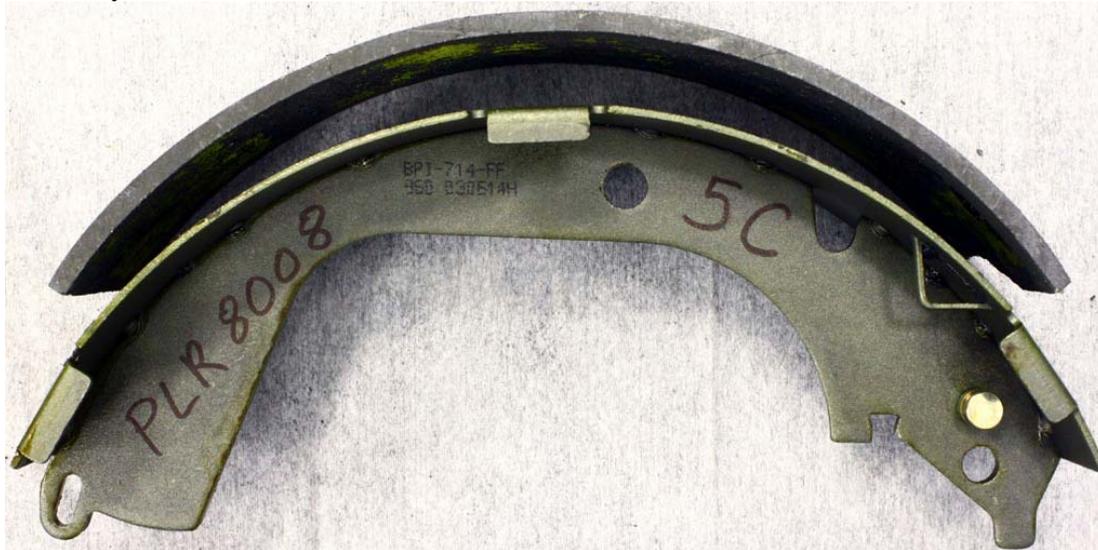
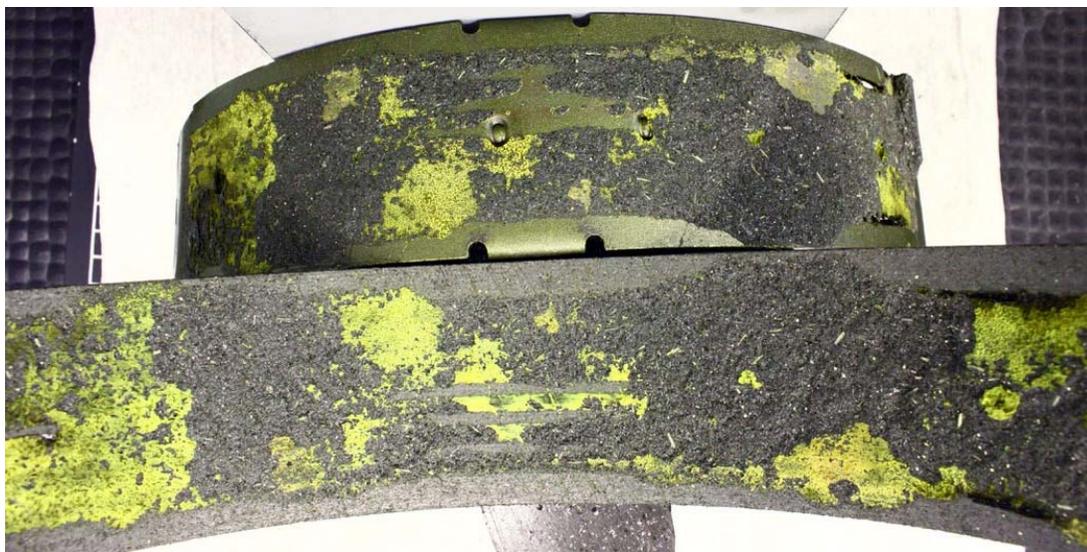
The defect involves the adhesion between the friction lining and the steel shoe. The lining of the brake shoe may detach from the steel shoe during normal service, causing the affected brake to fail. The defect does not affect the other brakes on the vehicle, and those brakes will continue to operate normally. If the lining detaches from the steel shoe, it will reduce the available braking force which could lengthen the required stopping distance, and increase the risk of a crash without prior warning. Photos are attached. The first two photos show brake assemblies in which the friction lining has detached from the steel shoe. The third photo shows one of the brake shoe parts at issue in this notification. As is apparent from the photo, the friction lining is detached in the photo and appears above the steel shoe. The last photo shows a steel shoe that has retained lining material and glue after detachment of the lining.

The adhesive between the lining and the steel shoe was not sufficiently bonded due to an inadequate curing process.

The brake lining which is adhesively bonded to the shoe steel may detach from the steel and not provide expected braking or may become lodged in the rear drum brake mechanism, causing the

When friction lining detaches, it is possible that the brake may make a popping noise and/or a metal-to-metal grinding sound.

BPI will replace the recalled brake shoes free of charge. If owners or purchasers have incurred costs to remedy the defect before receiving BPI's notification concerning the defect, they may submit a request for reimbursement to BPI and receive full reimbursement for their costs.

In the remedied parts, the lining in the replacement brake shoes will be adequately bonded with the steel shoe such that the lining will not detach from the steel shoe under normal service conditions. BPI has received assurances from its supplier, Xinyi, that it has taken steps to remedy the insufficiencies in the curing process and that remedied parts will conform to BPI's standards. Additionally, BPI is and will continue to conduct internal testing to ensure that the defect does not exist in the remedy parts. The remedy parts will be identifiable by date codes.
