14E-036  
(10 pages) Amended

**Amended PART 573 Defect and Noncompliance Report**

Date: July 10, 2014

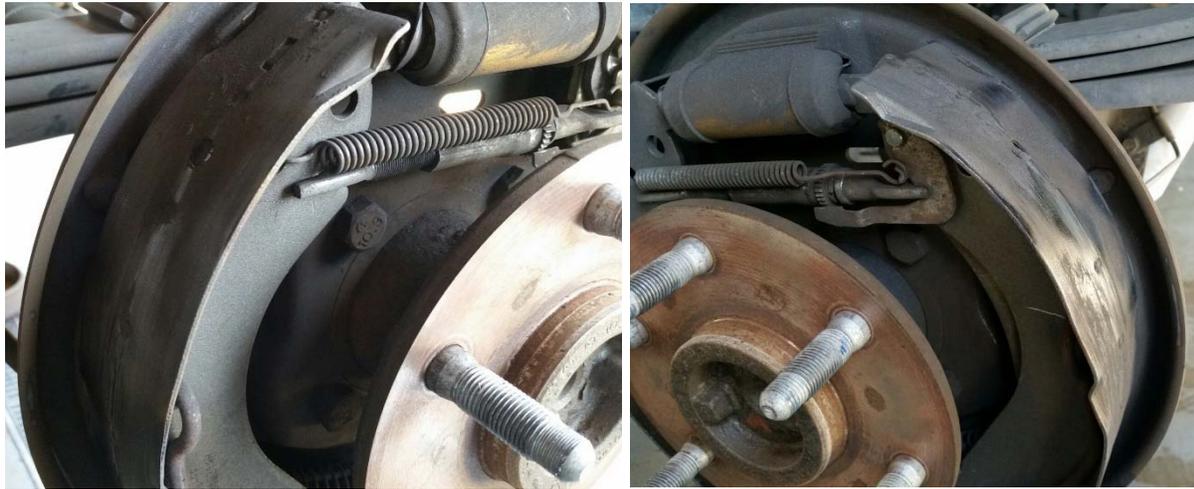
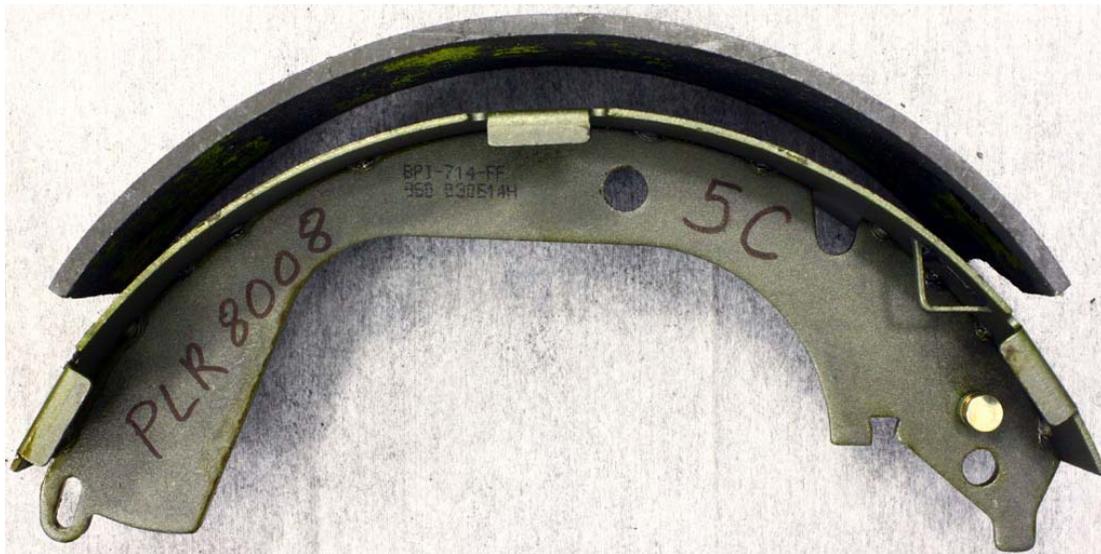
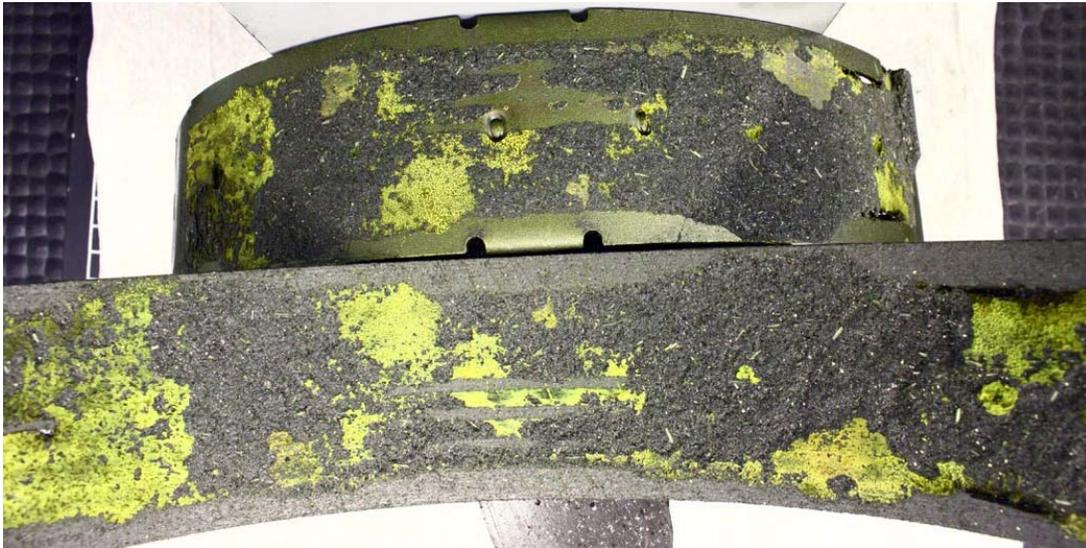
The defect involves the adhesion between the friction lining and the steel shoe. The lining of the brake shoe may detach from the steel shoe during normal service, causing the affected brake to fail. The defect does not affect the other brakes on the vehicle, and those brakes will continue to operate normally. If the lining detaches from the steel shoe, it will reduce the available braking force which could lengthen the required stopping distance, and increase the risk of a crash without prior warning. Photos are attached. The first two photos show brake assemblies in which the friction lining has detached from the steel shoe. The third photo shows one of the brake shoe parts at issue in this notification. As is apparent from the photo, the friction lining is detached in the photo and appears above the steel shoe. The last photo shows a steel shoe that has retained lining material and glue after detachment of the lining.

The adhesive between the lining and the steel shoe was not sufficiently bonded due to an inadequate curing process.

The brake lining which is adhesively bonded to the shoe steel may detach from the steel and not provide expected braking or may become lodged in the rear drum brake mechanism, causing the brake at issue to malfunction.

BPI will replace the recalled brake shoes free of charge. If owners or purchasers have incurred costs to remedy the defect before receiving BPI's notification concerning the defect, they may submit a request for reimbursement to BPI and receive full reimbursement for their costs.

In the remedied parts, the lining in the replacement brake shoes will be adequately bonded with the steel shoe such that the lining will not detach from the steel shoe under normal service conditions. BPI has received assurances from its supplier, Xinyi, that it has taken steps to remedy the insufficiencies in the curing process and that remedied parts will conform to BPI's standards. Additionally, BPI is and will continue to conduct internal testing to ensure that the defect does not exist in the remedy parts. The remedy parts will be identifiable by date codes.
