14V-458 - Amended
(7 pages)

PART 573 Defect and Noncompliance Report

RE: Safety Recall #14V-458, SAF-Holland CBX Suspension Pivot Bolt

Cast Beam Pivot Bolt Replacement Procedure

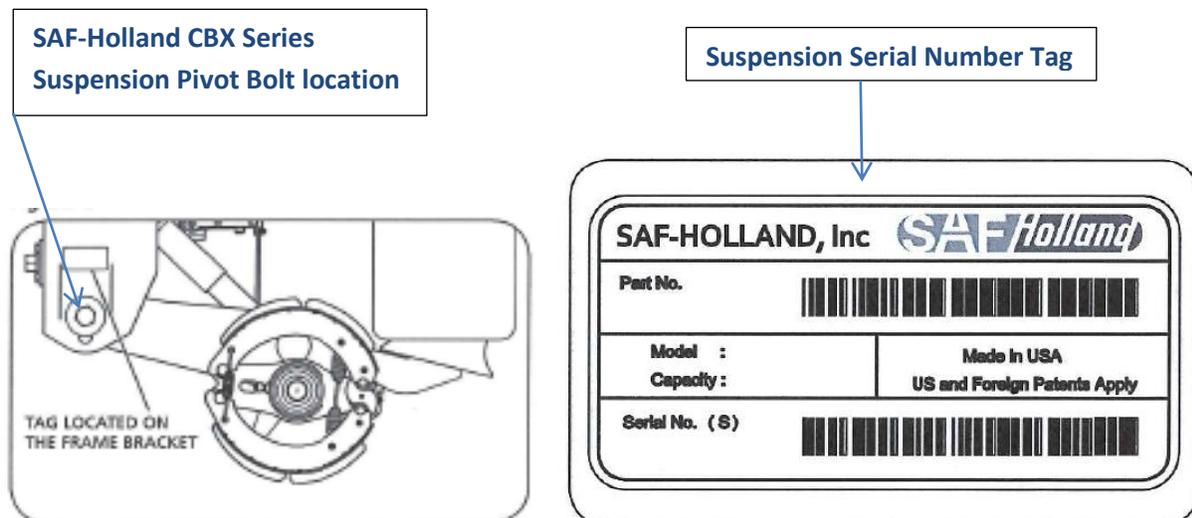
SAF-Holland CBX Suspension pivot bolt failure (pt. #93201070): 1289 CBX suspensions were shipped to Timpte which were assembled with the suspect suspension assembly pivot bolt. Cracks may occur at the junction of the pivot bolt head and body due to a micro-flaw created during the production process for the bolts. The bolt head and bolt body may separate allowing the CBX suspensions to disassemble. Trailer alignment would be an immediate indicator of the pivot bolt failure.

SAF-Holland has reported to Timpte that pivot bolts in their suspensions have failed. The pivot bolt is located where the suspension trailing arm and suspension tower are joined.

SAF-Holland had reported to Timpte that this defect is the result of a manufacturing process

issue and flaw by their supplier of the pivot bolt component.

Timpote will be supporting SAF-Holland's plan by contacting all of the affected Timpote trailer owners and assisting them with scheduling their trailers into a facility to have the pivot bolt replaced, per SAF-Holland's plan. Timpote will track the process and the completion of the updates through it's Warranty Administration process. Timpote will coordinate out efforts with those of SAF-Holland to correct the problem.
