REFERENCE NHSTA RECALL # 14E015.

**VILLA INTERNATIONAL**

ISS LINK ASSEMBLY, RECALL REPAIR

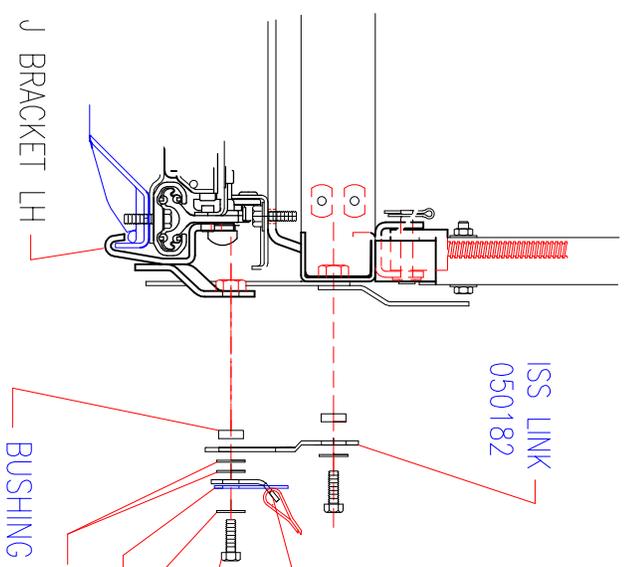
FRONT VIEW

LEFT SIDE OF DRIVERS SEAT SHOWN  
 RIGHT SIDE PASSENGER SEAT THE SAME.

**NOTE:**  
 REMOVE TWIST IN SEAT BELT BEFORE FASTENING END.  
 \* IDENTIFIES REPAIR KIT HARDWARE.  
 TIGHTEN REPLACEMENT BOLT TO 20 FT-LB.
