VEHICLE QUARANTINE NOTICE		
<b>To:</b> <b>For the attention of:</b> <b>Please copy to:</b>	<b>All North America Dealers</b> <b>After Sales Manager</b> <b>Executive Manager</b> <b>Service Manager</b> <b>Sales Manager</b> <b>Warranty</b> <b>Technician(s)</b> <b>Parts</b>	<b>Reference</b> <b>QN-07-0022</b>  <b>Issued:</b> <b>14 July 2014</b>
<b>Model:</b>	<b>DB9 and Rapide S</b>	
<b>VIN Range:</b>	<b>Refer to the separately published list of VINS</b>	
<b>Subject:</b>	<b>Replacement of Transmission Control Switches</b>	
		<b>Page 1 of 10</b>

**Reason for this Quarantine Notice**

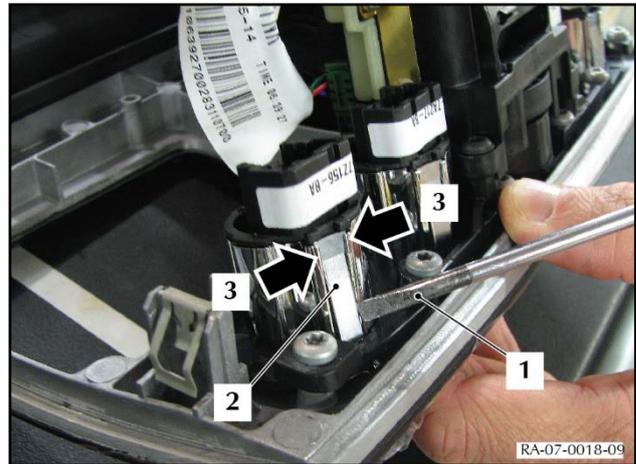
Figure 9

**Note: The plastic parts (3) that attach the retaining clip will break. This is usual.**

10. Use an applicable thin bladed tool (1) as a lever to remove the two metal retaining clips (2) from the “Drive” switch (refer to Figure 9).
