Firmware Update for Automatic Charge Current Reduction

Classification	Recall Bulletin	Section/Group	00 - Inspection & Service	Country/Region	North America
Year	2012-2014	Model	Model S Charging Equipment	Version	All

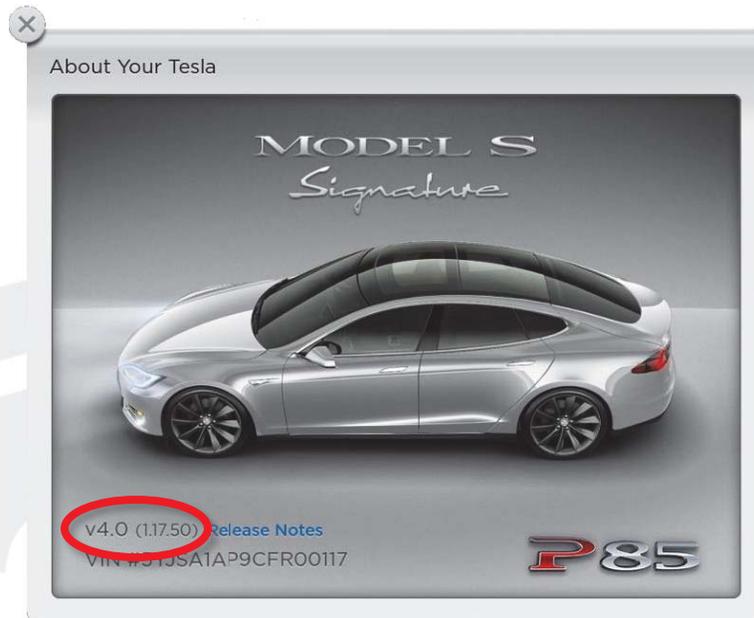
Figure 1

1. On the touchscreen, touch the Tesla logo. Check the version of the currently-installed firmware (Figure 1).

2. If the firmware version is 5.8.4 or later, the vehicle is up to date and no further work is needed. If the firmware version is earlier than 5.8.4, continue this procedure.
3. Connect a laptop with Toolbox to the vehicle.
4. In Toolbox, select Views > Firmware and ECU Programming > Vehicle Firmware Update, then follow the on-screen instructions.
