## PRODUCT SAFETY RECALL

**SUBJECT:** Inspect Power Steering Hoses

**MODELS:** 2015 Chevrolet Silverado 2500/3500 HD  
2015 GMC Sierra 2500/3500 HD

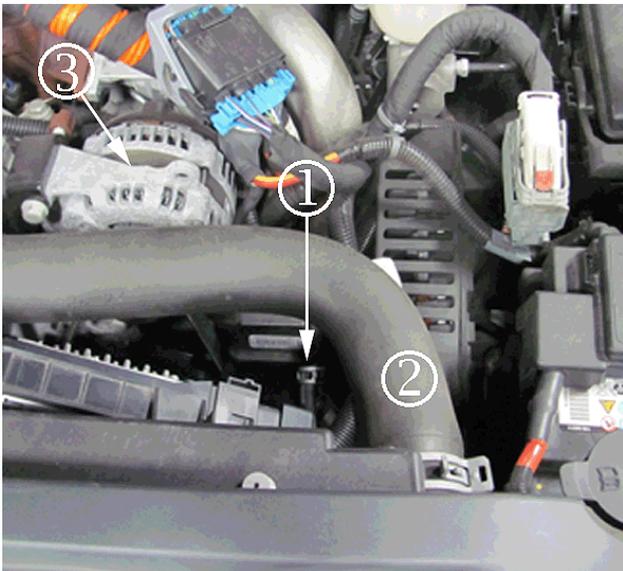
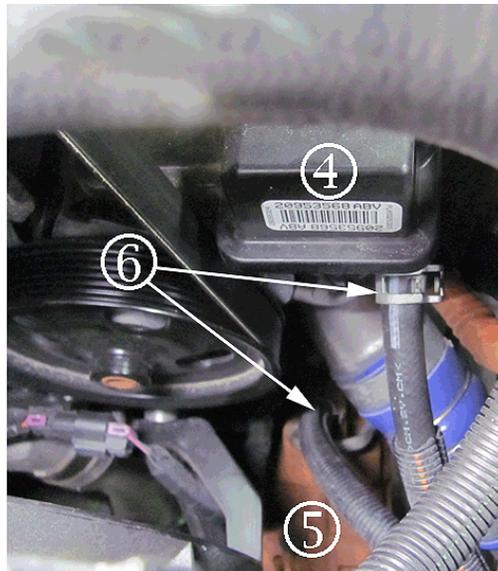
3940428

**Diesel engine shown in the photograph.**

**Note:** A stool is required to view and gain access to the power steering hose clamps at the power steering pump and power steering gear locations. The power steering pump and power steering gear are located (1) below the upper radiator hose (2) and alternator (3) on vehicles equipped with a diesel engine. Power steering pump (4), power steering gear (5) and power steering hose clamp locations (6) shown in diesel and gasoline engine photographs.

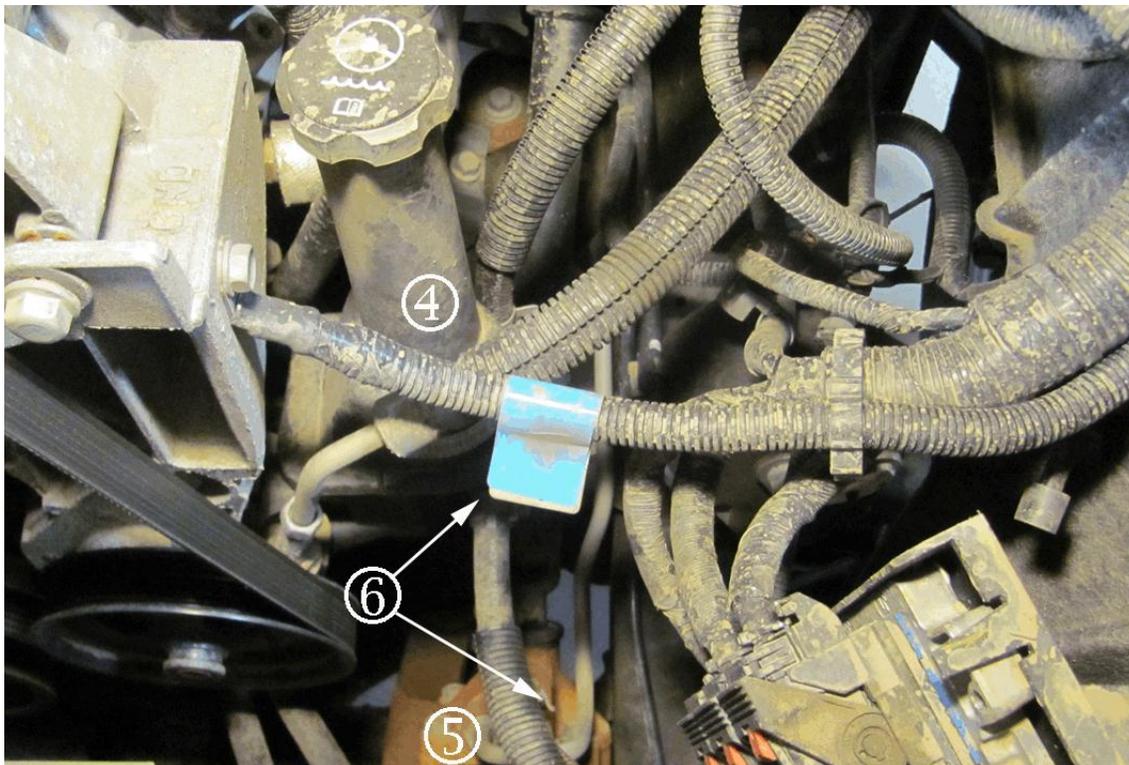
3940429

Gasoline engine shown in photograph.

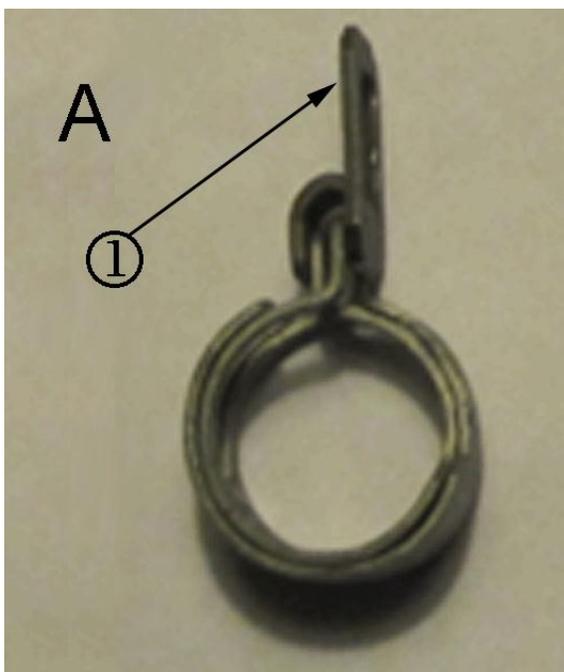
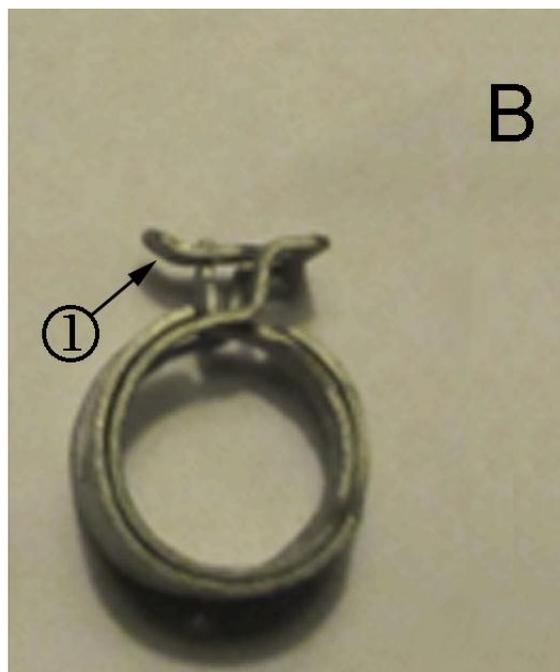
3940430

**Note:** There are two designs for the power steering hose clamp. The first design clamp (A) has an upright tab (1). Pull up on the tab (1) to release the pin and engage the clamp. The second design clamp (B) has a horizontal tab (1). Push up on the tab (1) to release the pin and engage the clamp. Refer to photograph. The power steering hose connection at the power steering gear and pump will be secure (tight) if the clamp is engaged. A long telescope-style mirror and light may be required to inspect the power steering hose clamps. Power steering fluid may be present on the power steering hose, pump or gear if a clamp is NOT engaged.

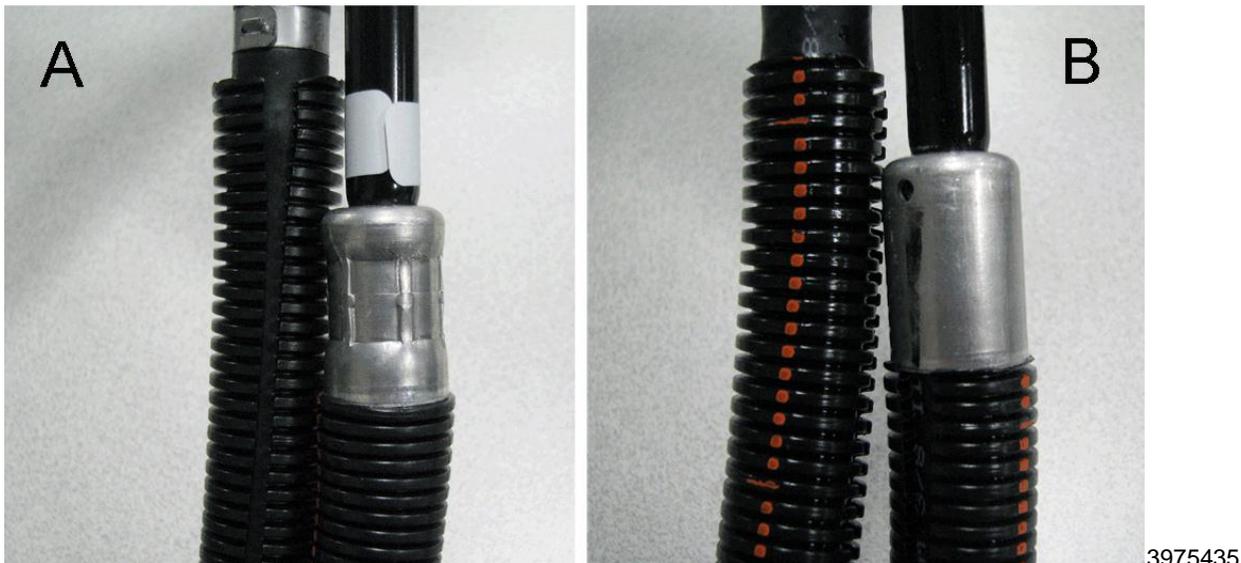
**(A) Crimp with swedge marks. This is a secure connection on the pipe ferrule.**

**(B) Crimp without swedge marks. This is NOT a secure connection on the pipe ferrule. Replace the power steering fluid cooler assembly.**

- If the power steering hose crimps are NOT secure and DO NOT show evidence of swedge marks, replace the power steering fluid cooler. Refer to Power Steering Fluid Cooler Replacement (Heavy Duty) in SI. Refer to the GM Electronic Parts Catalog (EPS) for parts information. Submit a separate warranty claim for the power steering fluid cooler replacement.
