## NEMA 14-50 Wall Adapter Upgrade, United States

| <b>Classification</b> | Recall Bulletin | <b>Section/Group</b> | 50 - External Charging Connectors | <b>Country/Region</b> | United States |
| <b>Year</b> | All | <b>Model</b> | Model S | <b>Version</b> | All |

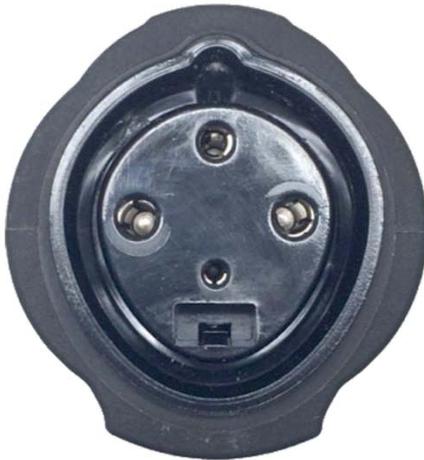
Factors such as corrosion, physical damage to receptacles, or the inappropriate wiring or installation of electrical outlets might cause higher than normal electrical resistance when charging with the Universal Mobile Connector (UMC) NEMA 14-50 adapter. When charging, higher-than-normal electrical resistance might cause excessive heating of the adapter.

Tesla Motors is recalling all black NEMA 14-50 adapters, which were included with all Model S vehicles that were delivered between September 15, 2012 and January 10, 2014. The new adapters with gray faces are not part of this recall.

Figure 1 (Old adapter with black faceplate)

Ensure that the vehicle has firmware version 5.8.4 or later. If the customer has not yet received the upgraded adapter by mail, provide the customer with an upgraded adapter if one is available in stock.

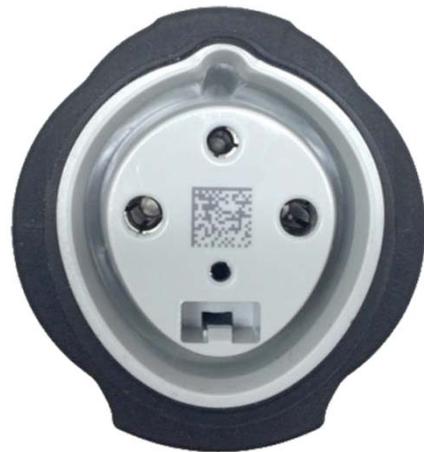
**NOTE:** Although the new adapter was originally designed with a thermal fuse to prevent overheating, the production version has strengthened materials and welds that prove to be more effective than the original design.

Figure 2 (New adapter with gray faceplate)
