PRO14-004USCA

Safety Recall Notice to End Users

NHTSA Recall #14E-046 of SKF 28554 and SKF 28555 wheel seal; SKF Recall # PRO14-003USCA

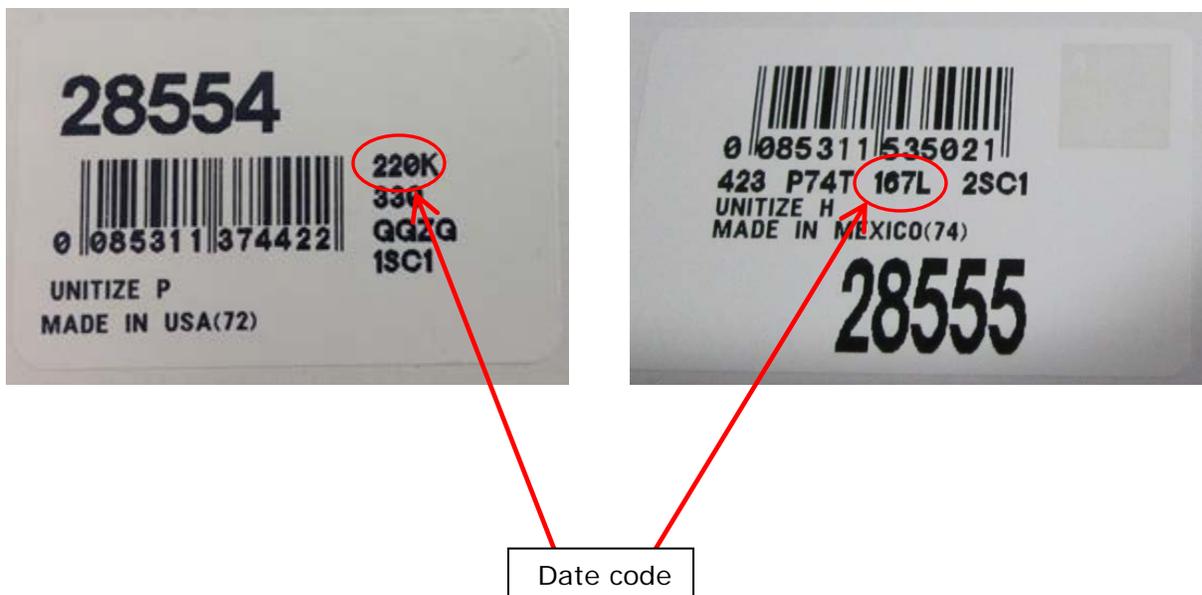
This recall includes SKF part numbers 28554 and 28555 that are identified by the date codes on the part number label. On part number 28554, date codes 203K through 228K (i.e. 203K, 204K, ... 227K, 228K). On part number 28555, all date code ranges are involved. These parts were sold exclusively in the aftermarket for use on the vehicles identified. **Important note: Only parts with one of these date codes are covered by this campaign.** The box part number label is shown below.

The location of the date code on the part number label is illustrated below:

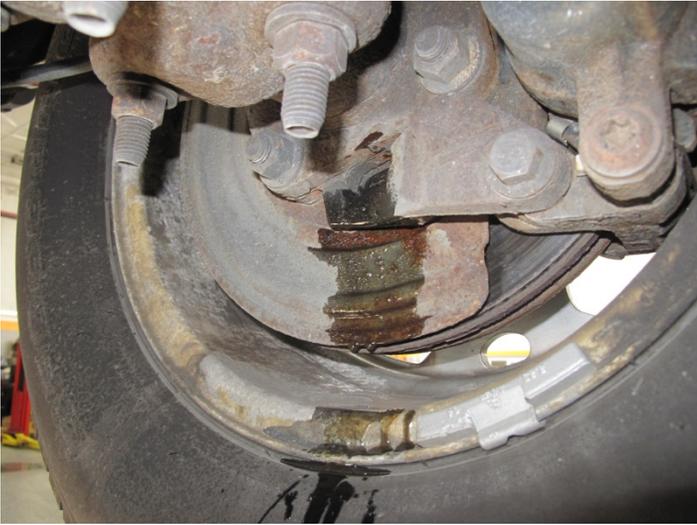
The defect in the wheel seal consists of the inside diameter of the seal being larger than specified. This defect may cause the gear oil to leak, which could contaminate the brake friction material. If contaminated, the friction material can be compromised. In extreme cases, the differential could lose too much gear oil, which could lead to premature bearing failure. The defect could cause a vehicle accident or crash resulting in severe personal injuries.

1. Raise and support the vehicle following the manufacturer's guidelines.
2. Carefully examine the back side of the wheel, tire, brake backing plate and axle housing flange for gear oil leakage. ***The affected wheel seal will have visible signs of gear oil leakage on the differential axle housing flange, the brake backing plate, the wheel and tire.*** Refer to Figures 1 & 2. Figure 1 illustrates a wheel end with a gear oil leak. Figure 2 illustrates a wheel end with no gear oil leak.

Figure 1
Defective – oil leak

If you have identified a wheel seal that is defective, remove the defective wheel seal and replace it with a non-defective replacement wheel seal using the manufacturer's recommended repair procedures. Replace friction material as required using the manufacturer's recommended repair procedures. Return the defective wheel seal to the place of purchase for reimbursement as identified above.

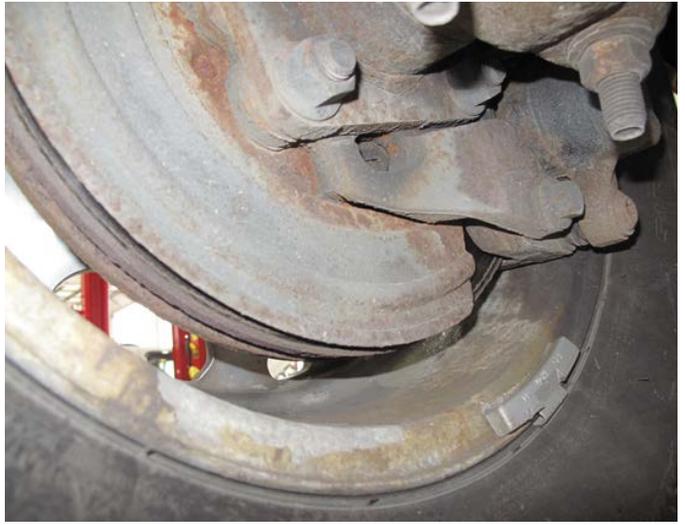
Figure 2
OK – no oil leak
