## **IMPORTANT SAFETY RECALL – 14V-xxx**

## SN-611-14

SUBJECT: *Muncie PTO switch leakage on Ford 6.8L Gas engines*

Re: Ford Super Duty Chassis with 6.8L gas engine and Muncie FR67 Series PTO

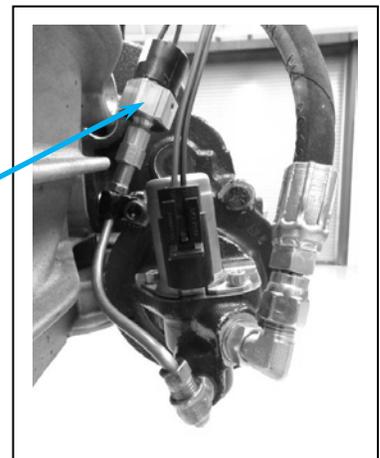
Muncie Power Products has issued a recall on FR67 series Power Take Off (PTO), when installed on Ford F350 to F550 with 6.8L Gas engine from June 1, 2009 through 2013. The Terex part number for the PTO is 94467 and the Muncie number is FR67-F1506-G4NX. A pressure switch attached to the PTO can develop a leak onto the exhaust if the thermal blanket is damaged. **Oil leaking onto the hot exhaust can result in a fire.**

Note: The PTO is located on the side of the transmission. The switch is located on the front of the PTO.

Switch to inspect for leakage

Immediately inspect affected vehicles for any oil leakage from the PTO switch and the condition of the thermal blanket around the exhaust pipe in front of and below the PTO. If the switch is leaking immediately remove the vehicle from service and replace the switch. Also inspect the thermal blanket around the exhaust pipe in front of and below the PTO for damage. Replace the thermal blanket if damaged.
