**NHTSA Safety Recall
No. 14V-327**

IMPORTANT SAFETY RECALL

QA 11-04**QUALITY ALERT**

Pressure Switch and Exhaust Thermal Blanket Inspection

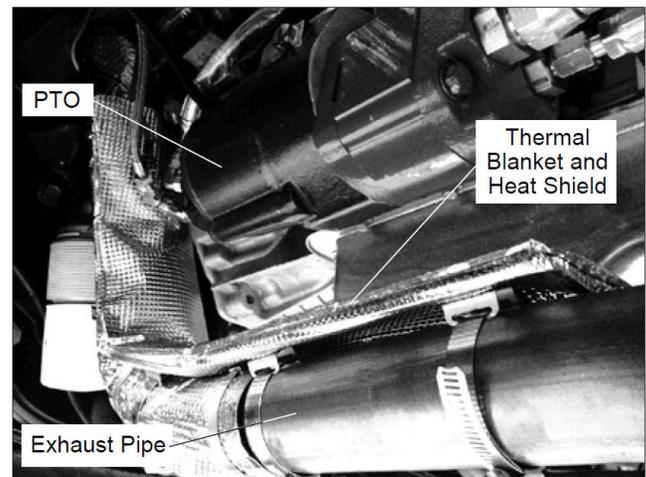
Figure 1 — Thermal Blanket

Stahl/Arbortech has been made aware of a possible issue concerning a pressure switch and exhaust thermal blanket (Figure 1) provided by the supplier of the power take off (PTO). Over time, the pressure switch can develop a low volume transmission fluid leak and the exhaust thermal blanket can deteriorate causing it to absorb hydraulic oil or transmission fluid. A buildup of oil or transmission fluid on the thermal blanket may increase the possibility of a fire. **Death or serious injury can result from a chassis fire.**

There is a Pressure Switch Relocation Kit, part number 43TK5532 available to move the switch away from the exhaust. This kit includes a new pressure switch, tubing, and adapters. If the exhaust thermal blanket fails the inspection and/or there is evidence of a pressure switch leak, remove the exhaust thermal blanket at the time of the inspection and install an improved Exhaust Heat Shield Kit, part number 970510446, within 30 days of removal of the exhaust thermal blanket. Pressure switches that pass the inspection must still have the Pressure Switch Relocation Kit installed at the next service interval.

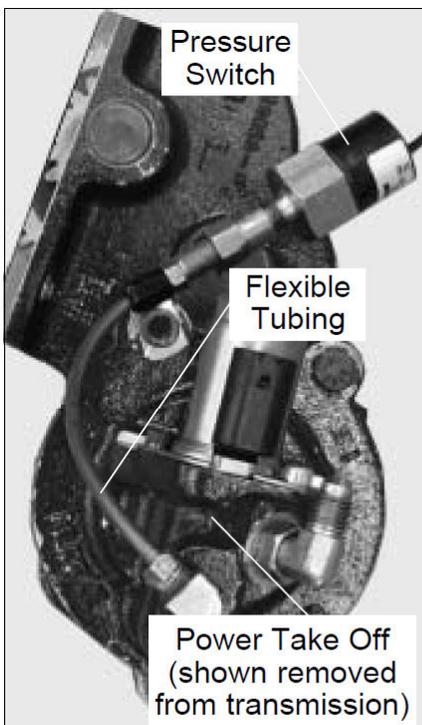
Figure 2 — Front Pressure Switch Location

1. Position unit on a level surface, apply the parking brake and chock the wheels. Shut off engine and allow the chassis exhaust system to cool to the touch.
2. Using a mechanic's creeper, get under the chassis near the PTO on the driver's side of the transmission.
3. Find the thermal blanket that is attached with band clamps to the exhaust system near the PTO.
4. Use your hand to determine if the thermal blanket is wet with fluid. Look at the pressure switch to see if it is leaking transmission fluid. The pressure switch is located either on the front side of the PTO connected to a flexible tube (Figure 2) or on the side near the rear of the PTO connected to a formed tube (Figure 3.)
