Service Bulletin

SAFETY and EMISSIONS RECALL

2014 NSS300/A (Forza) FUEL PUMP REPLACEMENT

**NSS300 #1
NOVEMBER 2014**

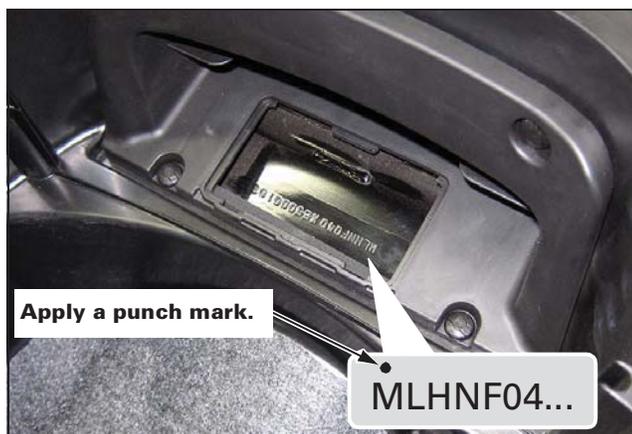
After you have completed the REPAIR PROCEDURE, apply a punch mark above the first character of the VIN located on the frame, under the tool box, inside the luggage box as shown.

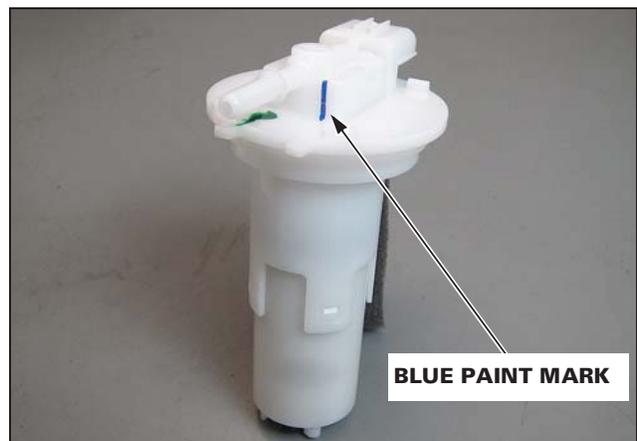
Be careful not to mix up the defective and replacement parts. The countermeasure part is identified by a blue paint mark as shown. Use care during unpacking and installation as the paint mark is easily wiped off.
