SAFETY RECALL BULLETIN

SUBJECT:			No: SR-14-012
LANCER FRONT PASSENGER AIR BAG INFLATOR – SAFETY RECALL CAMPAIGN			DATE: December, 2014
			MODEL: 2004-05 Lancer
CIRCULATE TO:	<input checked="" type="checkbox"/> GENERAL MANAGER	<input checked="" type="checkbox"/> PARTS MANAGER	<input checked="" type="checkbox"/> TECHNICIAN
<input checked="" type="checkbox"/> SERVICE ADVISOR	<input checked="" type="checkbox"/> SERVICE MANAGER	<input checked="" type="checkbox"/> WARRANTY PROCESSOR	<input checked="" type="checkbox"/> SALES MANAGER

PURPOSE

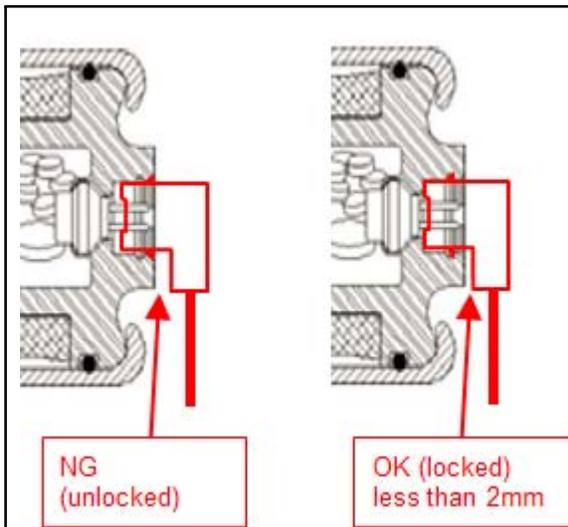
Measure the distance between the inflator and the wiring connector to ensure it is less than 2mm.

If the distance is more than 2mm, the connection is NG.

21. Ensure the connector is completely inserted into the electrical socket.
