PRODUCT SAFETY RECALL

SUBJECT: Hood Striker Corrosion

MODELS: 2013-2015 Chevrolet Spark

GM Recall #14456

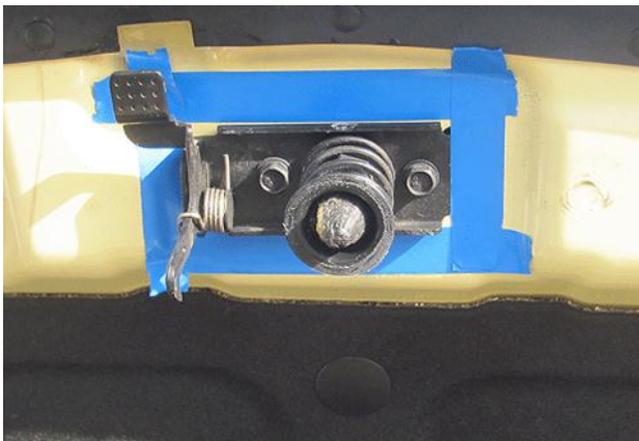
3997083

1. Raise the hood.
2. Locate the hood latch striker assembly, mounted on the hood.

3. Using masking tape, mark the location of the striker assembly.
4. Remove the striker assembly. Save the fasteners, they will be reused.
5. Install the new striker assembly. Align the striker using the masking tape.

6. **Tighten** 8.5 N.m (75 lb in).
7. Inspect the hood for proper alignment.
8. Remove the masking tape from the hood.
