PART 573 Defect and Noncompliance Report

On December 6, 2013 Hino Motors Sales U.S.A., Inc. decided that (a defect which relates to motor vehicle safety) exists in the motor vehicles listed below, and is furnishing notification to the National Highway Traffic Safety Administration in accordance with 49 CFR part 573 Defect and Noncompliance Reports.

**Model(s):** ND8J, NE8J and NF8J

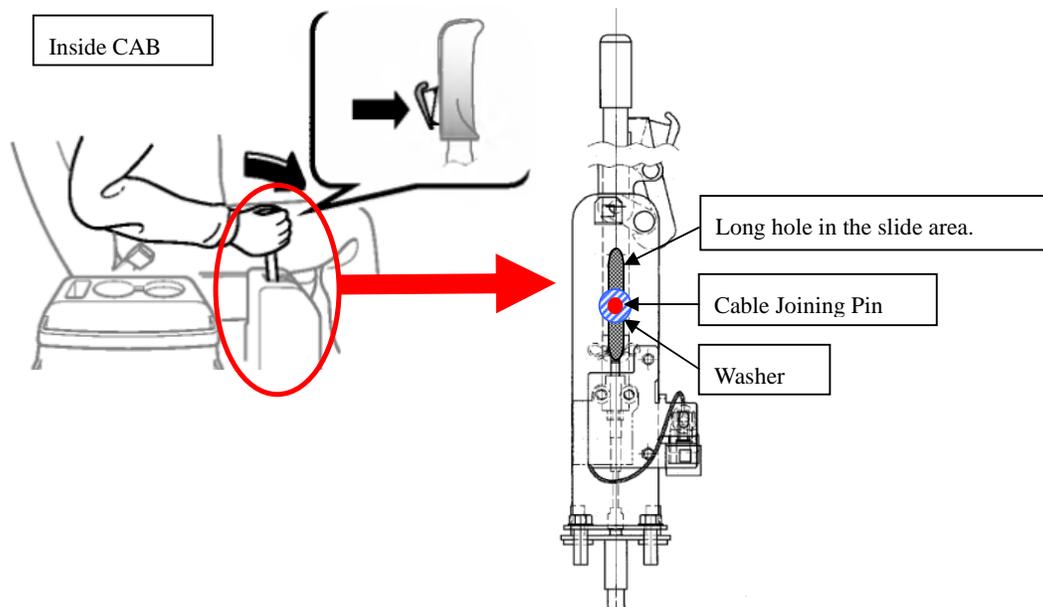
When the parking brake lever is pulled, the washer fixed to the cable joining pin of the parking brake lever can become stuck in the worn and enlarged “long hole” in the slide area. Please refer to the illustration below for details.

If the parking brake is not released in accordance with the instructions in the Driver's/Owner's Manual (such as releasing the parking brake lever only by pushing the lever release button, without holding the lever with the hand, until it is completely released), the tension of the brake cable could be released quickly, causing an increase in the friction between the long hole in the slide area and the cable joining pin. In addition, improper adjustment of the parking brake cable that is stretched due to repeated operation of the parking brake could increase the contact force between the cable joining

pin and the long hole in the slide area of the parking brake lever during the operation of the parking brake. If the parking brake continues to be operated in such a condition, the long hole in the slide area of the parking brake lever becomes worn and the long hole diameter becomes enlarged.

The washer fixed to the cable joining pin can become stuck in the worn and enlarged long hole when the parking brake lever is pulled. This situation may prevent the parking brake lever being pulled to its full stroke, leading to the application of insufficient brake force. In the worst case situation, vibration can cause the washer which is stuck in the worn and enlarged long hole to come off, releasing the parking brake lever and resulting in the vehicle moving.

We will measure abrasion loss on the long hole of the slide area of the parking brake lever of all the subject vehicles, and if the abrasion loss does not exceed a specified value, install a new larger washer to the cable joining pin to avoid the washer becoming stuck in the enlarged long hole. In the event the abrasion loss exceeds the specified value, replace the parking brake lever and install the larger washer.

Install a new washer with a larger diameter than the original washer.
