<b>GROUP</b> <b>Safety Recall Campaign</b>	<b>MODEL</b> <b>2014MY Forte (YD) w/1.8L and 2.0L Engines</b>
	<b>NUMBER</b> <b>SC 113</b>	<b>DATE</b> <b>February 2014</b>
<b>VOLUNTARY SAFETY RECALL CAMPAIGN</b>		
<b>SUBJECT: COOLING FAN RESISTOR AND/OR MULTI-FUSE UNIT REPLACEMENT (SC 113)</b>

This bulletin provides the procedure for replacing the cooling fan resistor and/or multi-fuse unit in certain 2014MY Kia Forte (YD) vehicles equipped with a 1.8L or 2.0L engine. Under certain circumstances, the cooling fan resistor can melt and create the risk of a potential fire. The Vehicles produced from December 5, 2012 through January 27, 2014 will have the cooling fan resistor and multi-fuse unit replaced. The vehicles produced from January 28, 2014 to April 17, 2014 will have only the multi-fuse unit replaced. For vehicles equipped with 1.8L engines, the ECU will also be reprogrammed. Kia is requesting the completion of this recall campaign on all affected vehicles. Before conducting the procedure, verify the vehicle is included in the list of affected VINs.

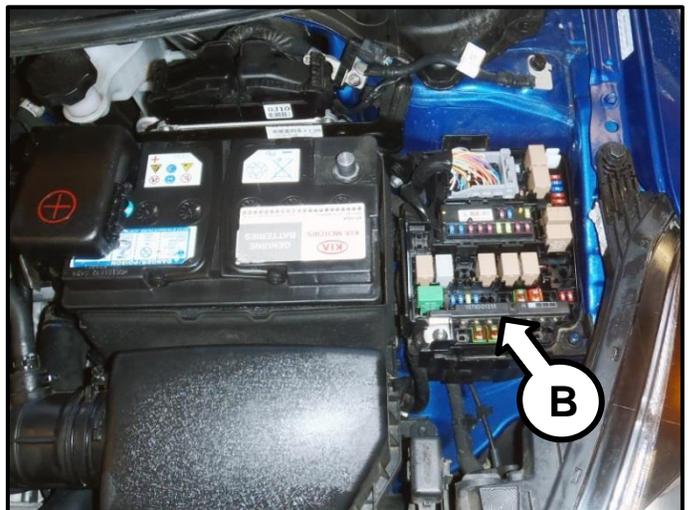
4. Locate the multi-fuse unit (B) at the front of the engine room fuse box.
