Recall Bulletin

PRODUCT SAFETY RECALL

SUBJECT: Rear Axle Shaft Not Properly Heat Treated

MODELS: 2015 Chevrolet Silverado 1500
2015 GMC Sierra 1500

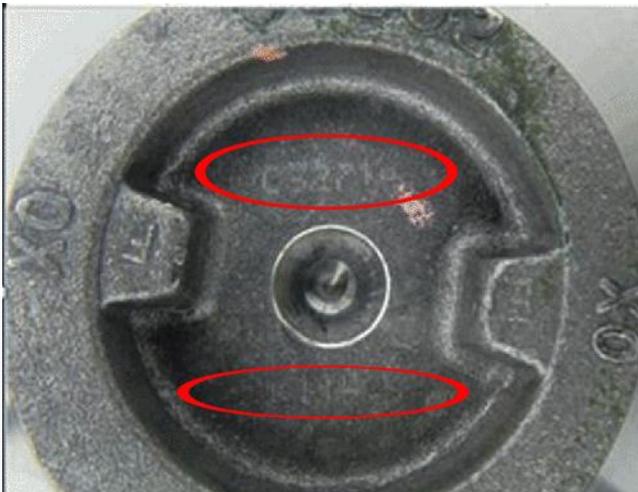
4051503

2. Locate the manufacturing code numbers located in the end of the left and right axle shafts. This code consists of two sets of numbers, one above the center point of the axle beginning with a “C” and one below beginning with a “K”.
3. If the code reads, C327-K138 or C326-K106, Replace the axle shaft. Refer to *Rear Axle Shaft Replacement* in SI.
