Follow Up Meeting with NHTSA

February 7, 2013

EA11-003 TDI High Pressure Fuel Pump

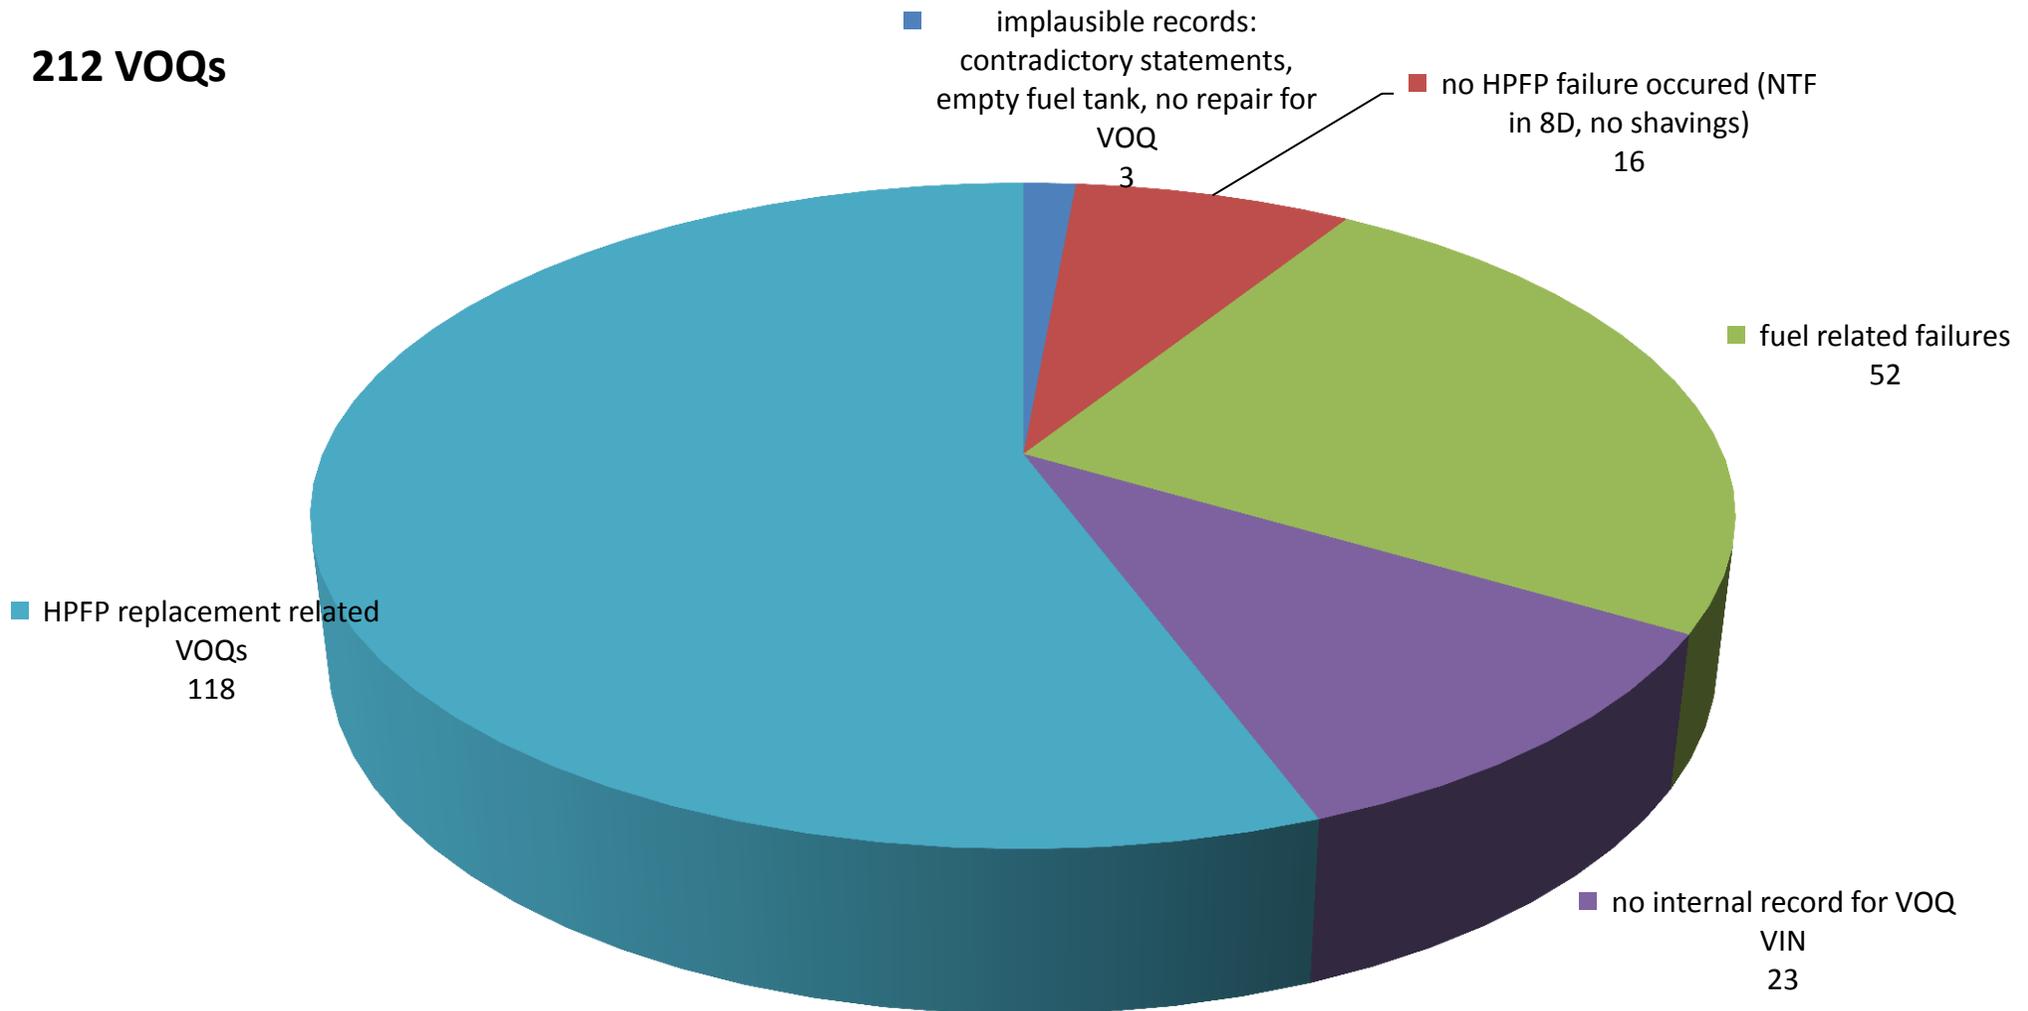
Case assessment for VOQs provided by NHTSA

- NHTSA provided 213 VOQs for evaluation
- 1 VOQ (10451977) was excluded from evaluation as the cause was a fractured fuel line (subject to recall 11V-490)
- The following slides are based on review of the 212 remaining VOQs

212 VOQs

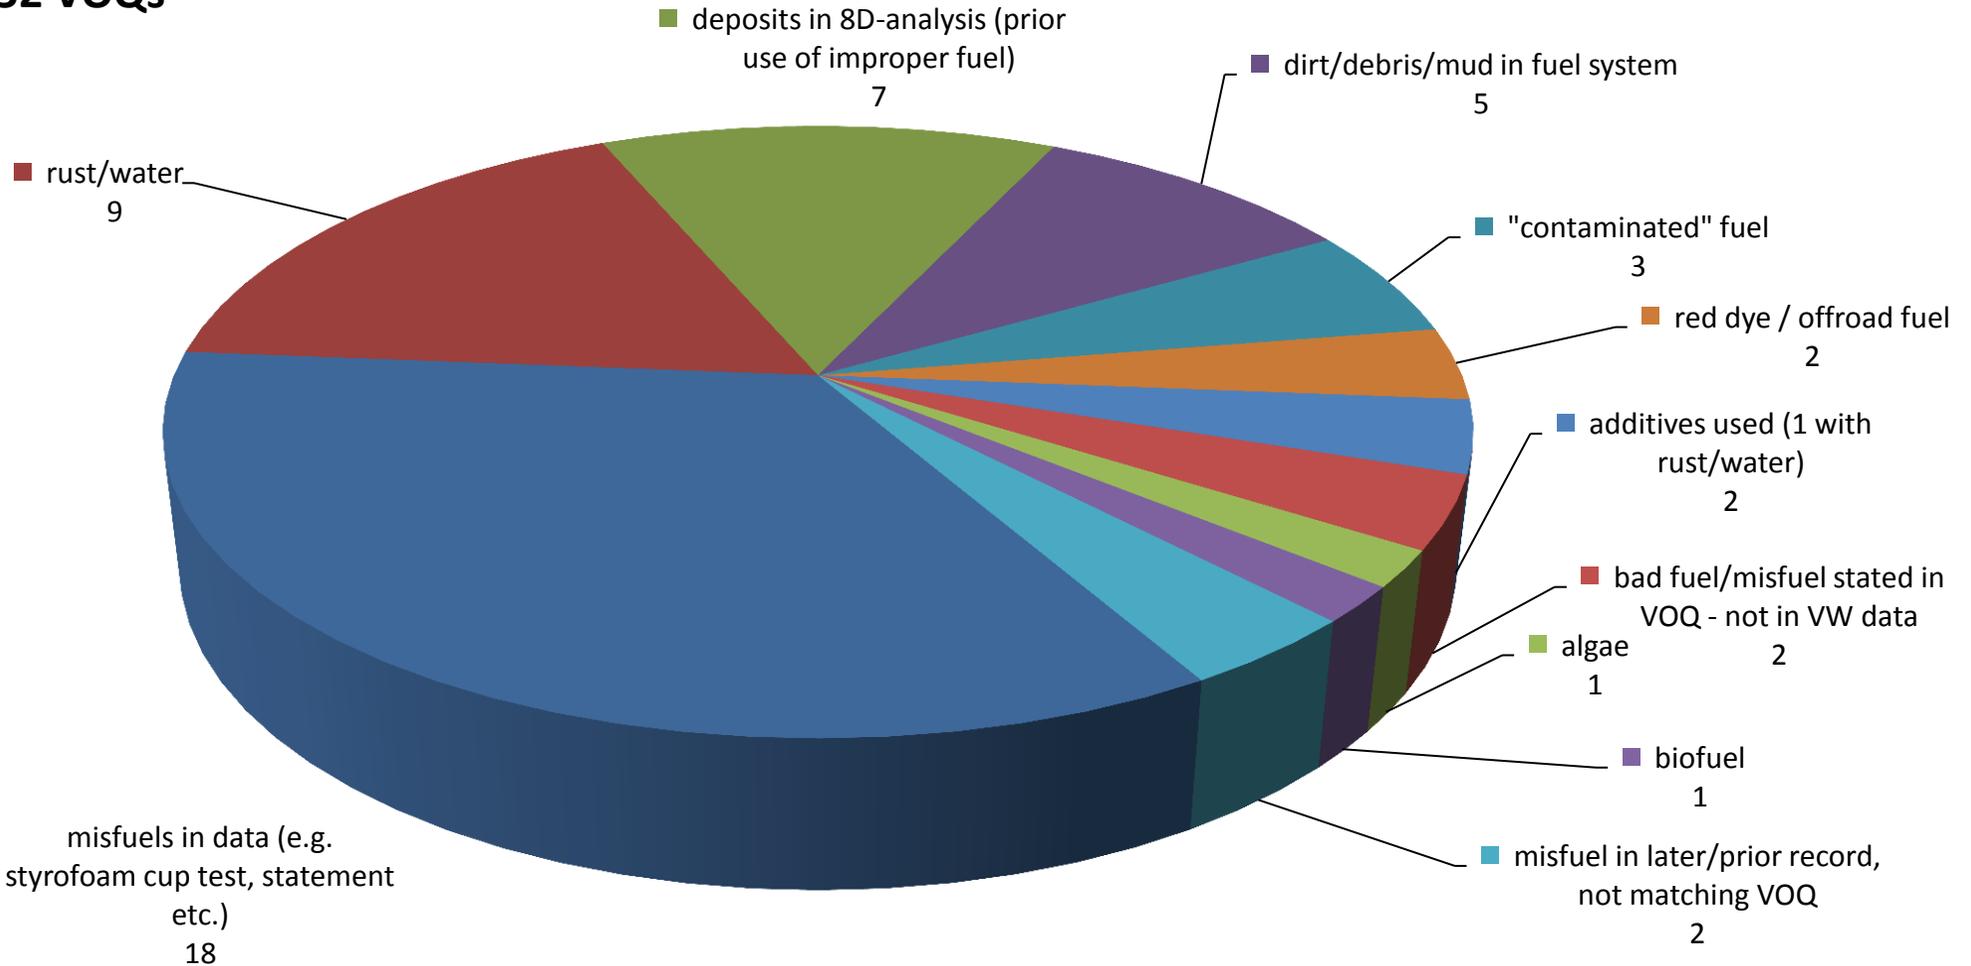
Details for Fuel Related VOQs – 52 VOQs

52 VOQs

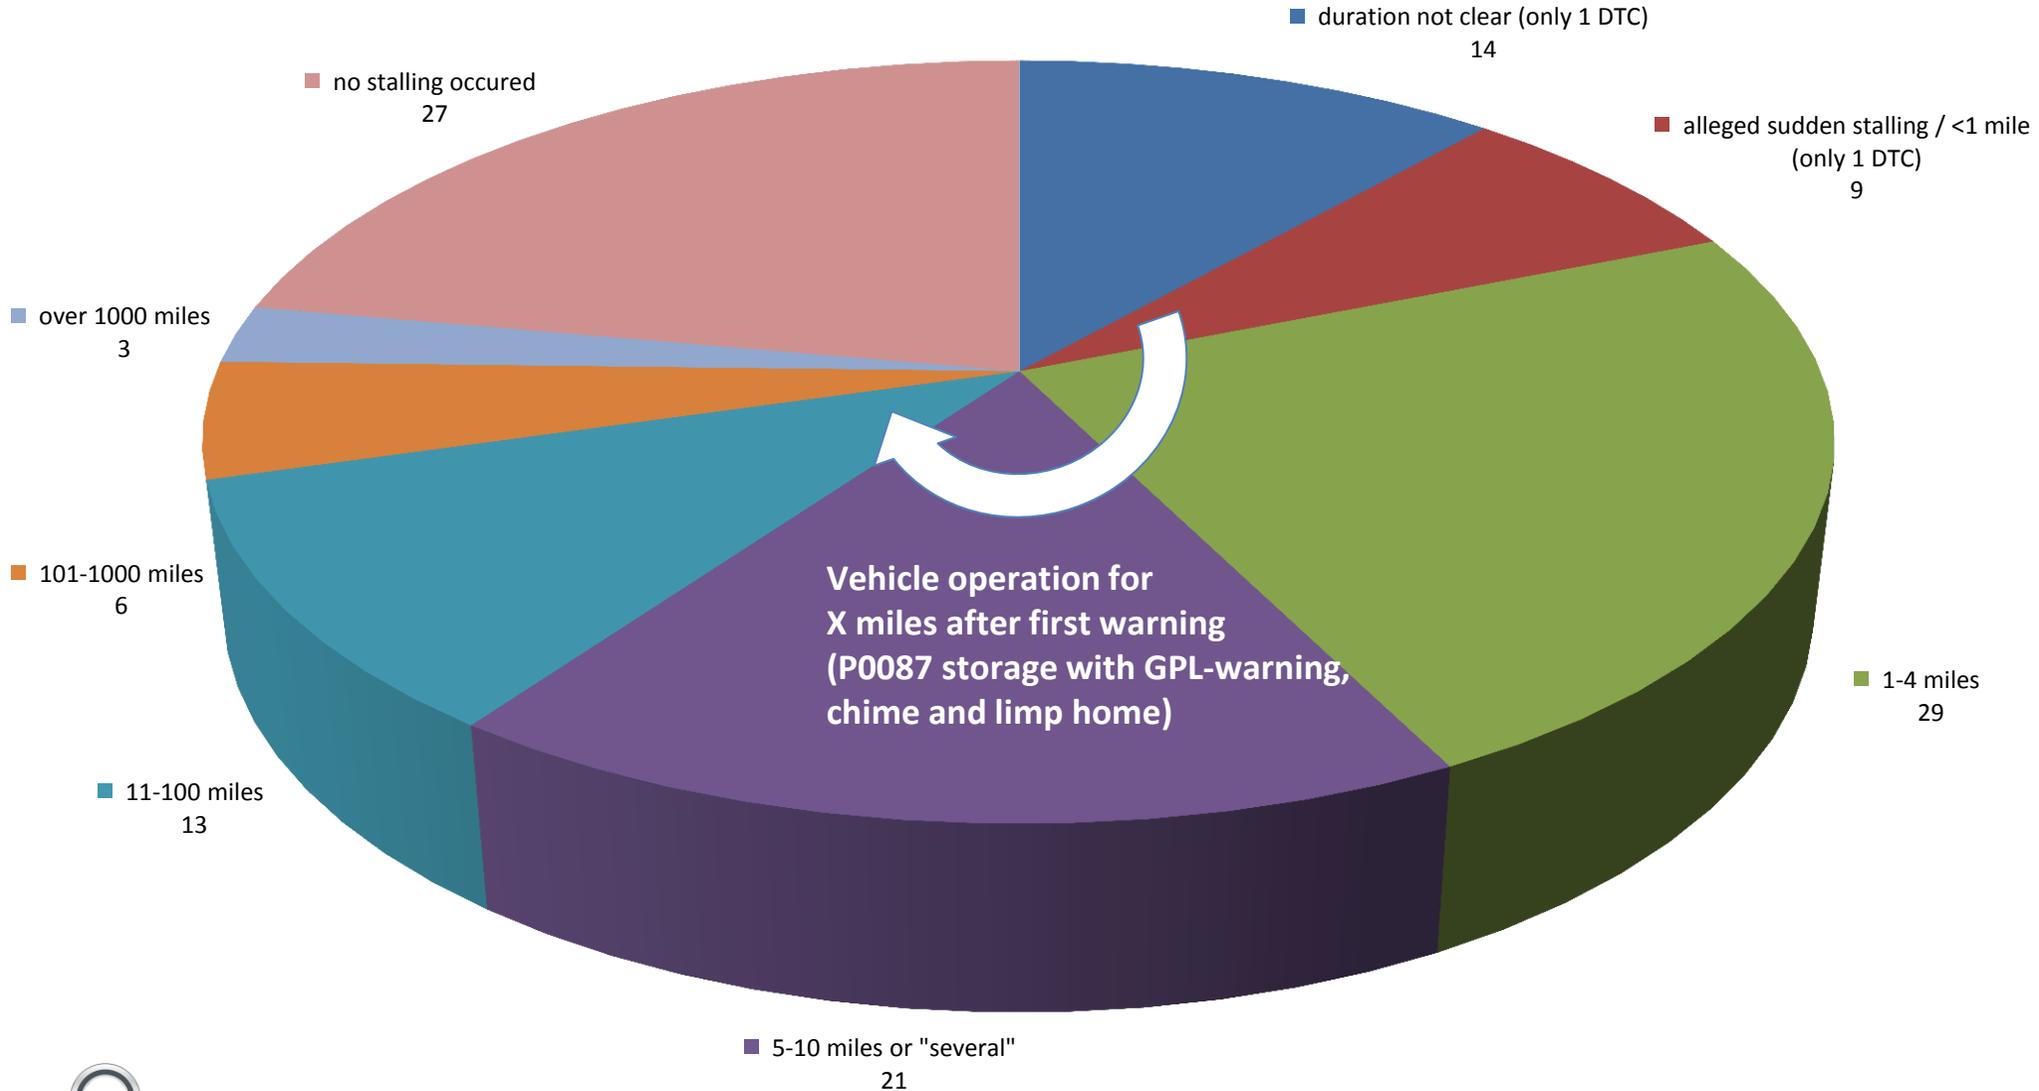
DTC recording duration (122 VOQs)

- Several recordings of P0087 or other DTCs after P0087 was stored, indicate continued operation after warning and limp home occurred.
- Recording of codes over several miles indicated, that no sudden stalling without warning occurred. However, as for example ignition cycles are not recorded, this is no absolute proof.
- Warning duration is primarily estimated from log, secondary from customer verbatim and other data.

- Single recording of one P0087 DTC may result from only one control mode being affected and does not allow the direct conclusion of a sudden stalling.
- For example VOQ 10475371 shows only one P0087 DTC and customer expressively states „no stalling“.
- Volkswagen's understanding here is, that a customer complaint of „sudden“ can neither be proved nor disproved when only one DTC was recorded.
- Here the customer verbatim is the only source of information.
